Report on Building Damage in Northern Ibaraki Prefecture by
The 2011 off the Pacific Coast of Tohoku Earthquake
Released on March 30, 2011

Dr. Toshiyuki Kanakubo and Dr. Akira Yasojima
Dept. of Engineering Mechanics and Energy
University of Tsukuba
(Translated by Shunsuke Otani)

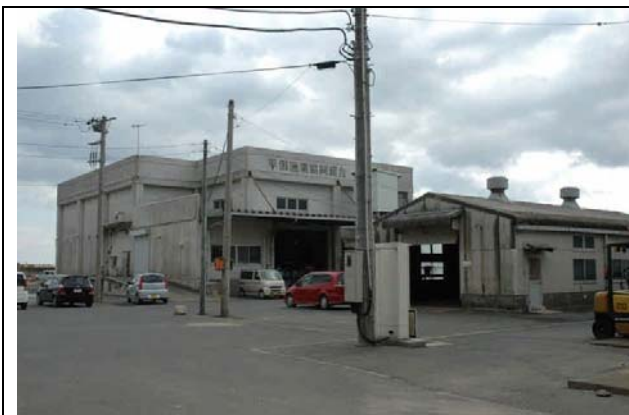
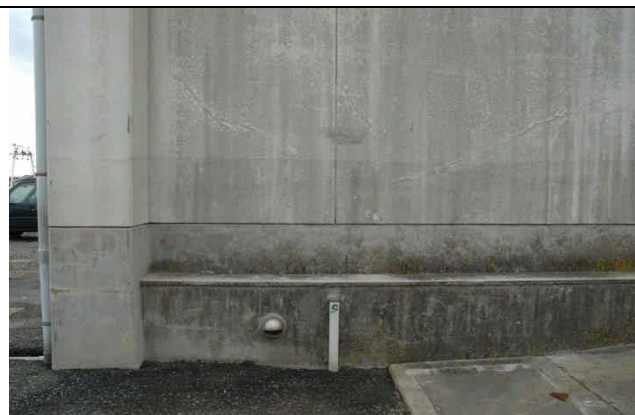
Photo 1: Shear cracks on Fisherman's Cooperative Association Building.

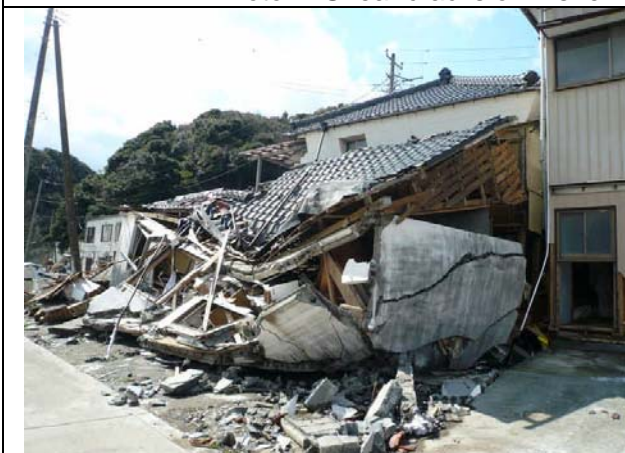
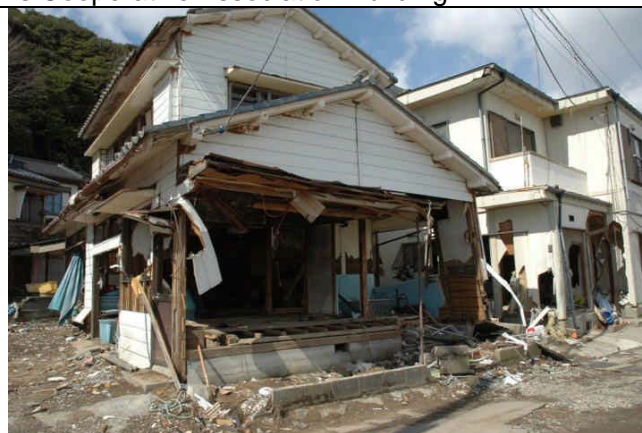
Photo 2: Damage of houses due to tsunami attacks.

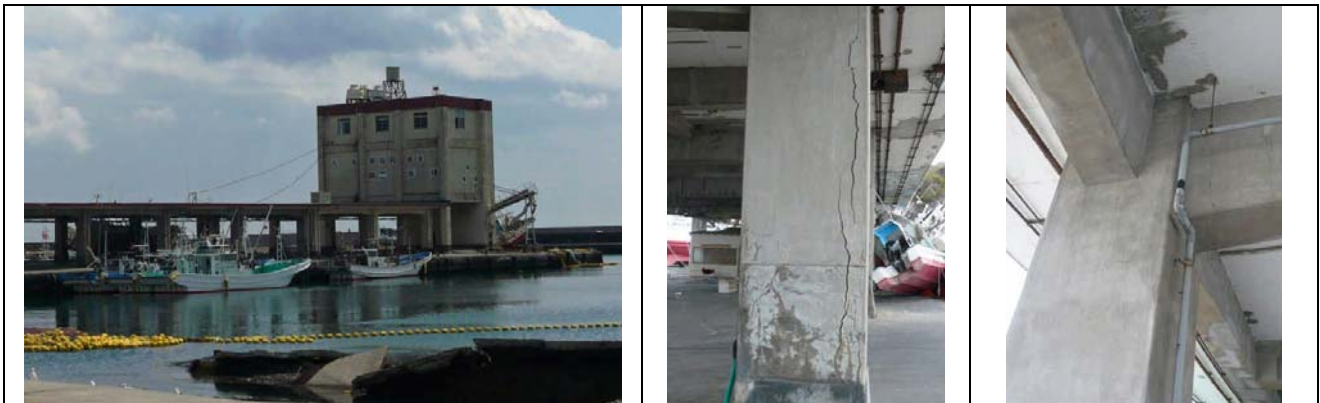
In the Fisherman's Cooperative Association Building, longitudinal cracks were observed along the cover concrete of columns, flexural cracks in girders (Photo 3), and diagonal shear cracks in walls (Photo 4).

Photo 1: Cracks in a column and a girder in the Fisherman's Cooperative Association Building.

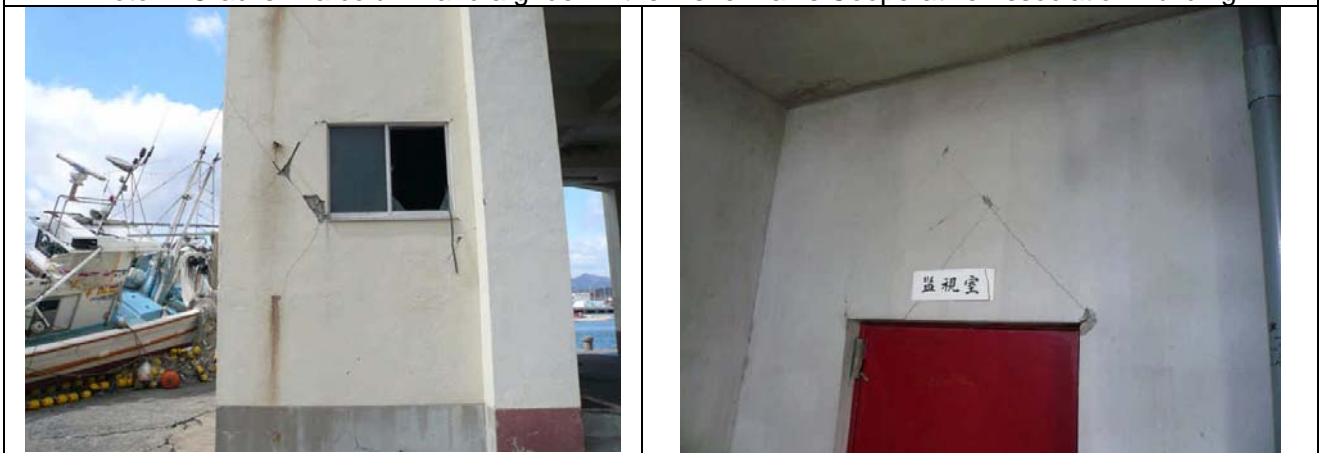
Photo 4: Diagonal cracks in walls in the Fisherman's Cooperative Association Building.

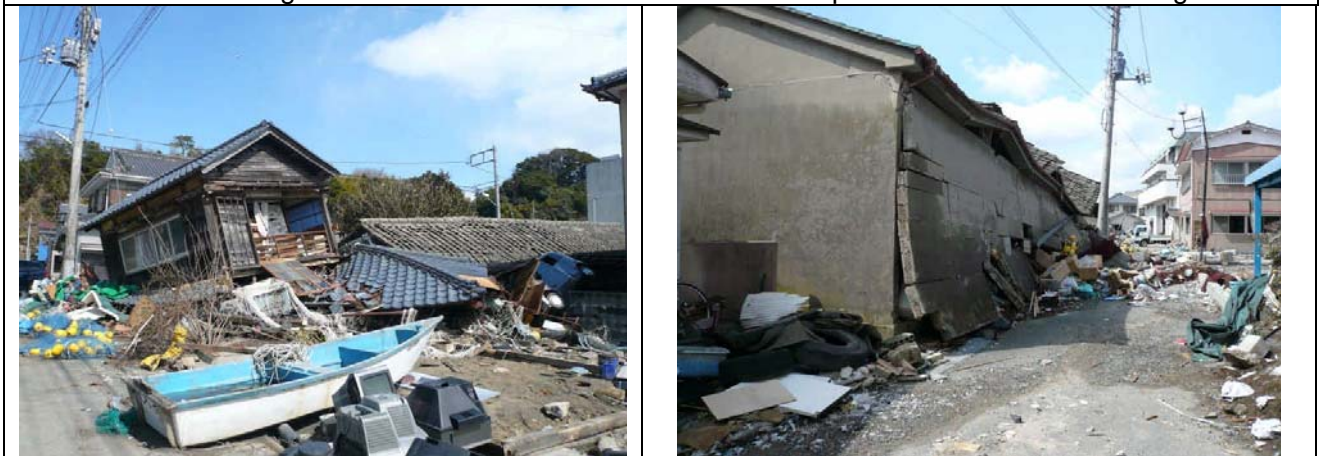
The damage by tsunami was severe in the port.

Photo 5: Damage of houses due to tsunami attacks.

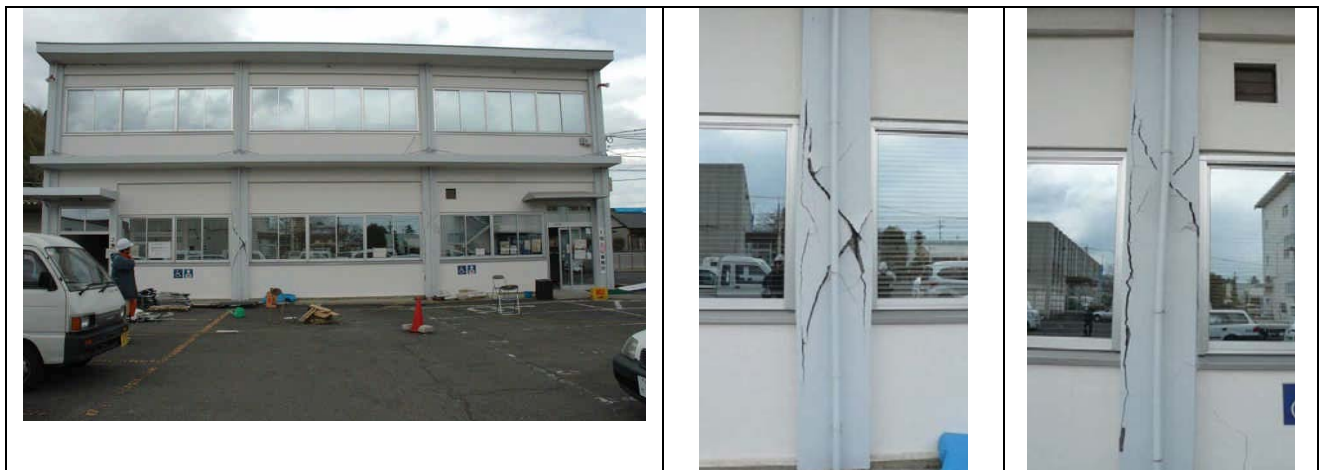
Many shear cracks were observed in the main (constructed in 1958) and second (constructed in 1964) municipal buildings; the entrance into two buildings was prohibited (Photos 6 to 8).

Photo 6: Shear failure of columns in Second Municipal Building.

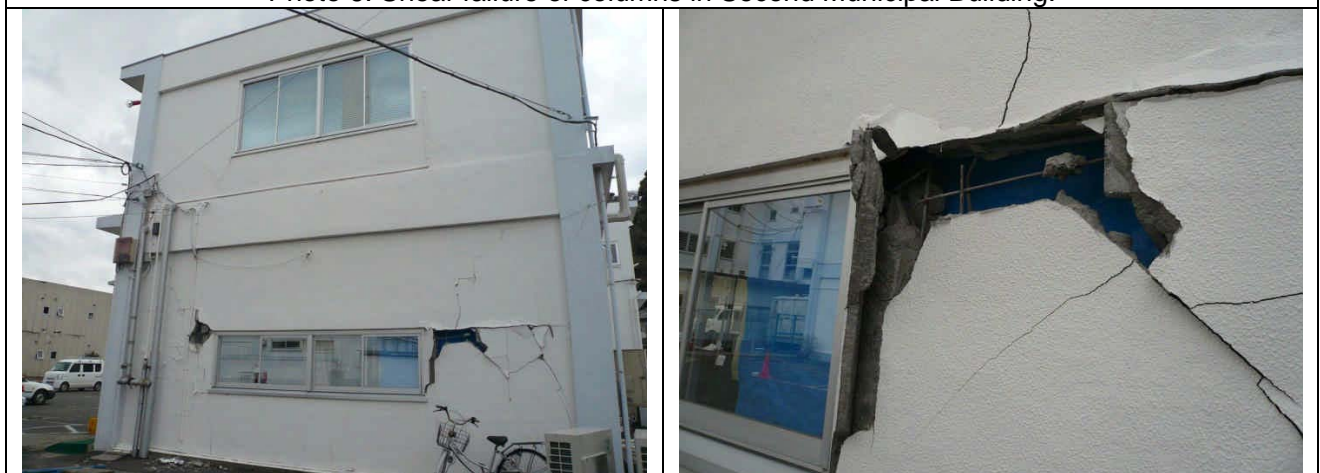
Photo 7: Damage of an end wall in Second Municipal Building

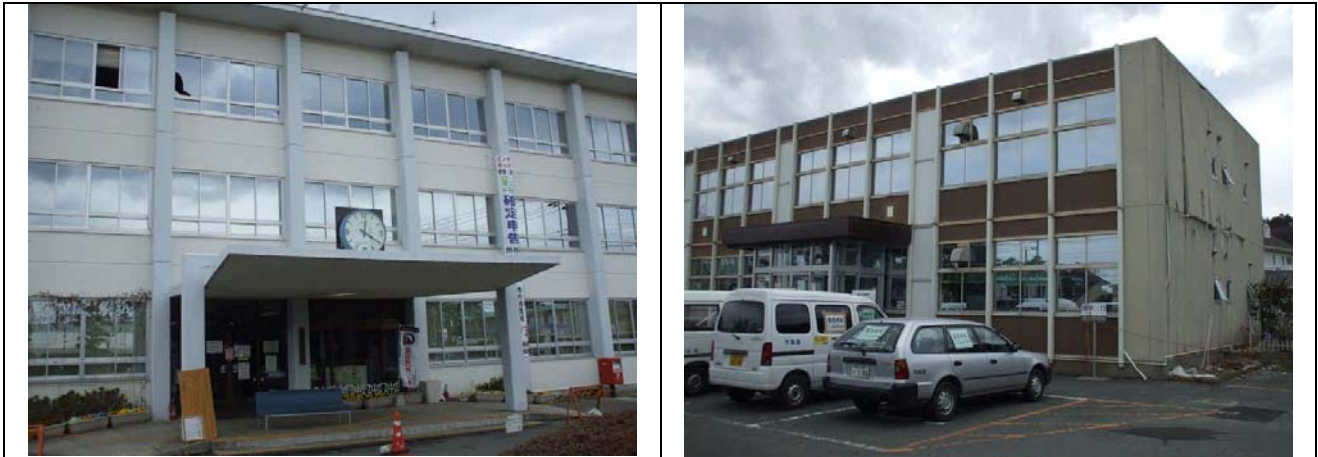
Photo 8: Main(left) and Third (right) Municipal Buildings (light cracking in Main Building and damage in exterior wall panels in the Third Building)

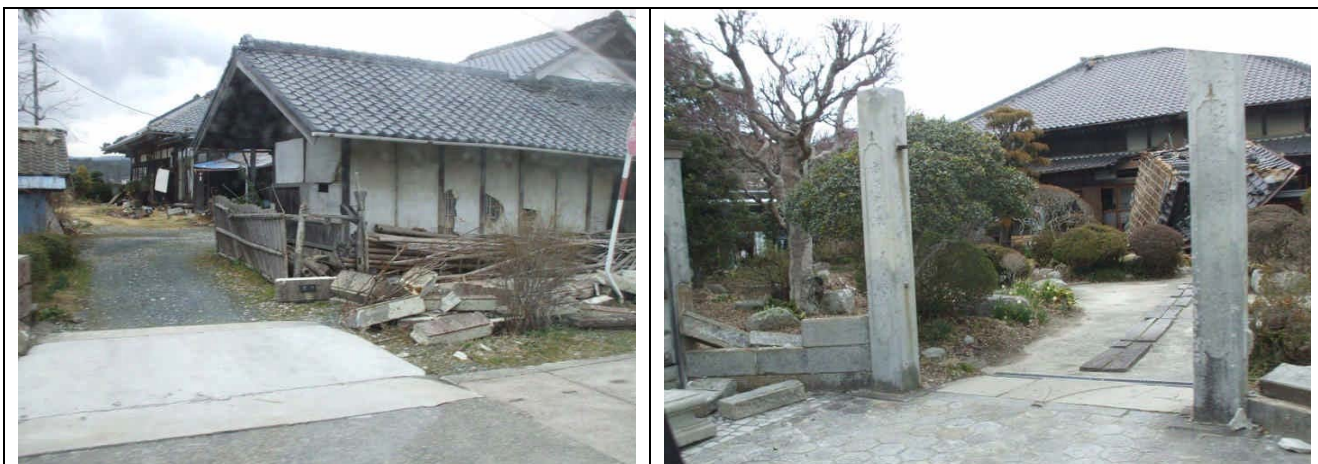
Soil liquefaction, half destruction of houses, fall of roof tiles were seen in Shimo-teduna district (Photo 9).

Photo 9: Damage in a detached house and fall of masonry walls and roof tiles.

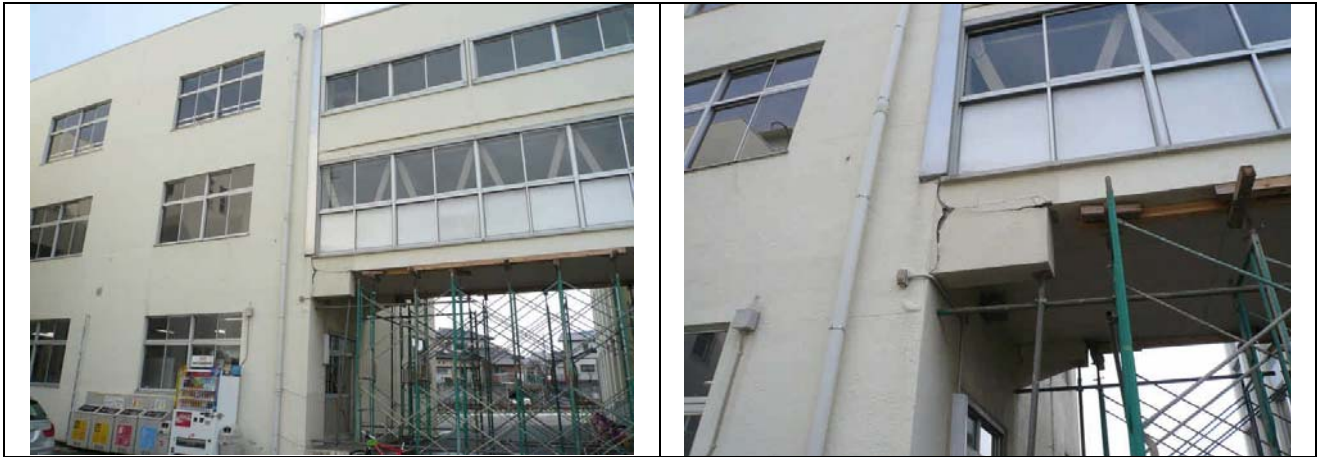
Photo 10: Damage of a protruding part of Hitachi City Municipal Office Building

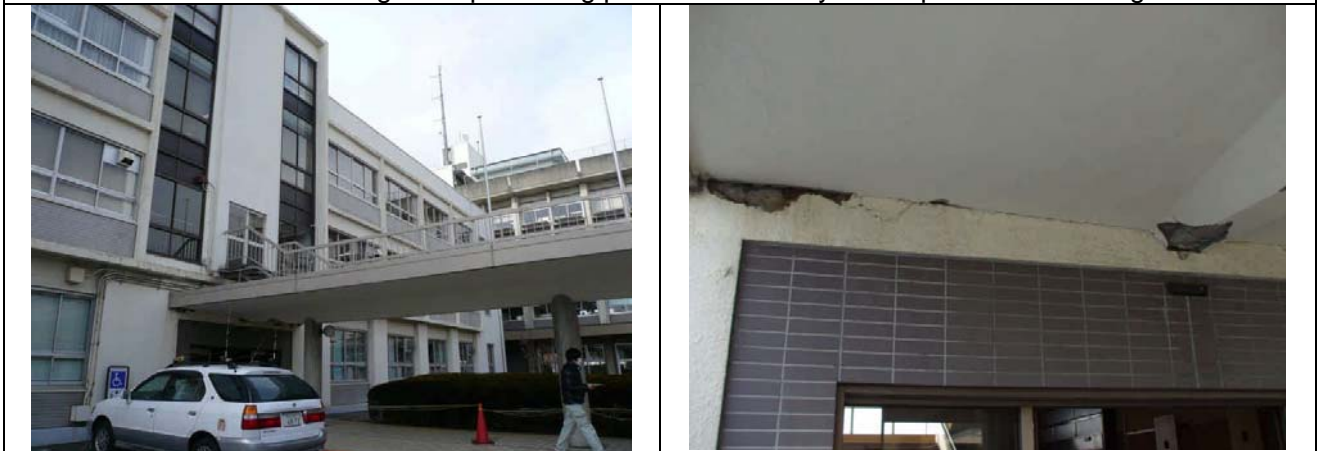
A connecting corridor between two Municipal Buildings, constructed in 1965, suffered light cracking (Photo 11).

Photo 11: Cracking in the connecting corridor of Hitachi City Municipal Office Buildings

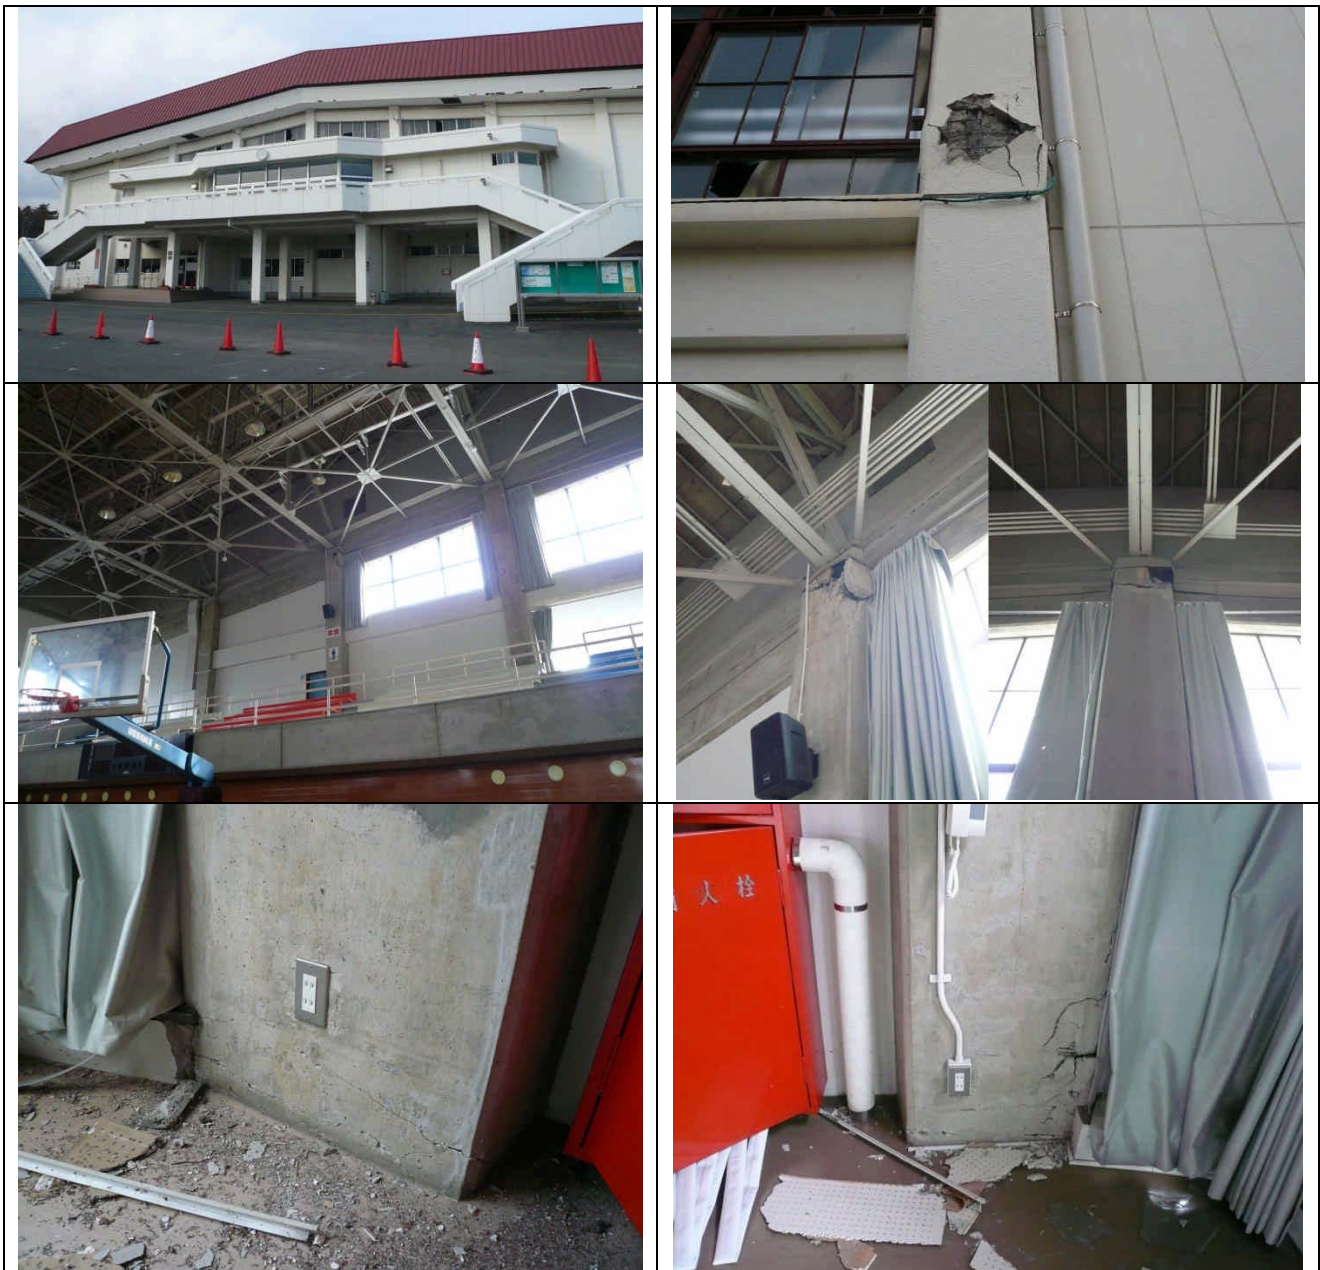
Damage of Municipal Central Gymnasium was observed in the second story column (Photo 12). Crushing and spalling of concrete was observed at the top and bottom of second story exterior columns. Bracing members in the ceiling buckled and also fractured at the welding (Photo 13). Shear cracks were observed in the entrance walls (Photo 14). Glasses and interior finishing panels fell down.

Photo 12: Damage observed in Hitachi City Municipal Central Gymnasium

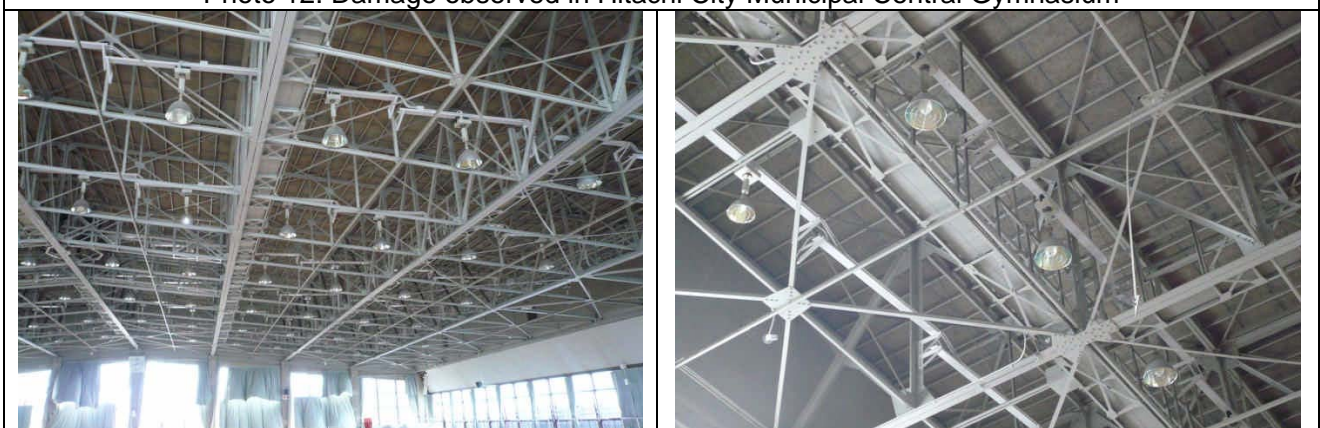
Photo 13: Damage on brace members (left: buckling, right: fracture)

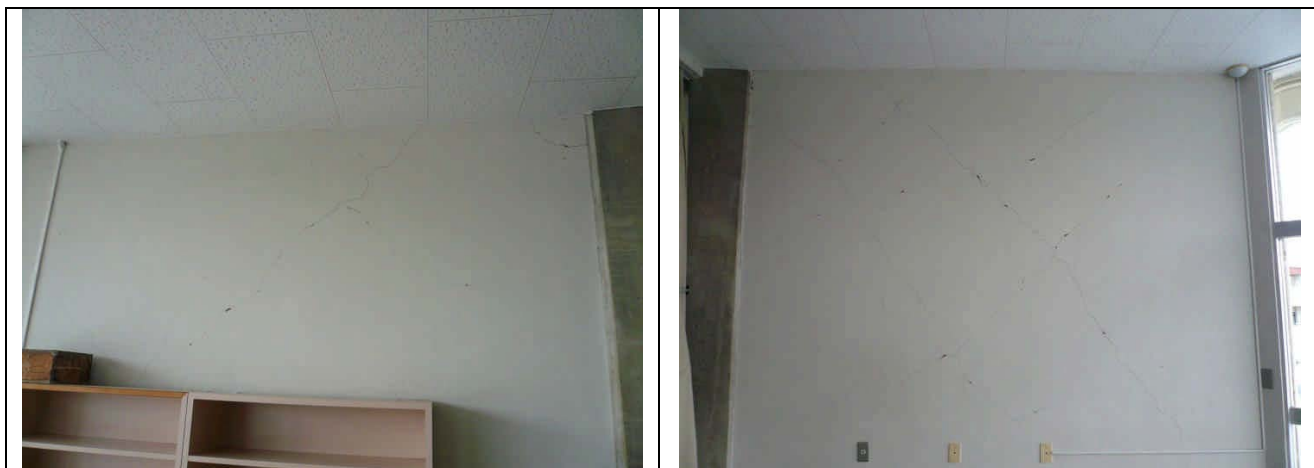
Photo 14: Damage in entrance walls in Hitachi City Municipal Central Gymnasium

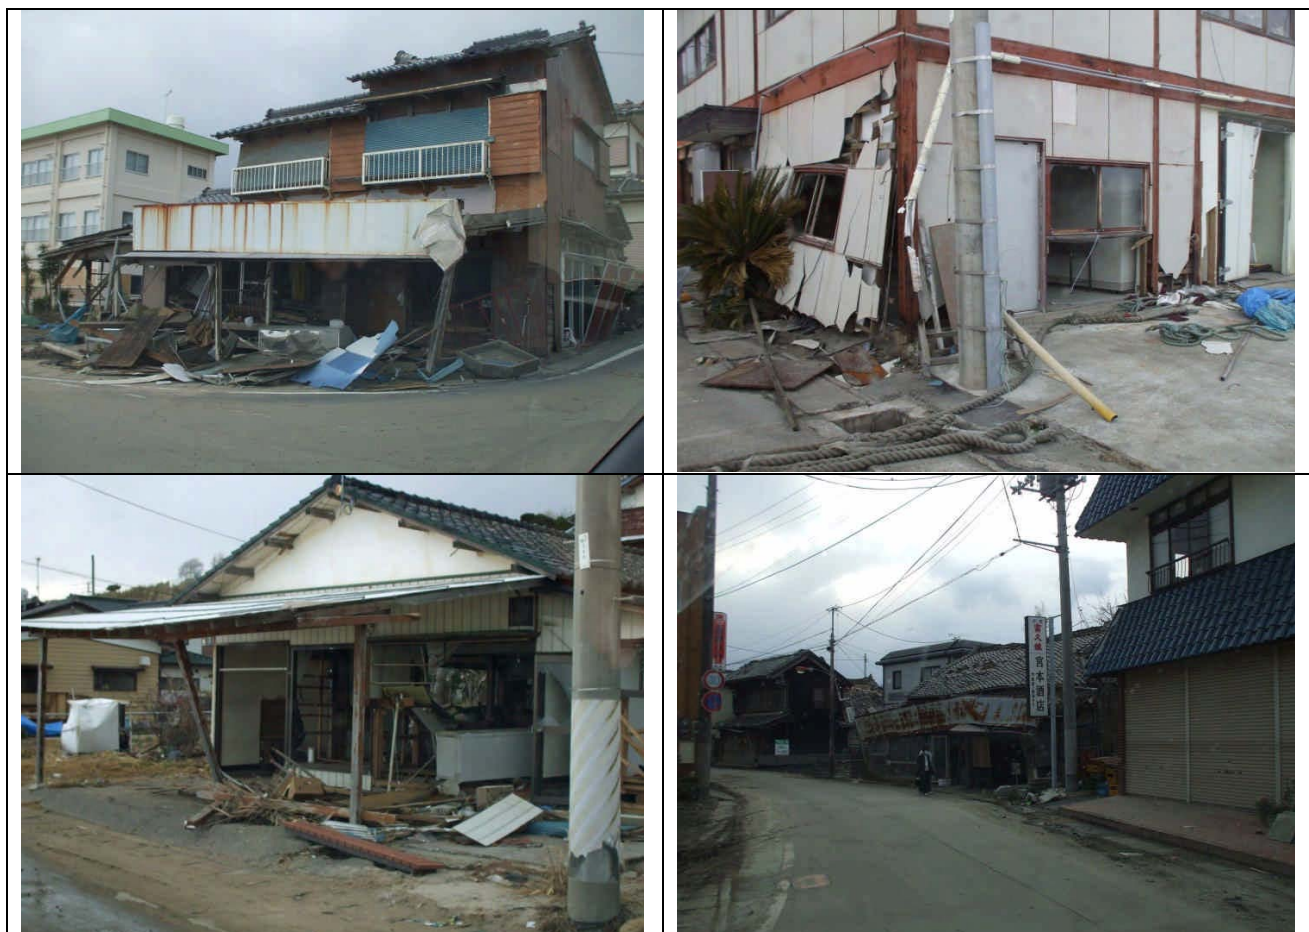
Tsunami attacks caused heavy damage in Kuji Coast.

Photo 15: Tsunami damage in Kuji Coast

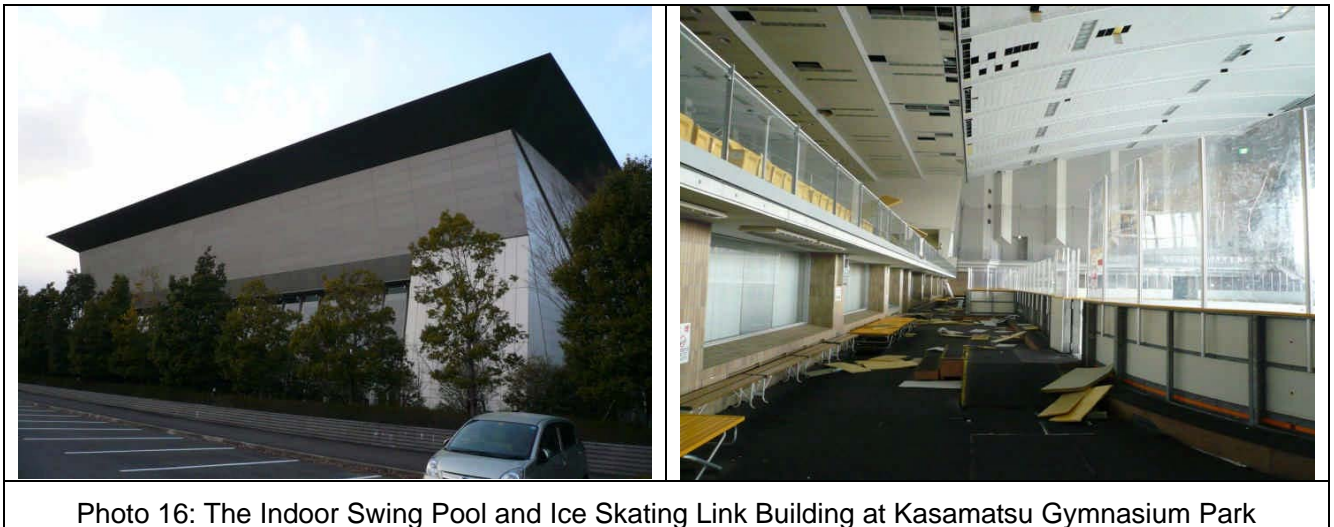
The ceiling panels fell down in the Indoor Swimming Pool and Ice-skating Link at Kasamatsu Gymnasium

Park (Photo 16).

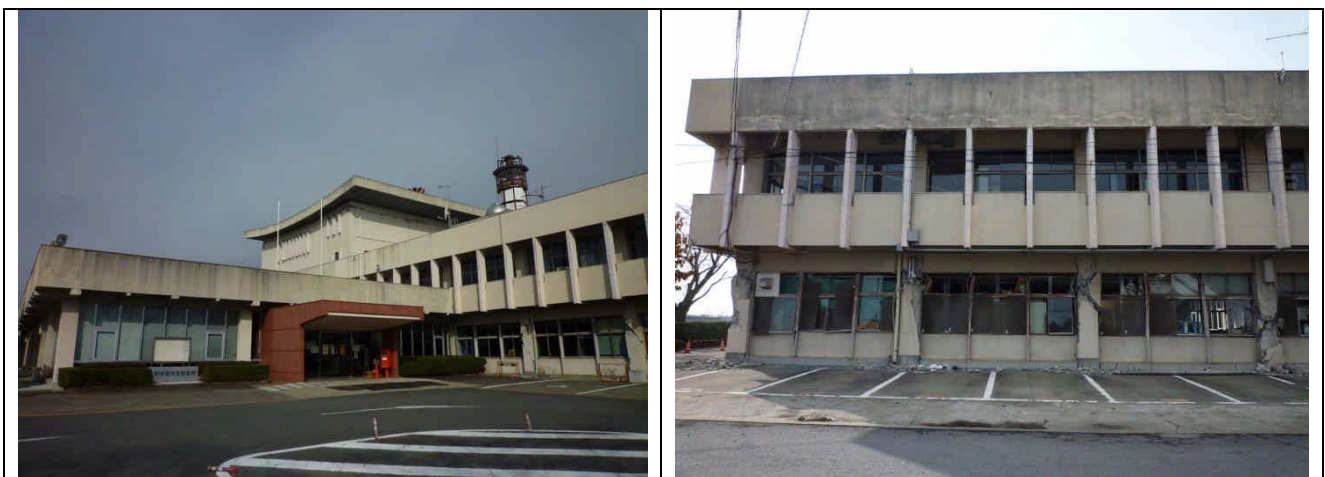
The Branch Municipal Office Building of the Kasama City suffered severe damage by ground shaking. First story columns failed in shear and some columns lost vertical load resistance. Some columns in the second story also failed in shear. Shear failure was also observed in columns with a wing wall. The dimension of columns were 550 mm deep in the direction of shear failure, longitudinal reinforcement was either 10 bars or 12 of 22 mm plain bars, lateral reinforcement was 9 mm diameter plain bars at 250 mm on centers. Clear height was either approximately 780 mm or 1800 mm.

Photo 17: Damage of the Branch Municipal Office Building of Kasama City

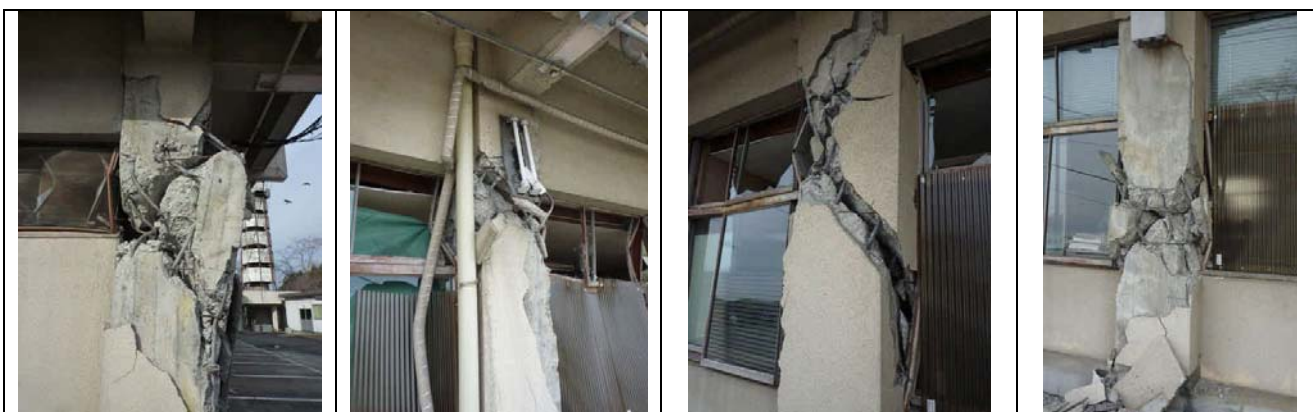
Photo 18: Shear failure of columns in the Branch Municipal Office Building of Kasama City

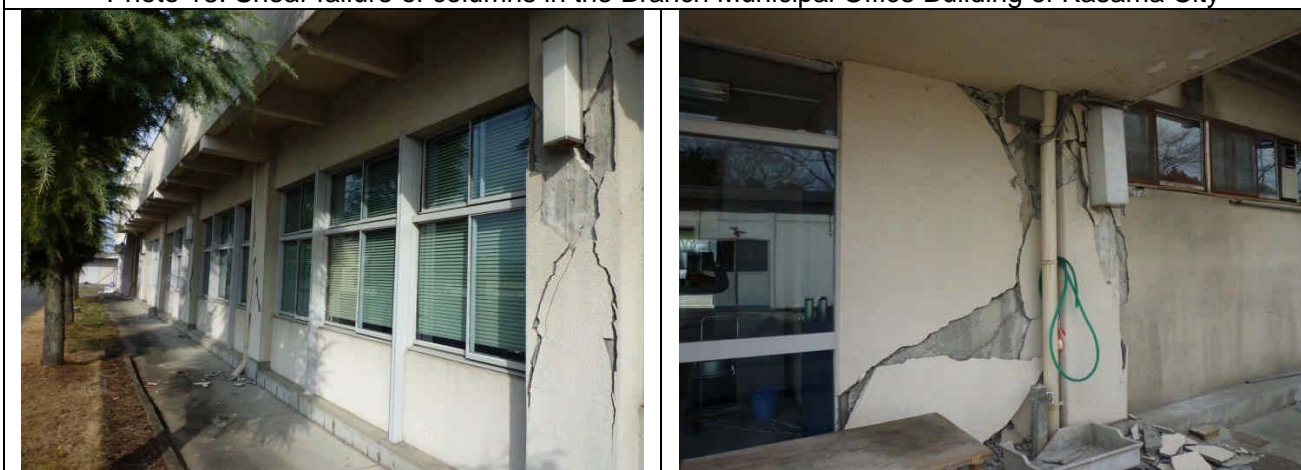
Photo 19: Shear failure of a column and a column with a wing wall of the Branch Municipal Building

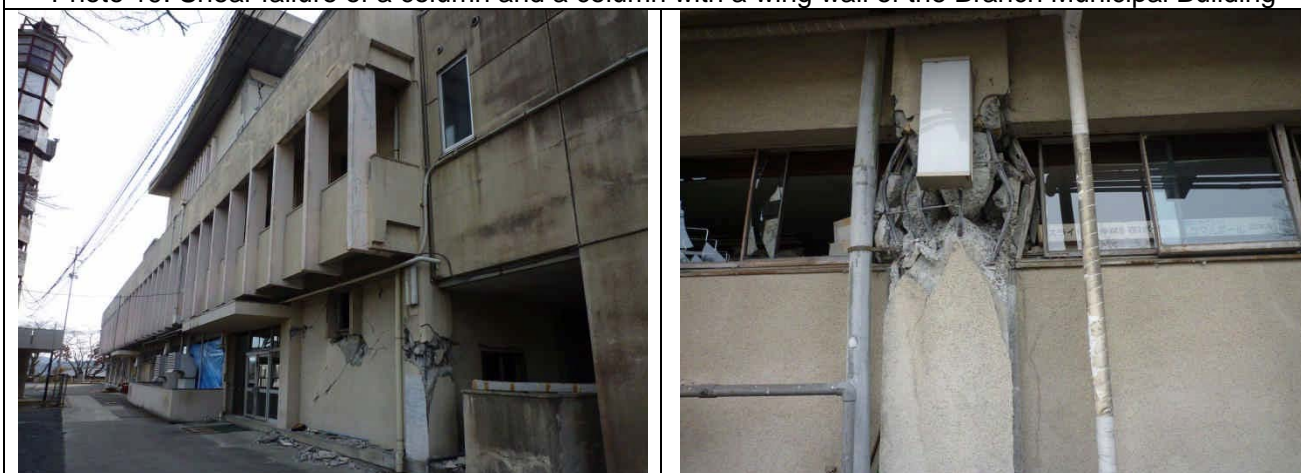
Photo 20: Shear failure and loss of gravity load resistance of columns in the Branch Municipal Building of Kasama City

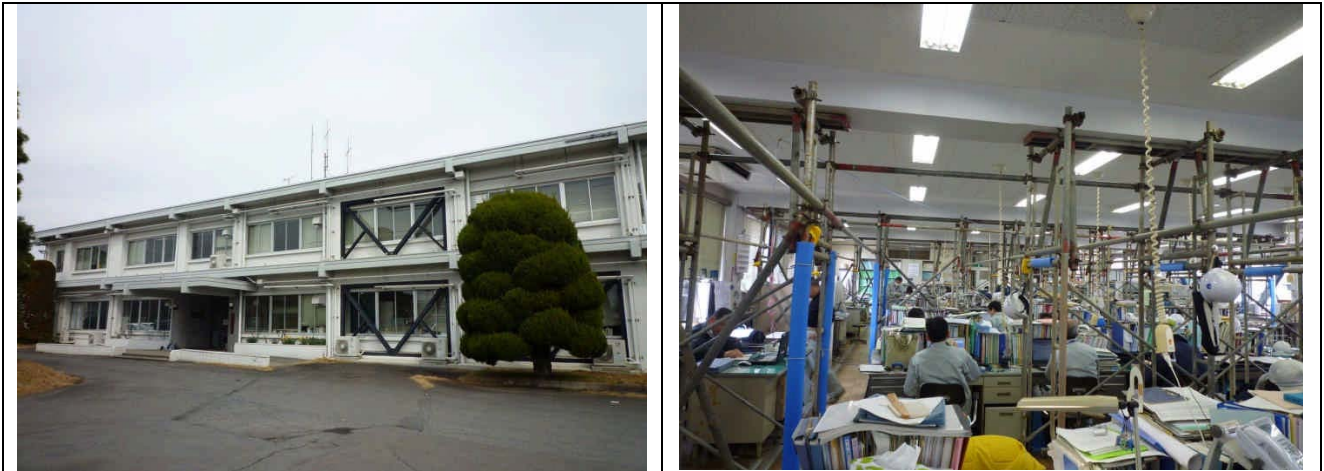
The Hitachi-Ohmiya Civil Engineering Service Building, constructed in 1968, was retrofitted before the earthquake. The settlement due to cracking in girders, shear cracking in columns and concrete crushing of columns was observed. The longitudinal reinforcement was diameter 22 mm plain bars, and lateral

Photo 21: Over view and inside of the Hitachi-Ohmiya Civil Engineering Service Building

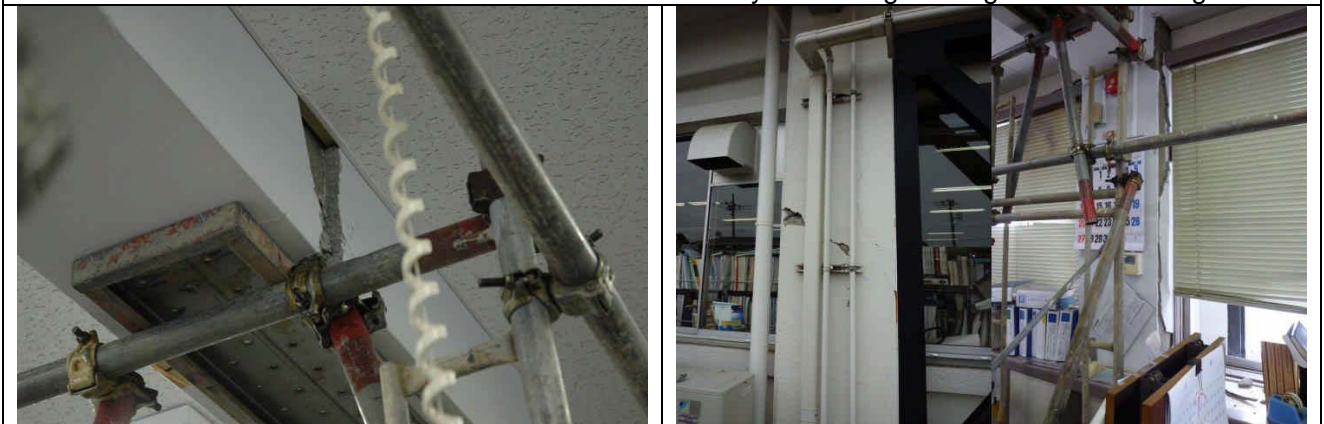
Photo 22: Cracks in a girder and a column in the Hitachi-Ohta Civil Engineering Service Building

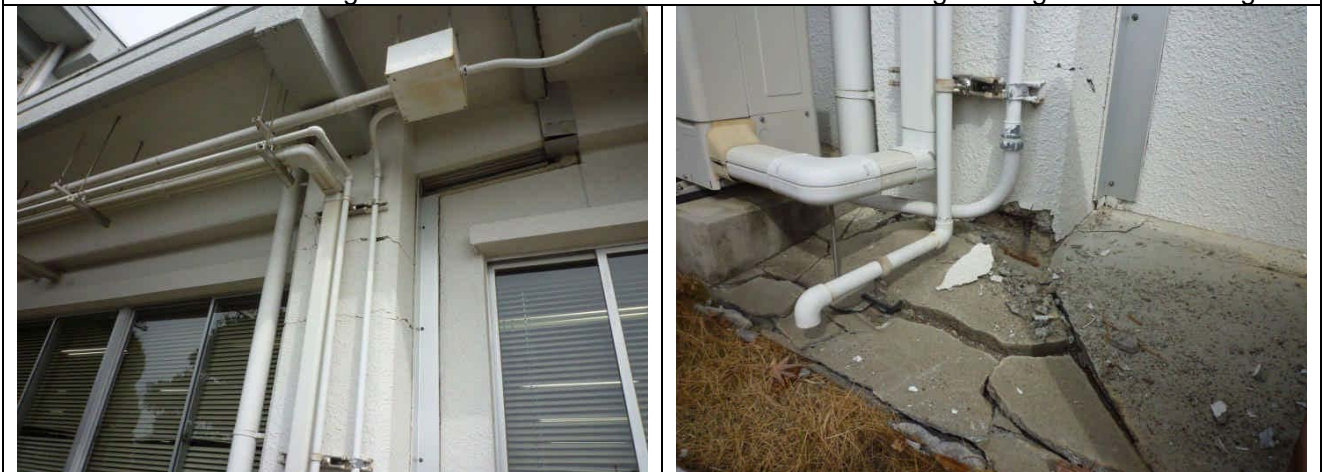
Photo 23: Flexural crack and concrete crushing in columns of the Hitachi-Ohta Civil Engineering Service Building

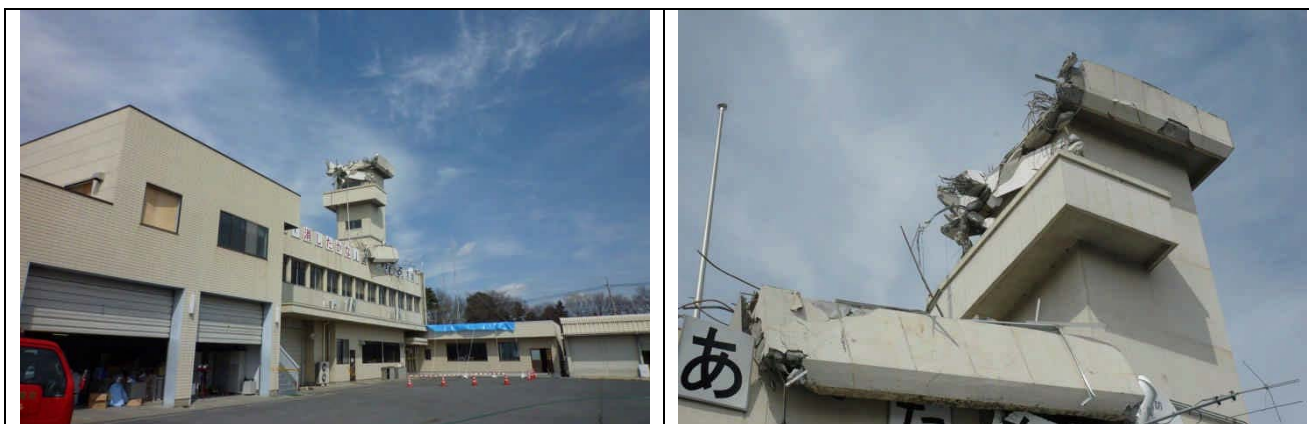
The roof of a tower for training fell on the roof of the Hitachi-Ohta Fire Fighting Headquarter Building during the earthquake.

Photo 24: Overall view and fall of training tower roof in the Hitachi-Ohta Fire Fighting Headquarter Building

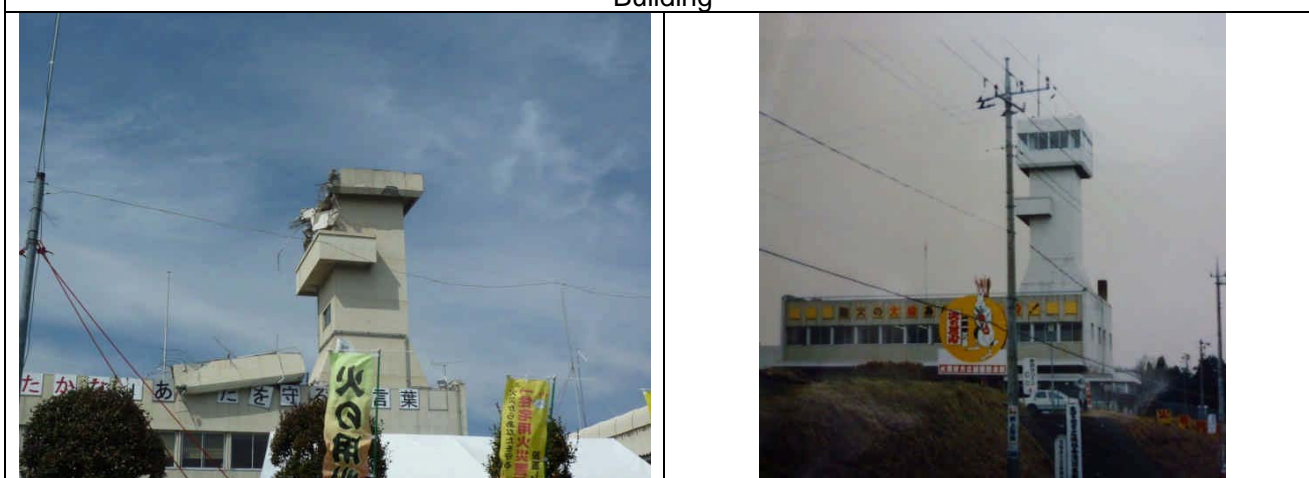
Photo 25: Before (right) and after (left) of the Hitachi-Ohta Fire Fighting Headquarter Building

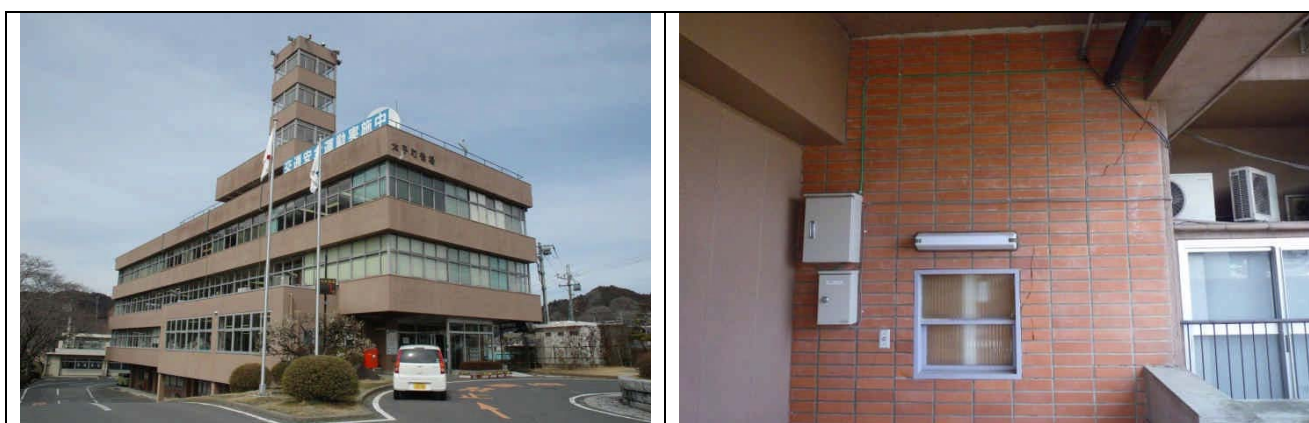
Daigo-machi Municipal Office Building (No. 12 in the route map) suffered minor cracking in walls. Most damage in the town was deformation of roads and landslides. The fall of roof tiles was relatively small in the number.

Photo 26: Overall view of Daigo-machi Municipal Office Building and cracks in a wall

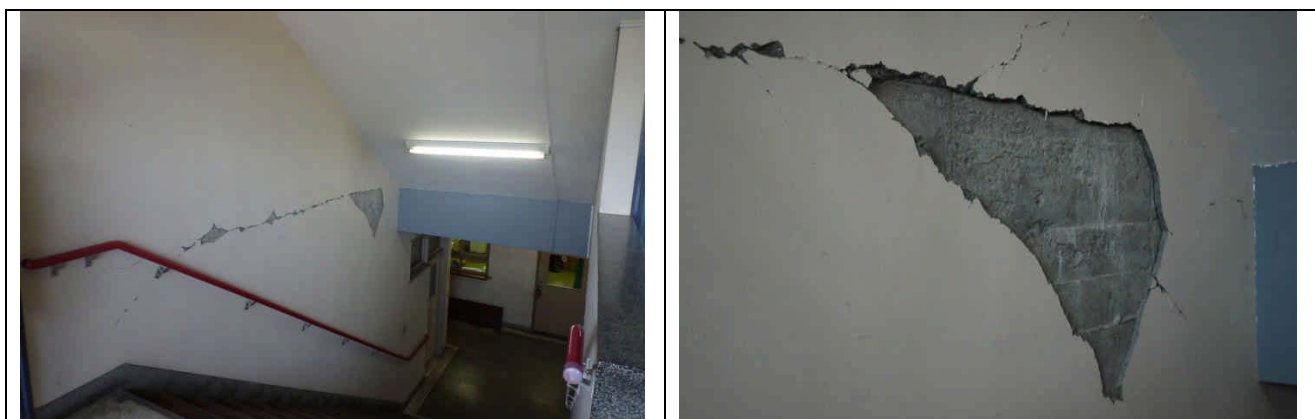
Photo 27: Cracks in walls in Daigo-machi Municipal Office Building

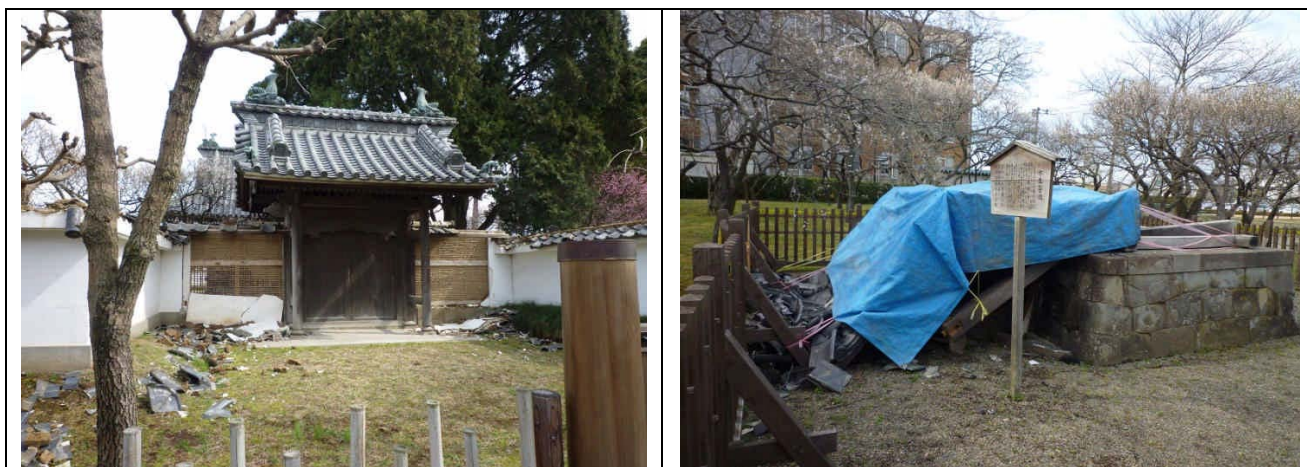
In Kohdo-kan Park (No. 14 in the route map), minor damage was observed in traditional buildings. Damage was observed in the gymnasium building of Mito First High School.

Photo 28: Damage of Confucius Mausoleum Entrance Gate, and collapse of Alarm Bell Building

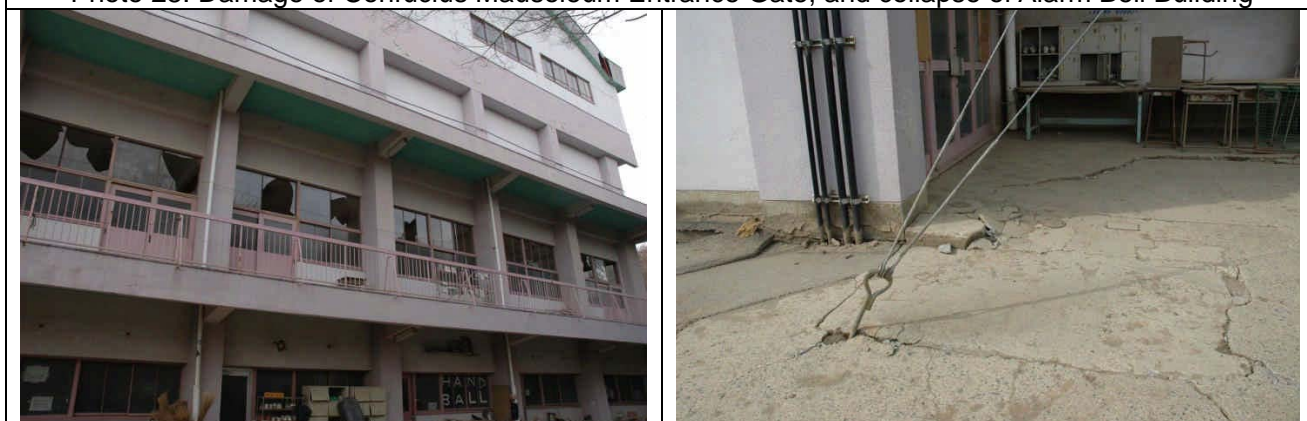
Photo 29: Damage in Gymnasium of Mito First High School and its foundation
