Report on Building Damage in Central Ibaraki Prefecture by
The 2011 off the Pacific Coast of Tohoku Earthquake
Released on April 3, 2011

Dr. Toshiyuki Kanakubo,
Department of Engineering Mechanics and Energy
Graduate School of Systems and Information Engineering,
University of Tsukuba
Dr. Juan Jose Castro
Center for International Education and Exchange, Osaka University
(Translated by Shunsuke Otani, University of Tokyo)

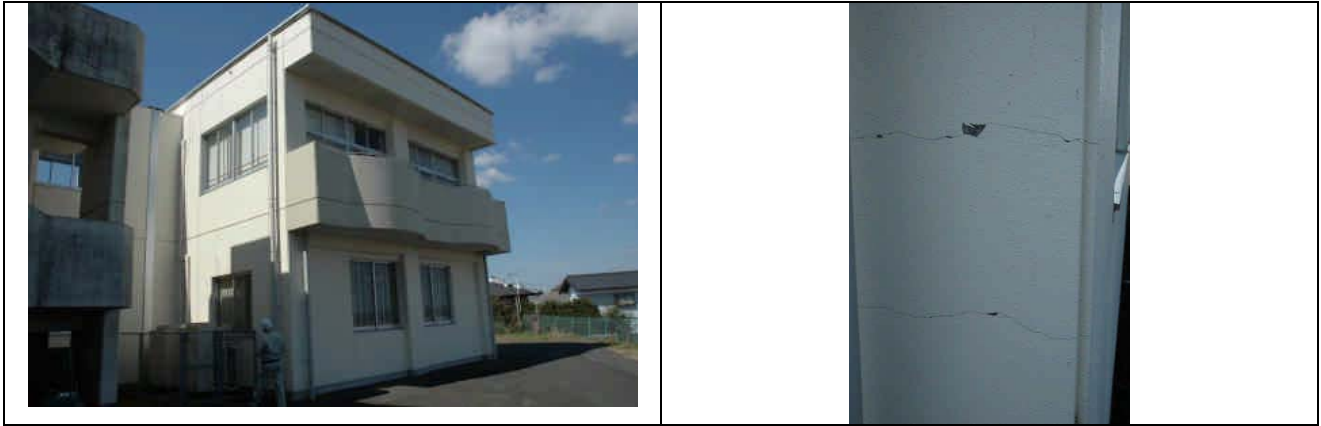
The school building for special education is two-story reinforced concrete construction and was constructed after the 1981 revision of Building Standard Law Enforcement Order (New Seismic Design Provisions). Flexural cracks were observed in columns and walls of Special Class Building (Photo 1). A reinforced concrete building for normal classes was constructed before the enforcement of New Seismic Design Provisions, and was not retrofitted at the time of the earthquake, but no damage was observed. In the neighborhood of the school, the overturning of tomb stones (Photo 2) and damage on masonry warehouses were observed (Photo 3).

Photo 1: Flexural cracks in columns in a building in accordance with the New Seismic Design Provisions

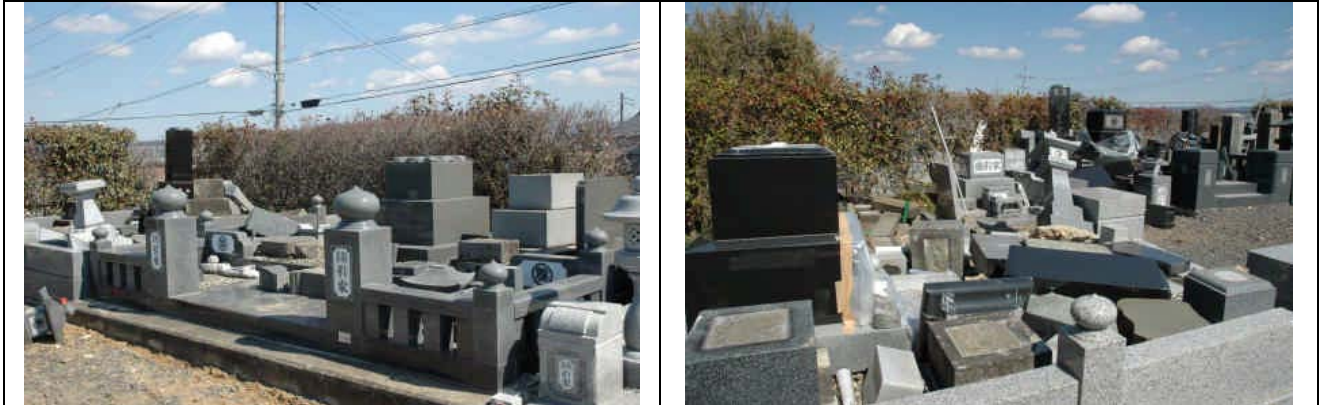
Photo 2: Overturning of tomb stones near the Gundo Elementary School

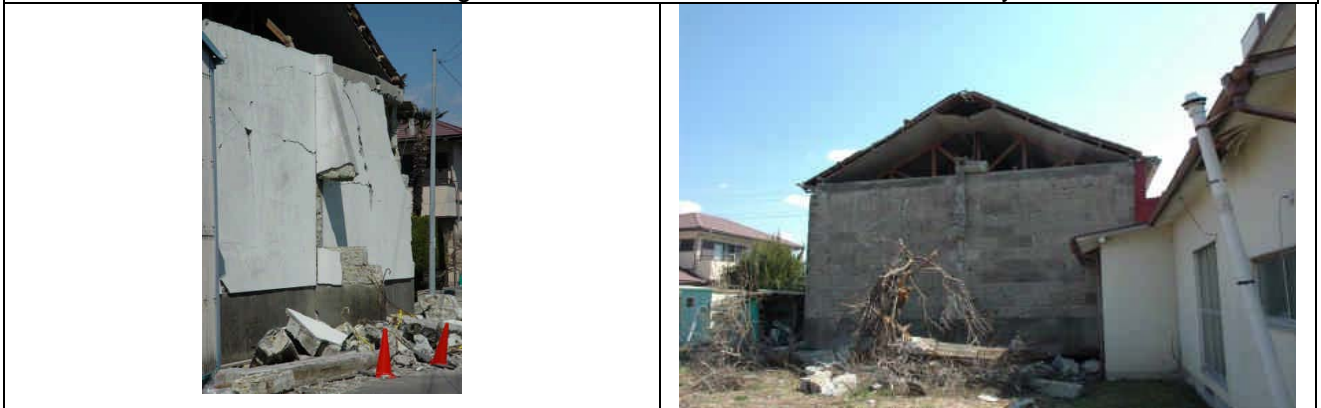
Photo 3: Damage of Masonry Warehouses near Gundo Elementary School

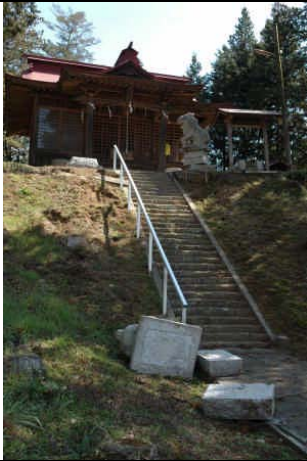
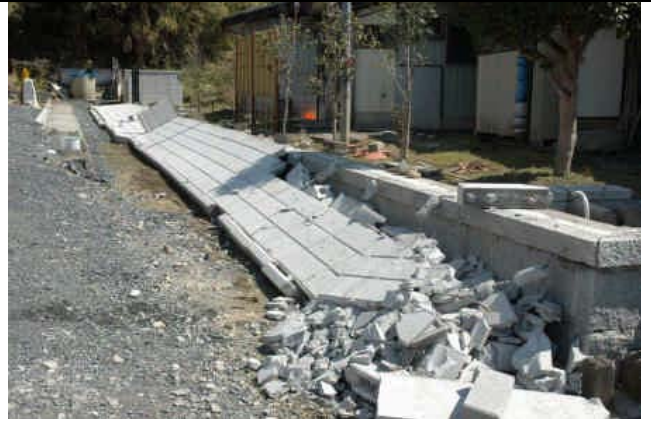
There are more rich farming houses in Nakano-machi: in each lot, there are a residential house, a barn, a warehouse and a storage. A guardian dog masonry statue of a shrine fell to the foot of stairs (Photo 4). Concrete block walls along a plot fell down (Photo 4). Damage of roof tiles was seen many places (Photo 6).

Photo 4: Fall of a guardian dog statue and also concrete block walls along a lot

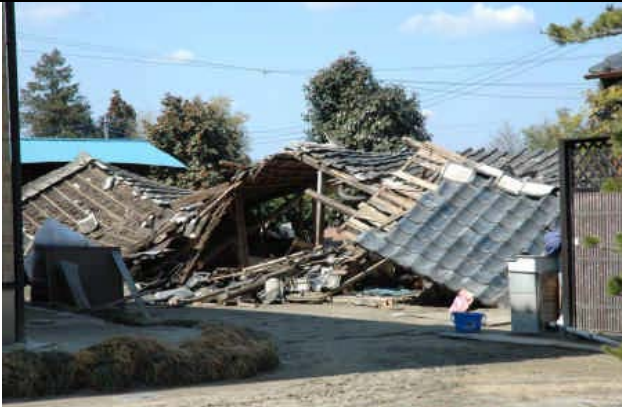
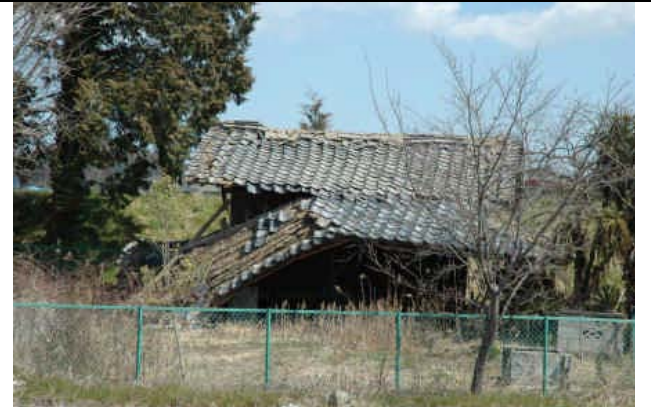
Photo 5: Collapse of timber barns

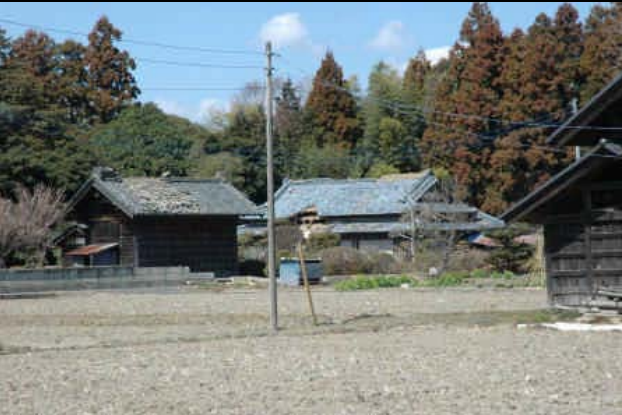
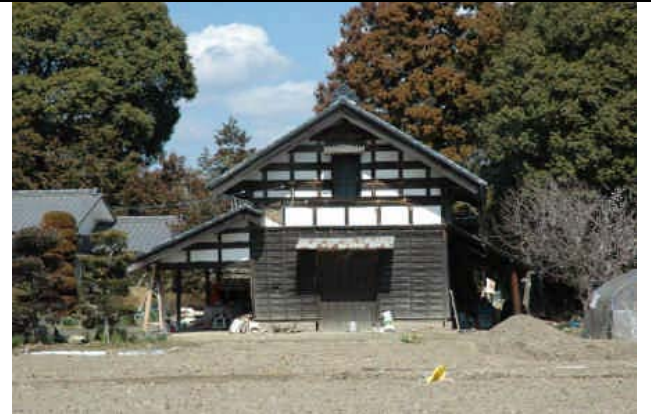
Photo 6: Damage on roof tiles and a tilted traditional barn

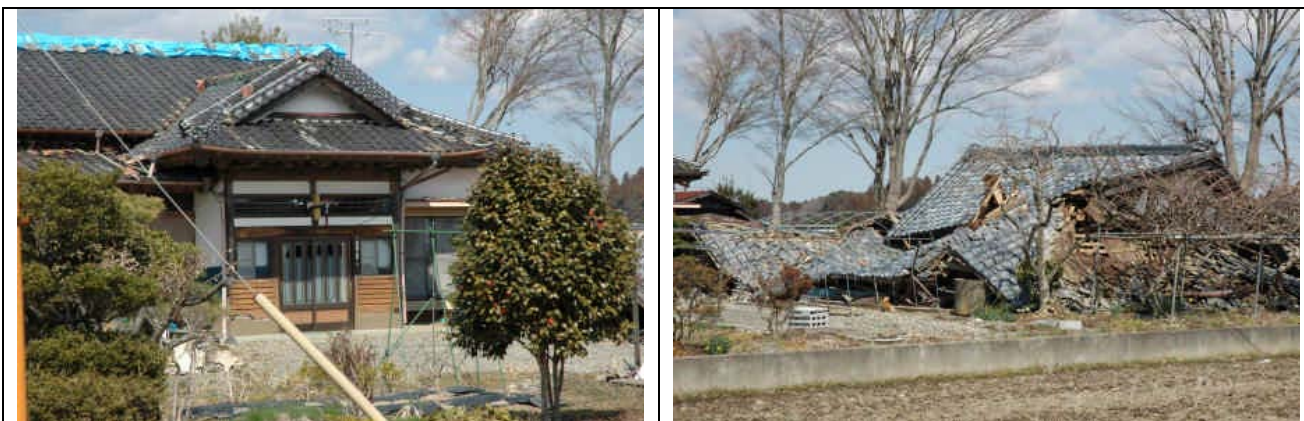
Damage similar to those observed in Nakano-machi was seen in Fujita-machi. In a house lot, exterior wall finishing fell from the house, roof tiles were damaged and a barn collapsed (Photo 7).

Photo 7: Fall of exterior wall finishing of a house and collapse of a timber traditional barn

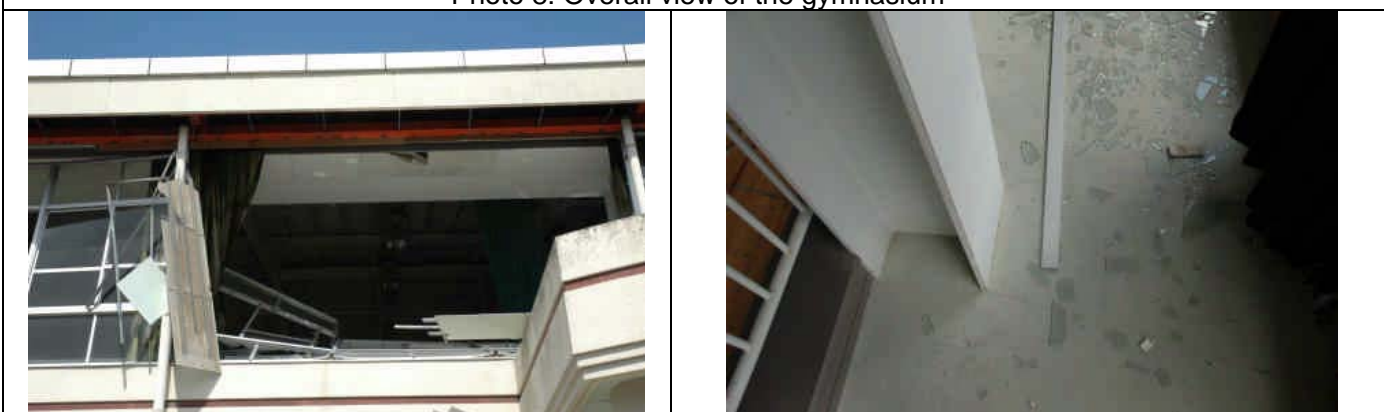
Photo 9: Fall of glass panes and cracking at the base of a steel column

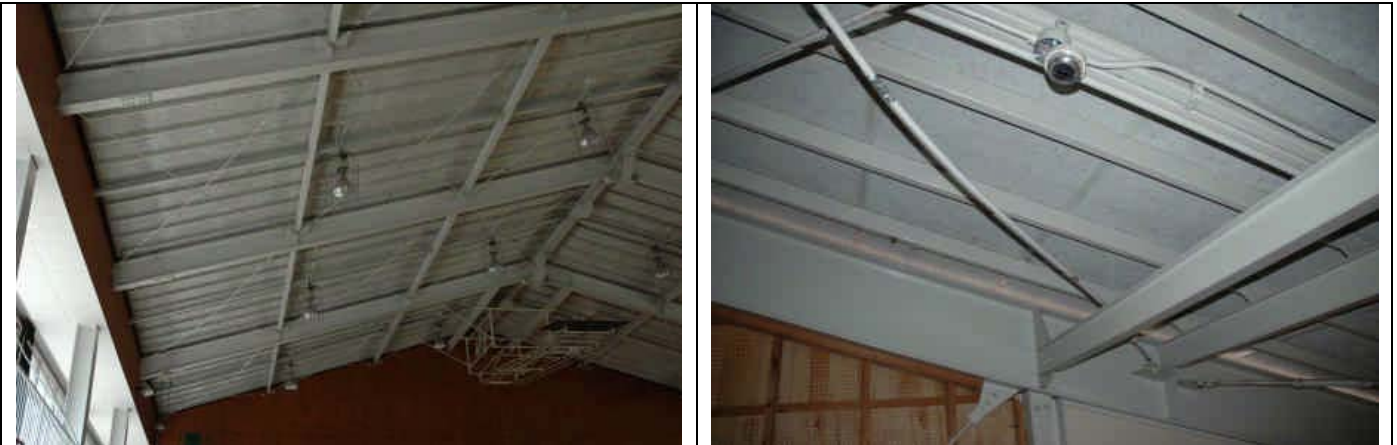
Photo 10: Deformation of ceiling brace members

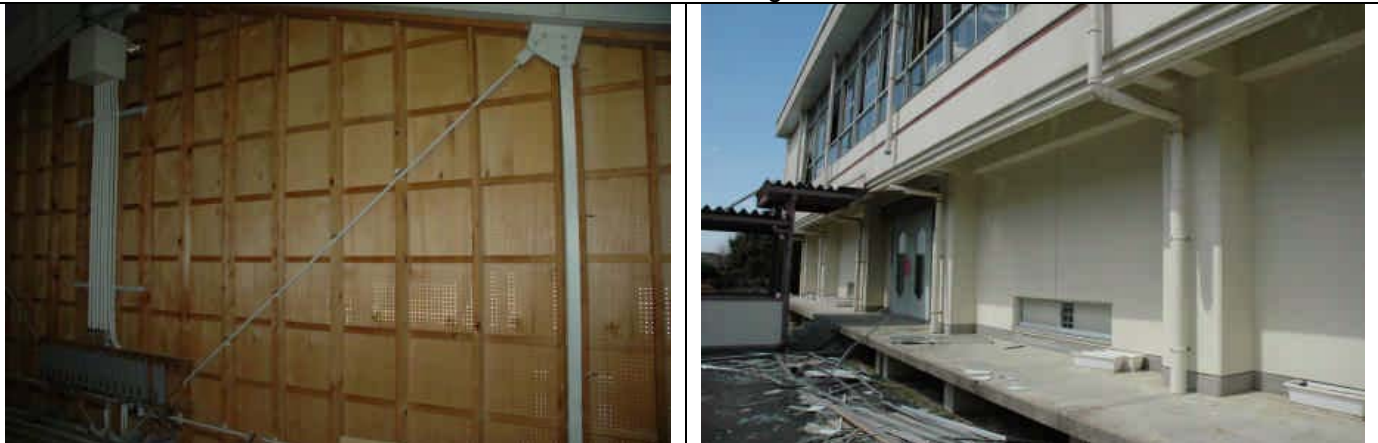
Photo 11: Vertical brace members in the end wall and first-story reinforced concrete column were undamaged.

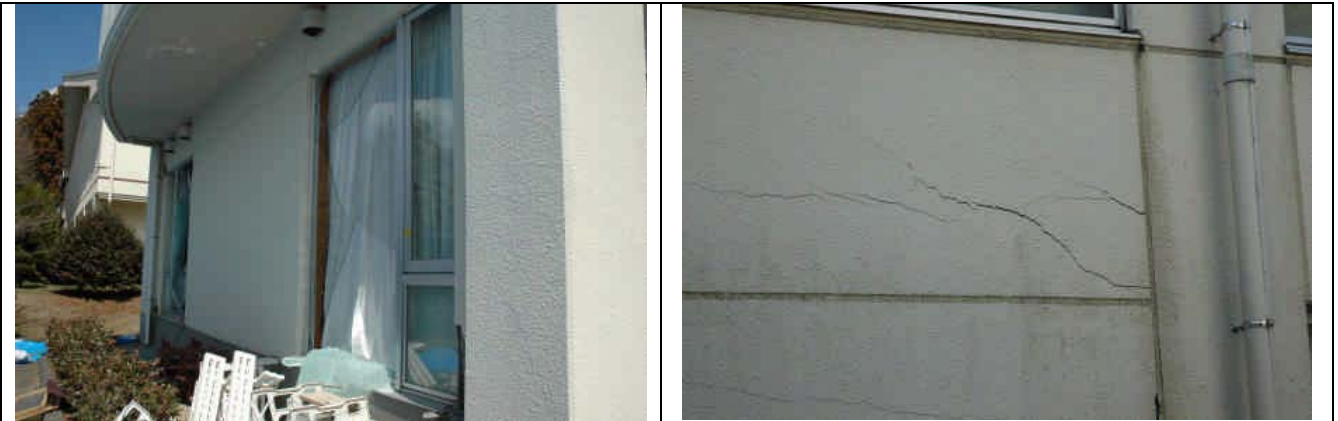
A special visual and audio education building was constructed in 2003; two-stories reinforced concrete moment-resisting frame building with 2 bays in longitudinal direction and one span in the transverse direction. Horizontal cracks in a girder, breakage of glasses (Photo 13), a diagonal crack and spalling of concrete at the top and bottom of a first story column were observed (Photo 14). Cracking does not seem to be caused by the horizontal ground shaking, there could be some effect of vertical ground shaking or uneven settlement.

Photo 13: Breakage of glasses and horizontal cracks in the girder

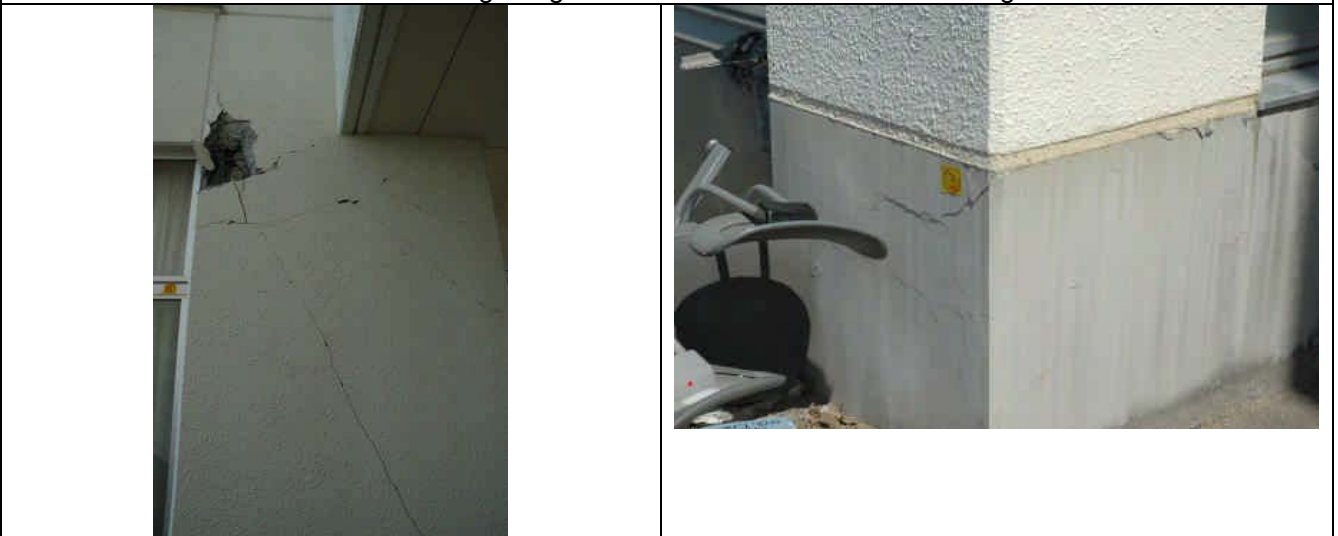
Photo 14: Diagonal crack at the top and crack at the base of a first-story column

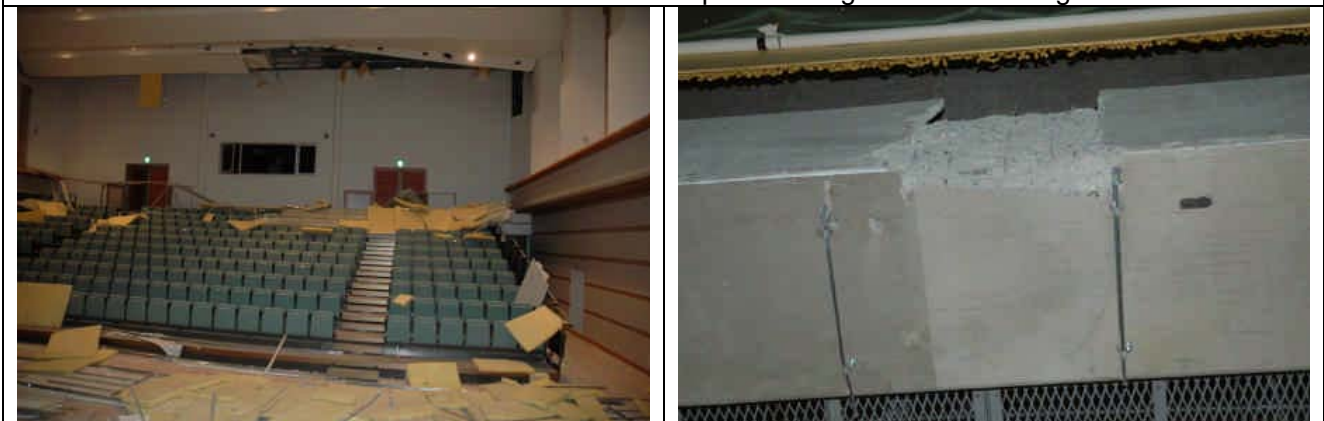
The Municipal Exchange Center building (Photo 15) is located on the same hill as the Kanasago Elementary School. The two-story reinforced concrete building was completed in 1997. The main hall is two-story open ceiling and one quarter of ceiling panels fell down (Photo 16, left). Spalling of concrete was observed in the long span girder above the stage presumably caused by out-of-plane bending (Photo 16, right). The concrete spalling was observed at mid-height of a tall column of the entrance hall; horizontal cracks were observed in other columns at about same height, these cracks may be associated with concrete placement joint.

Photo 16: Fall of ceiling panels (left) and damage in the girder above the stage (right).

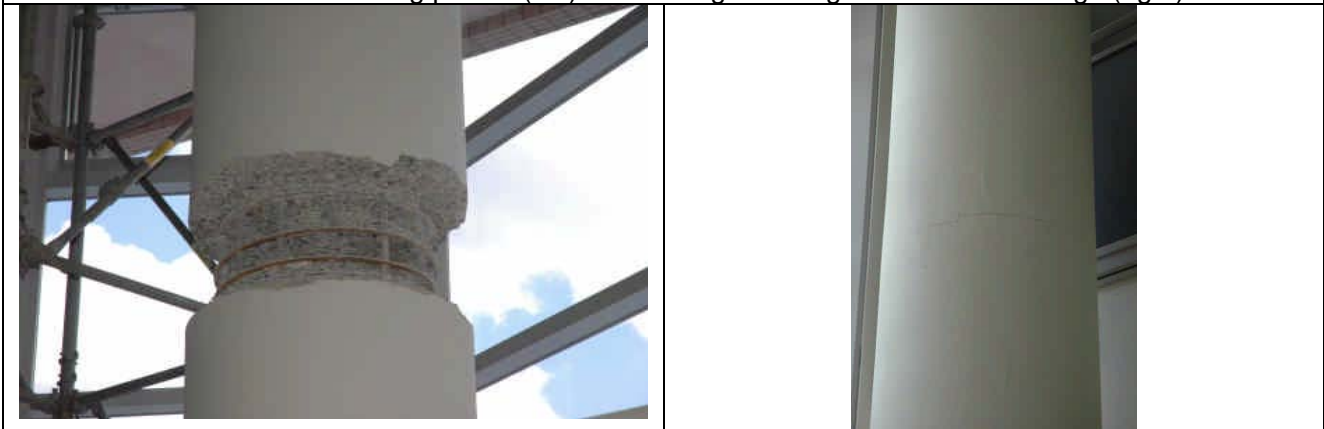
Photo 17: Damage of tall columns in the entrance hall

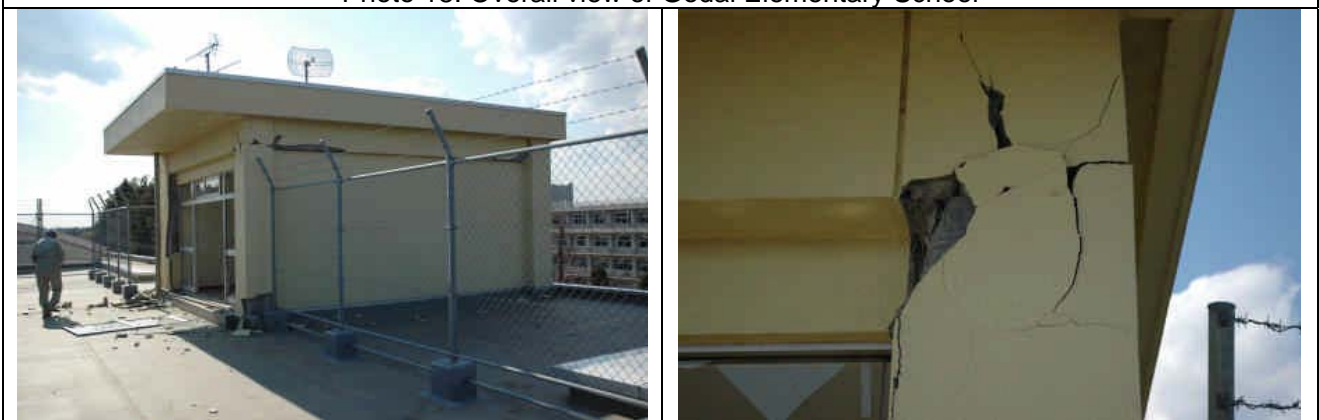
Photo 19: Damage of the penthouse

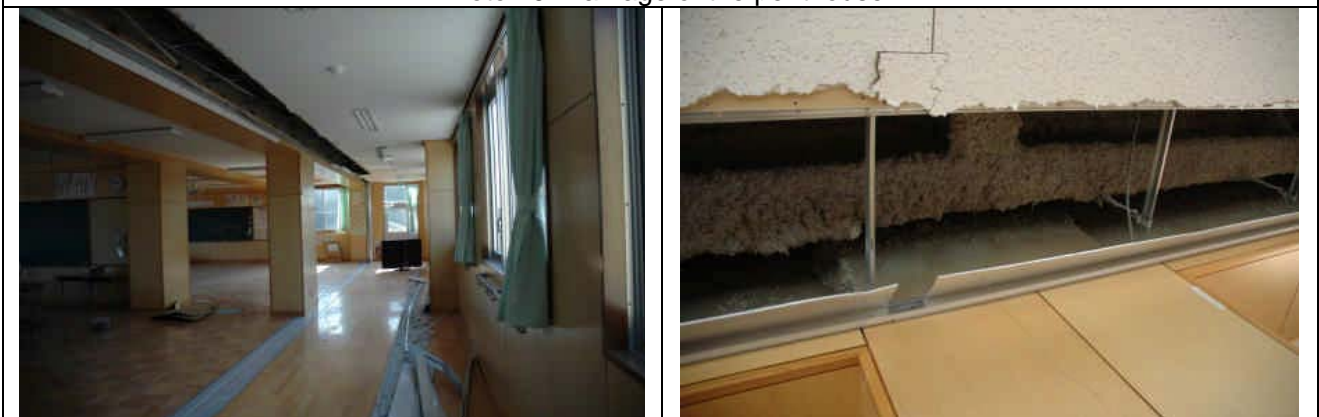
Photo 20: Damage of expansion joint between the existing and a new addition

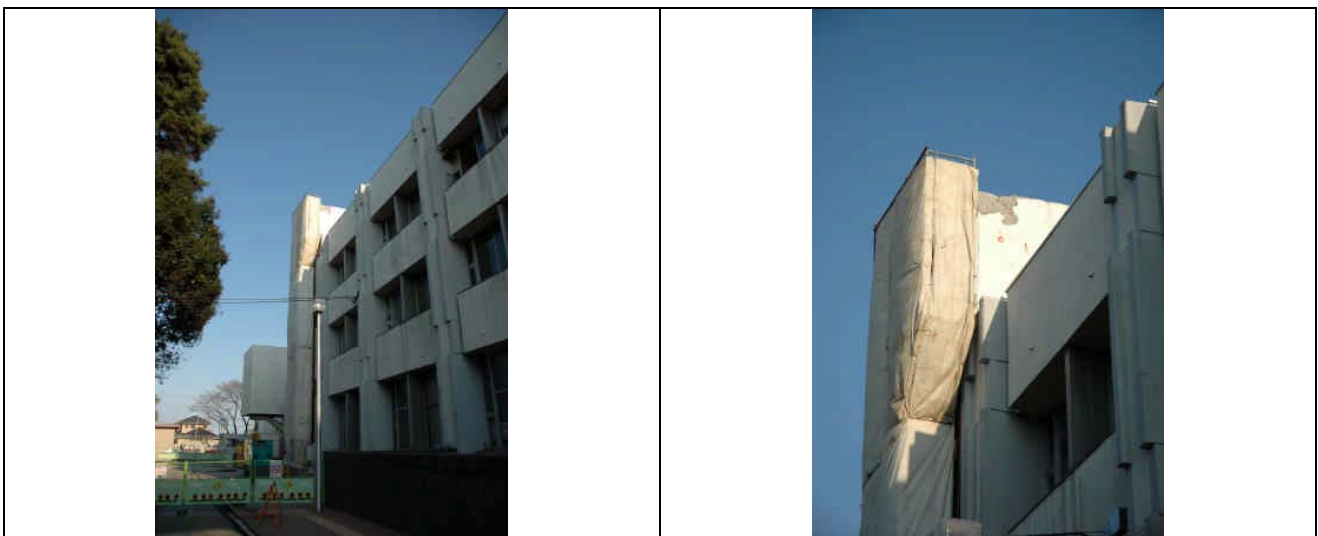
A chimney was damaged in the Naka City Municipal Office Building; the chimney was removed at the time of visit (Photo 21).

Photo 21: Damage of a chimney (after removal)

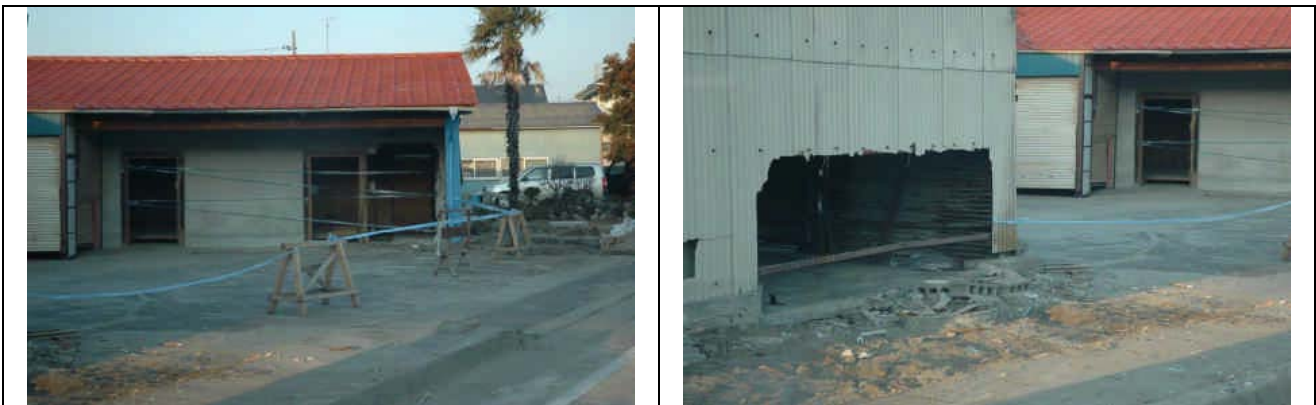
Tsunami wave reached the waste height. A house was partially damaged. The edge of a road fell down.

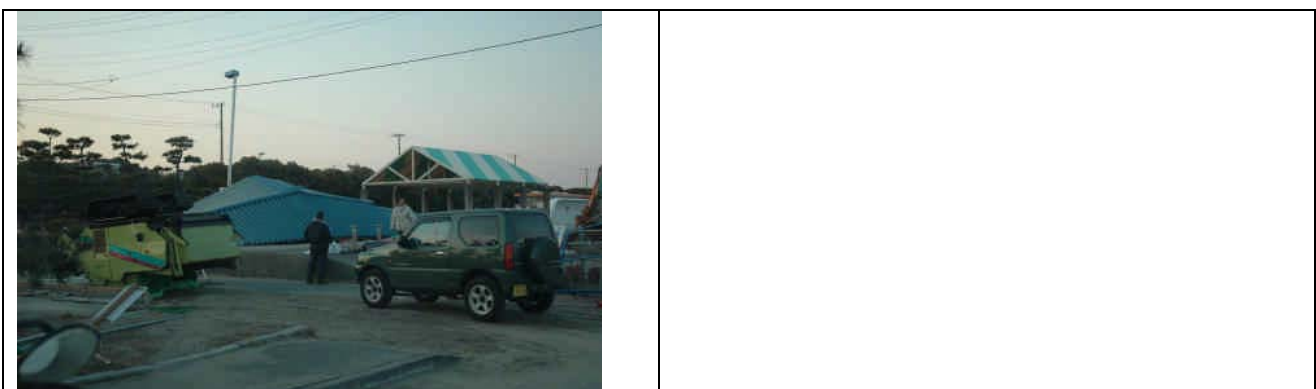
The trace of tsunami wave was seen on roads and private lots, but the debris was all cleared and cleaned. A shopping mall near the sea shore was inundated above the floor and a beach house collapsed.
