# **A Numerical Investigation on the Collapse of** the Champlain Towers South in Florida

Abstract— In this study, the Champlain Towers South building collapse in Florida allegedly caused by a deck collapse was examined through the finite element analysis based on the existing hypotheses and investigation. The Adaptively Shifted Integration (ASI) – Gauss code was applied for the numerical analysis. In addition, the member strength failure algorithm of RC components was modified, and the flat-plate structure was introduced into the numerical model of the building. According to the analyses, the building did not collapse when the pool deck beams connecting to the columns of the 1stfloor interior, so-called key columns, were removed by the collapse of the pool deck. When the model was revised to include deterioration of concrete slab and corrosion of rebars, and then triggered by the removal of columns in the underground parking garage, the middle section of the buildings reached a total collapse. This supports the latest collapse theories, which cite punching shear failure at pool deck columns as the initiating event.

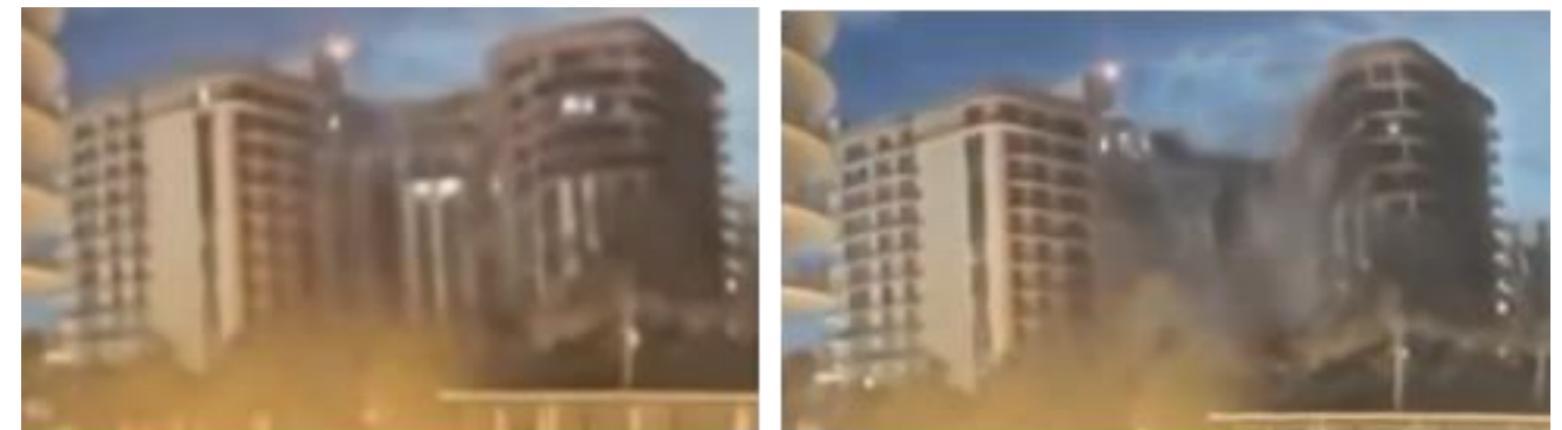
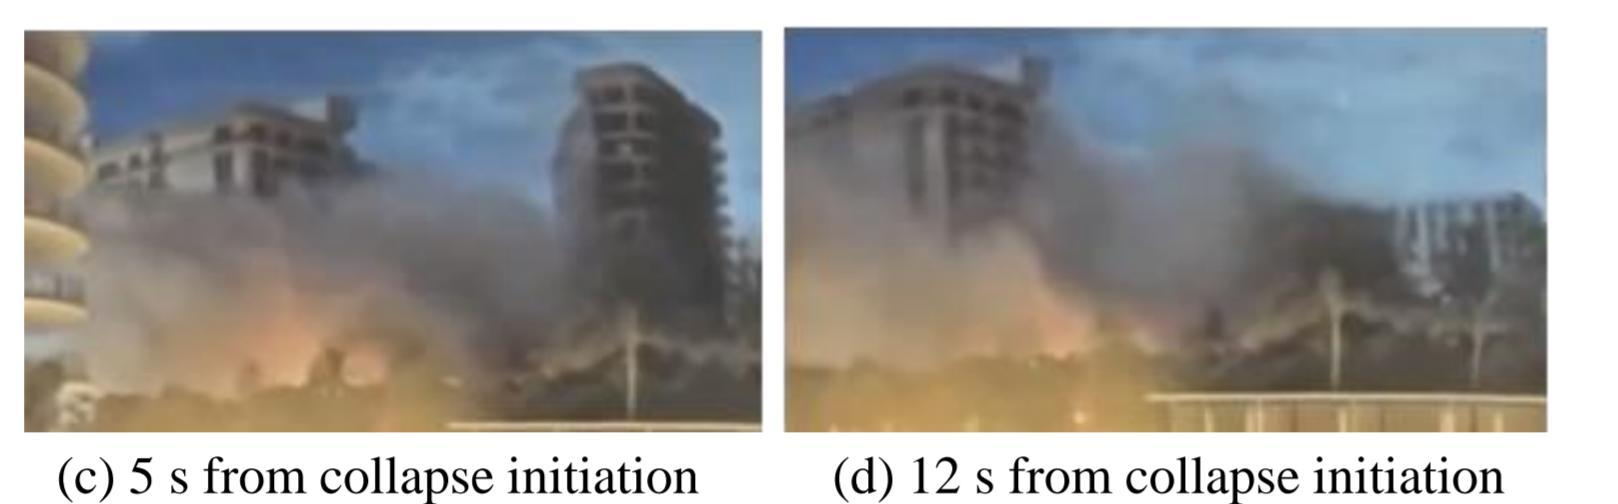
The middle and eastern sections of Champlain Towers South in Florida (Fig. 1), USA, a 13-story condominium built in 1981, collapsed without warning at approximately 1:25 a.m. on June 24, 2021. According to the surveillance video, the collapses of the middle section and the following eastern section only lasted for 12 seconds (Fig. 2). At least half of the 136 units in the building had collapsed (Fig. 3), and all of them were characterized by the fact that they collapsed instantly after it began to collapse.

Figure 2. Collapse sequence of the Champlain Towers South.

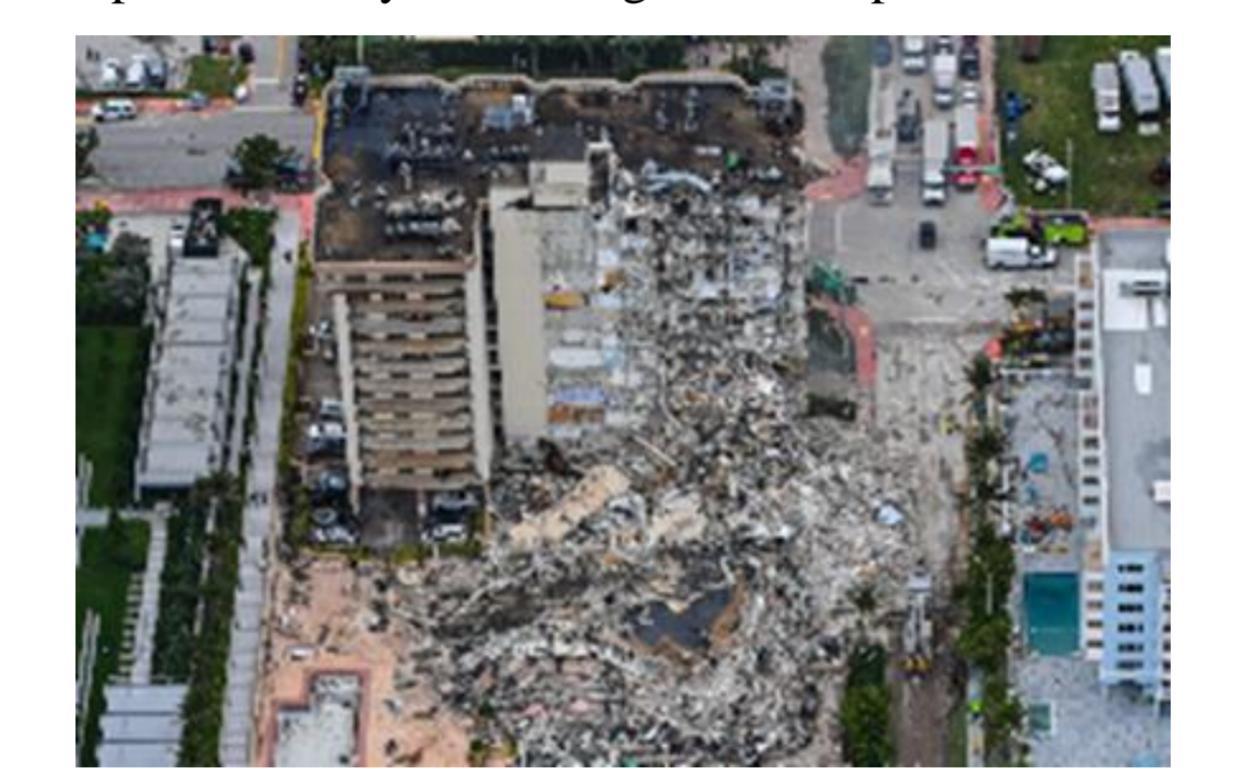
Figure 3. Collapsed site of the Champlain Towers South.

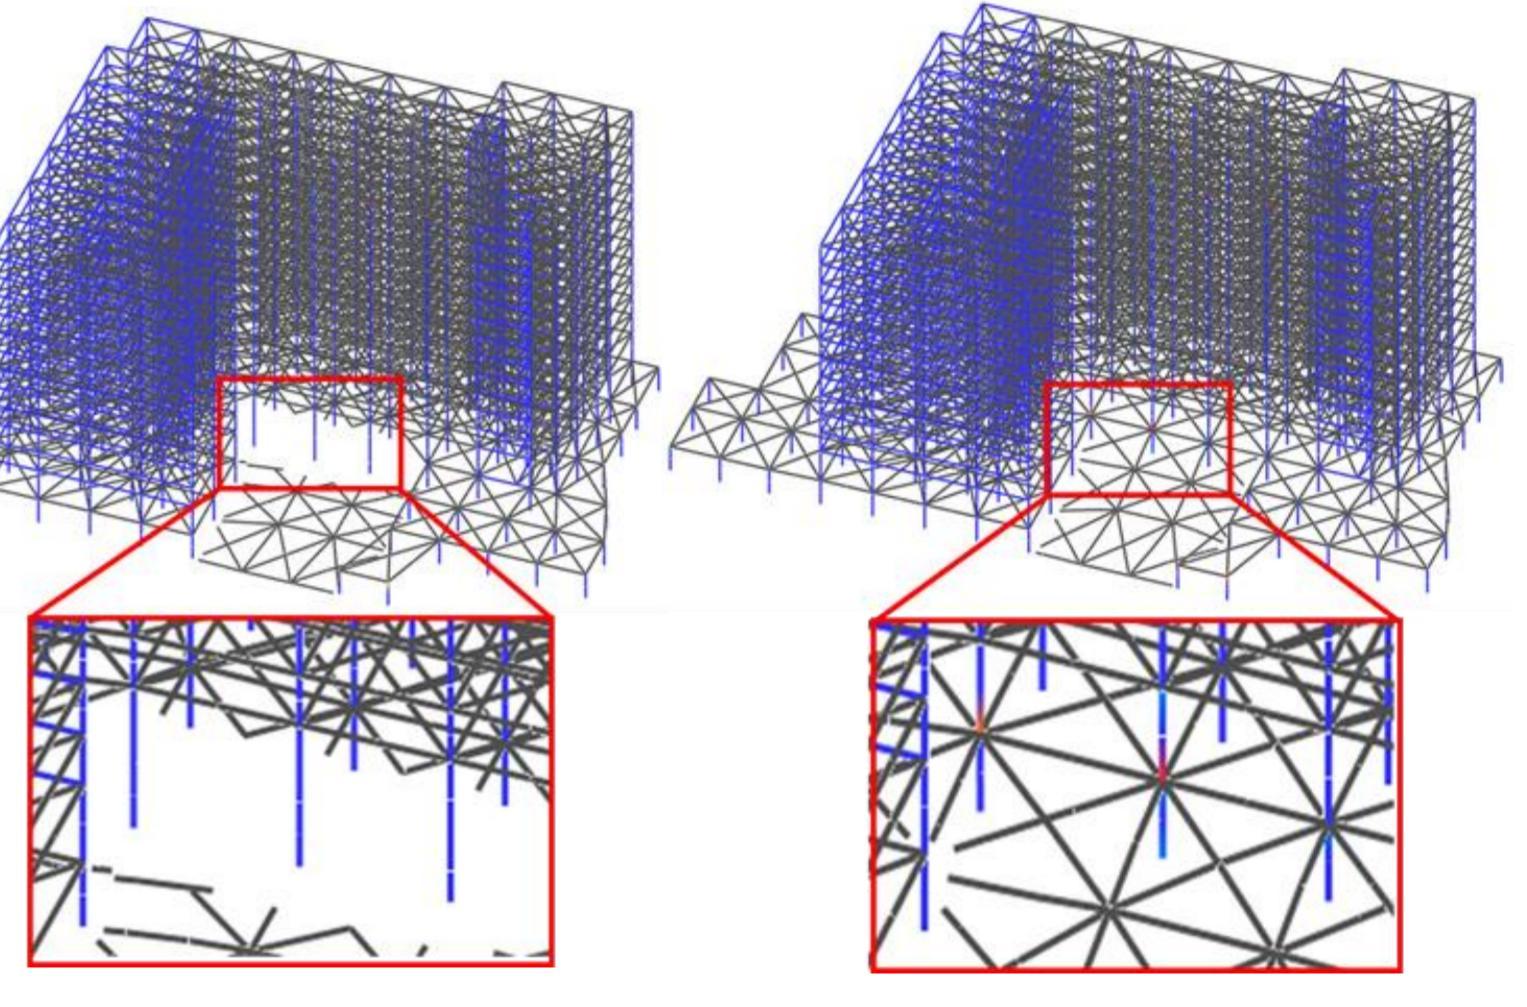
Figure 5. Numerical results based on the hypotheses with pool deck collapse as the main cause.

A 13-story RC building model was analyzed based on the hypotheses published in newspapers (Fig. 4). In the case where the extent of pool deck collapse exceeded the key column (Hypothesis 1), neither the final state nor buckling of the key column was confirmed. In the case where the extent of pool deck failure did not exceed the key column (Hypothesis 2), the key column was in the final state, but the entire building did not collapse (Fig.

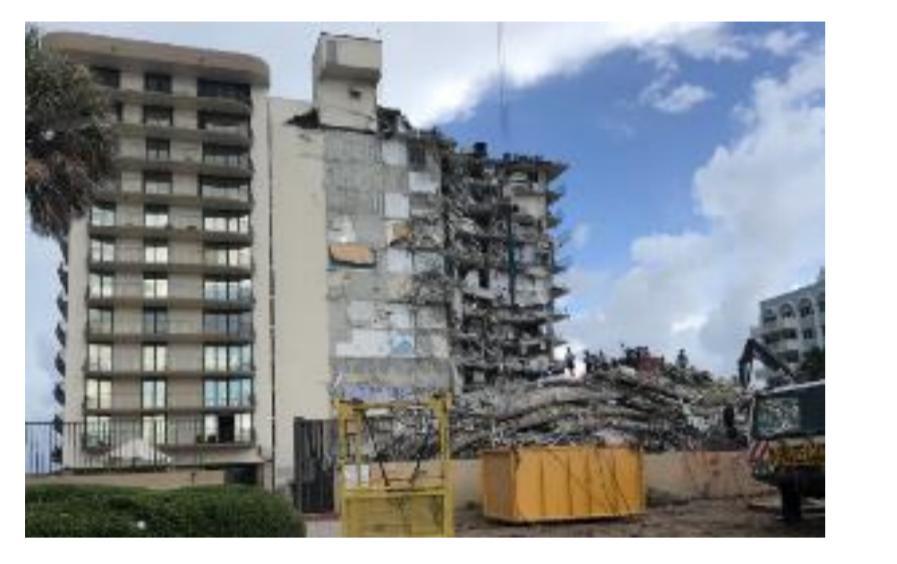
Figure 6. Western section remaining after the accident.

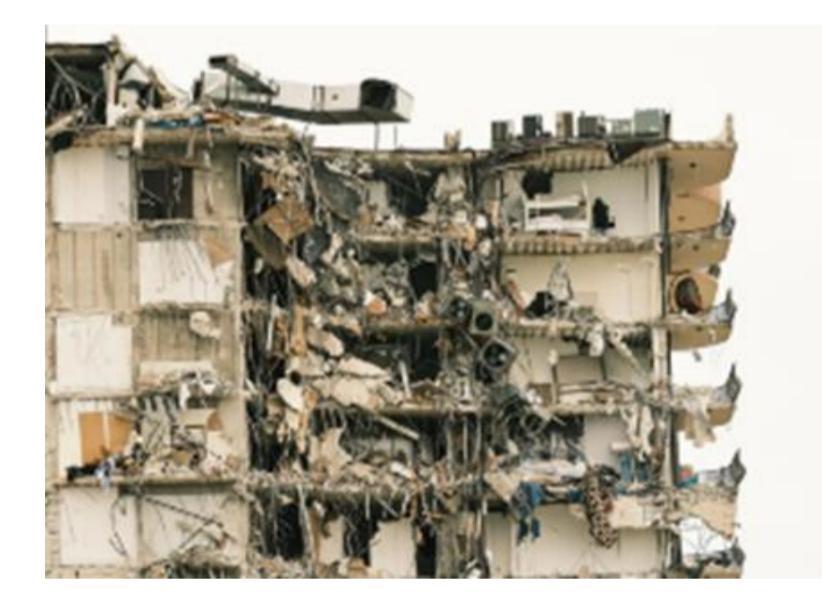
Figure 7. Enlarged photo of a collapsed section.

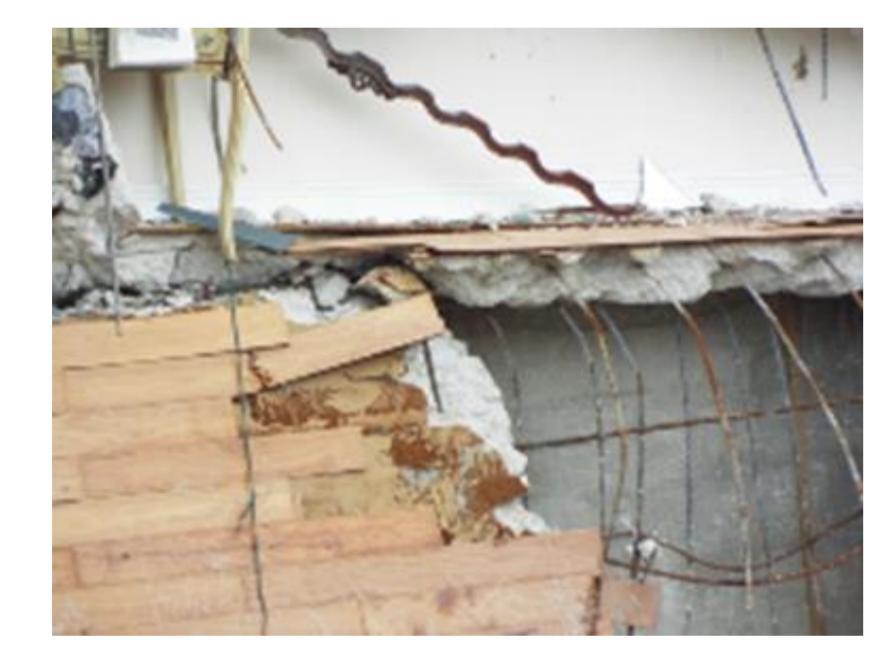
Figure 8. Cross-section of a collapsed floor.

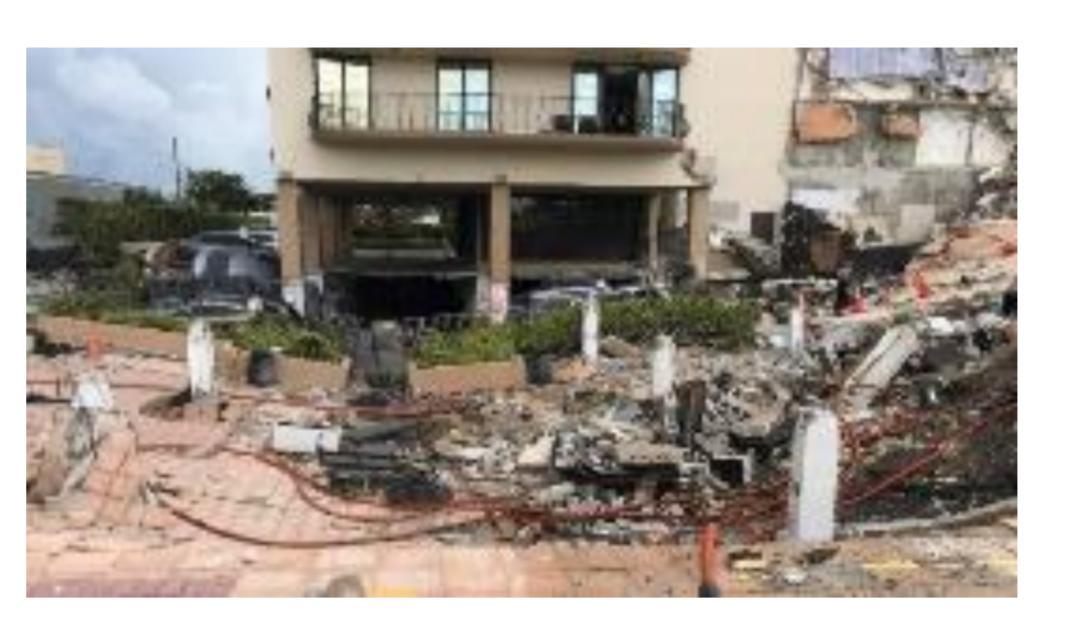
Figure 11. Slabs of the eastern section. This photo is looking north from the pool deck across the debris pile. The roof is at the left, the tan tile is on the 13th story balcony slab, the red tiles on 12th, and so on, with the pink tile at far right the 9th floor balcony. This indicates the eastern section toppled south and then west.

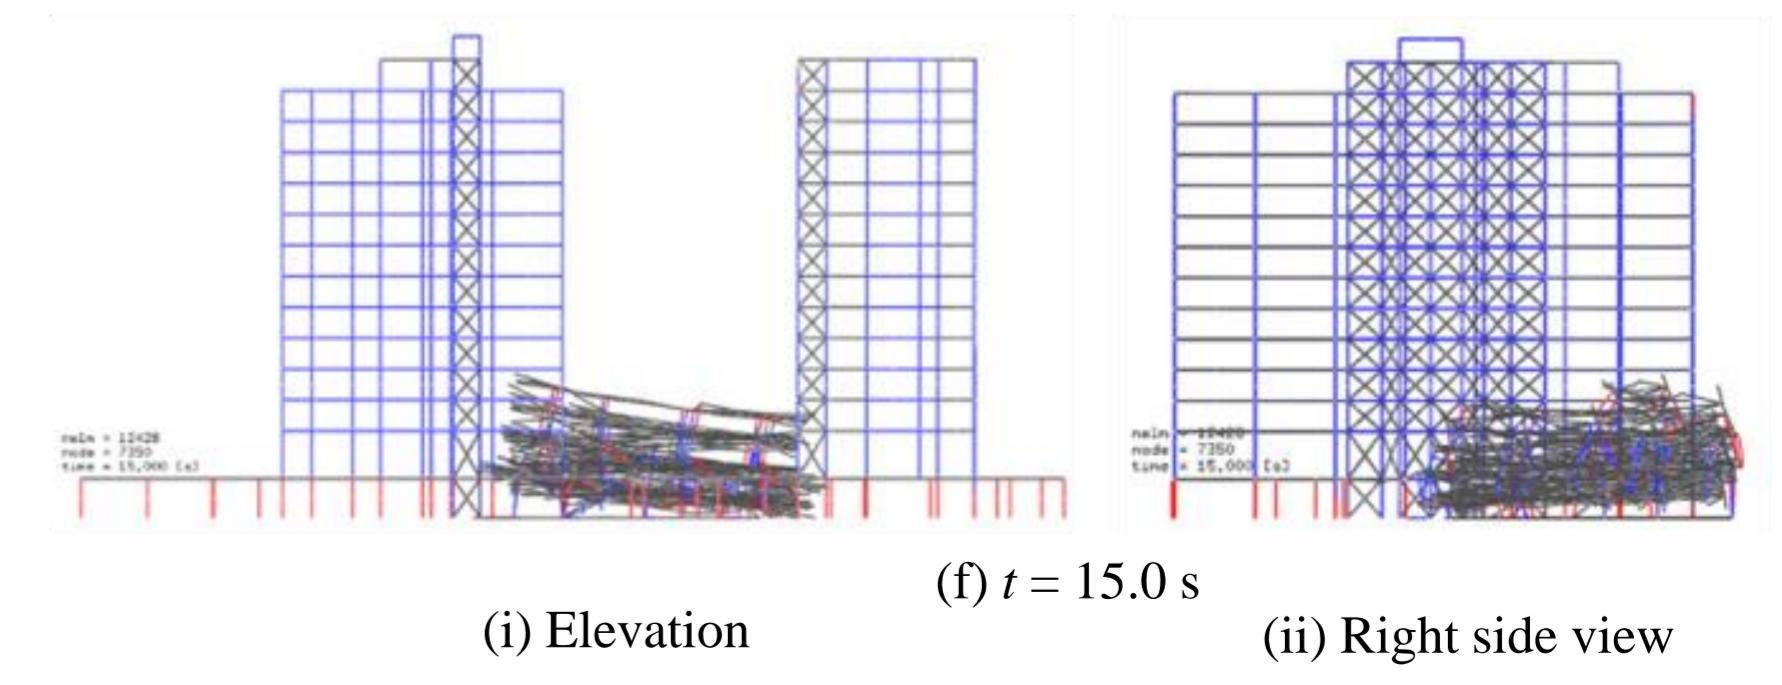
A collapse analysis was conducted based on the hypothesis that removal of key columns was the main cause of the collapse, by constructing a model that considered the pullout of the rebar and the reduction in the bearing capacity of the reinforced concrete based on the investigation (Fig. 6 - Fig. 12). The model confirmed the collapse of the middle section, but no collapse was observed in the eastern section of the building (Fig. 13).. These results suggest that the pullout of the rebar at the connection joint between the wind-resistant wall and the flat-plate floor, the reduction in bearing capacity of the basement columns, and the removal of key columns were some of the main mechanisms of the collapse of the Florida Condominiums.

Figure 13. Numerical results based on the hypothesis with deterioration of concrete slabs, corrosion of rebars, and loss of key columns as the main cause.
