Numerical Investigation on the Collapse of the CTV Building Caused by the 2011 New Zealand Earthquake

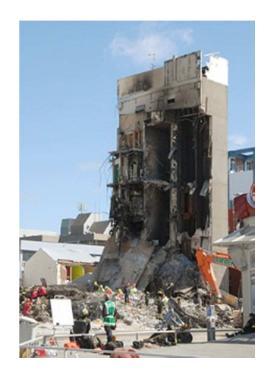
A six-story high, reinforced concrete (RC) framed structure called the Canterbury Television (CTV) building collapsed totally with only the north-core wall remained standing (Fig.1), due to the earthquake of magnitude 6.3 which occurred in New Zealand on 22nd of February, 2011. Many overseas students including Japanese students died in the event. Hyland and Smith [1] investigated on the possible cause of the collapse. They concluded that the building swayed and twisted violently. Once the column on the mid to upper levels on the east face failed, other columns rapidly became overloaded and failed. Then the beams and floor slabs fell down and broke away from the north-core.

Fig.1 Remain of the CTV building after the collapse
