COLLAPSE ANALYSIS OF BUILDINGS SUBJECTED TO SEISMIC EXCITATION, TSUNAMI, AND DEBRIS COLLISION

Daigoro Isobe¹ and Yuan Qi Dong²

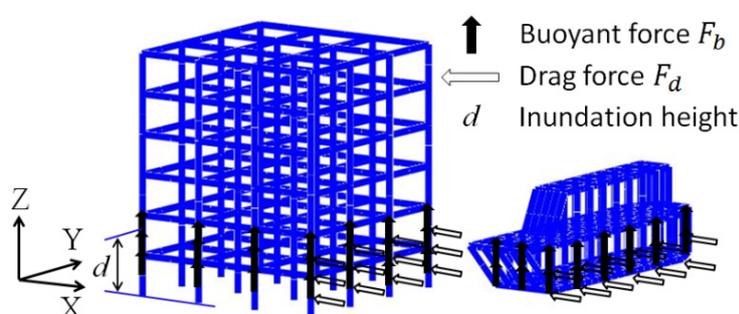
Fig. 1 Drag force and buoyant force applied to the building and tsunami debris

The Great East Japan Earthquake and the following tsunami which occurred on the 11th of March, 2011, caused a big disaster along the ocean-side of Tohoku area. The big tsunami carried different kinds of debris such as ships and cars up the stream, which caused additional damages to the buildings in the area [1][2]. In this study, a structural collapse analysis of a steel building is performed using a finite element code based upon the ASI-Gauss technique [3]. A seismic excitation recorded in Kesenuma-shi is first applied to the steel building model, followed by an input of the drag force and buoyant force due to tsunami wave. At the last phase of the analysis, a debris model with a velocity is collided, as shown in Fig. 1, and the collapse behavior of the building is analyzed.

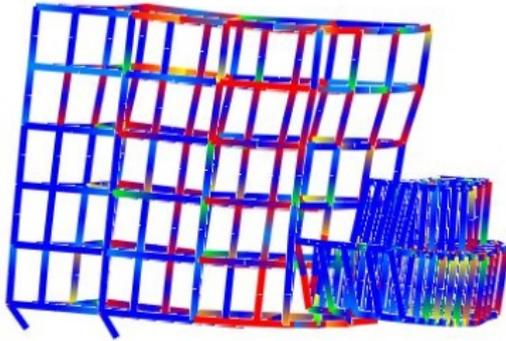
Fig. 2 Behavior of the building after collision with tsunami debris (model with a wall placed under water level)

The story drift angle and the drag force applied to the building during the sequence are both investigated, and are compared between models with and without a wall placed under water level. The latter model tends to withstand both the tsunami and the debris collision while the one with a wall is totally washed up by tsunami after a direct hit from the debris (see Fig. 2). However, the impact force of debris and continuous application of the drag force on the collided debris leads to a severe damage of the building with a story drift angle of about 0.036 rad (see Fig. 3), even if the building of the latter case has survived the tsunami itself. This indicates that the anti-collision as well as anti-tsunami considerations are both similarly important in the structural design of a tsunami refuge building.

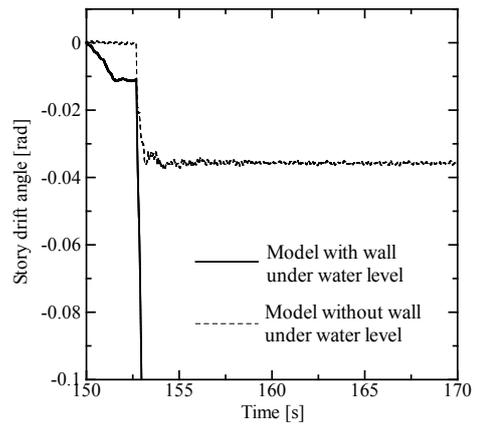
Fig. 3 Story drift angle of the building at the 1st floor
