## **Seismic damage evaluation of existing low-rise RC buildings Suffered by the 2011 off the Pacific Coast of Tohoku Earthquake**

### **ABSTRACT**

### 2.1 Observed damage

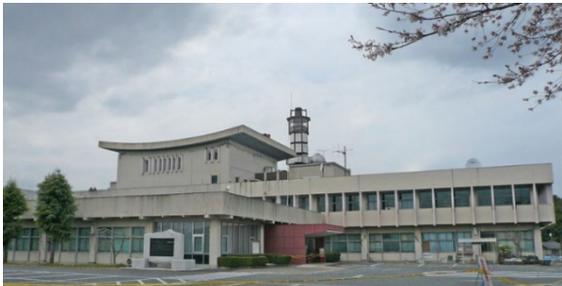
Fig.1 View of building (A)

The front view of the building (A) is shown in Fig.1 and the size and reinforcement of typical columns are shown in Table.1. First floor plan is shown in Fig.2 and framing elevation of line A is shown in Fig.3. The building (A) is a 3-story building constructed in 1965 and it has a 1-story building partially. It has 11 spans in longitudinal direction and 5 spans in 1<sup>st</sup> story and 2 spans in other story in lateral direction. It has an atrium in 1<sup>st</sup> story and an assembly hall which floor height is higher in 3<sup>rd</sup> story. The height of the 1<sup>st</sup> floor is 4.05m, 2<sup>nd</sup> is 3.60m, 3<sup>rd</sup> is 3.10m and 7.00m. The building is formed of rigid frame with the RC walls. Strong ground motion which had observed at distance of 150m in southern direction from this building and acceleration response spectrum are shown Fig.4. The maximum acceleration of ground motion is 967.4 cm/s<sup>2</sup> in north-south direction and 595.8 cm/s<sup>2</sup> in east-west direction. Acceleration response spectrum is distinguished in period 0.3 to 0.4 and 0.6 to 0.7 and value in north-south direction is higher.

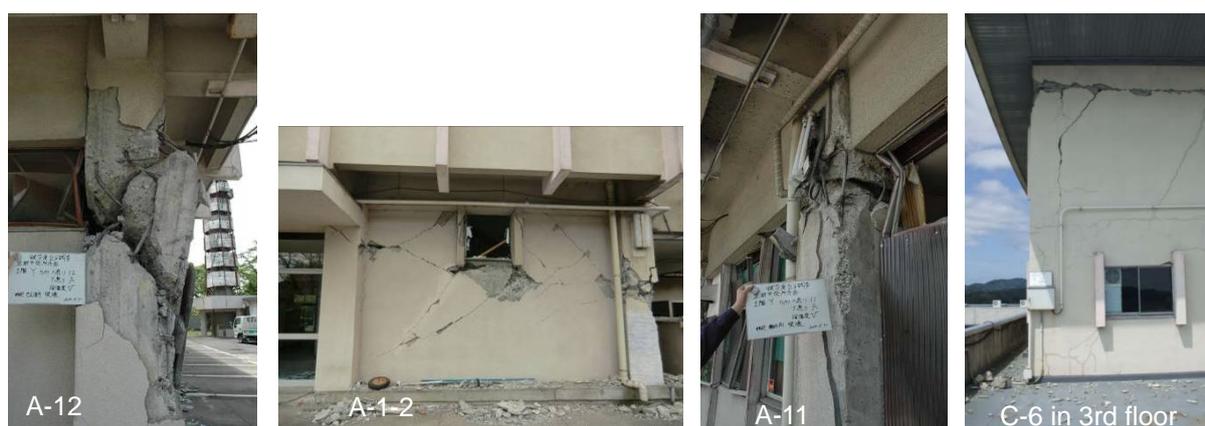
1<sup>st</sup> floor plan and damage levels in columns and walls are shown in Fig.5. The damage level of each column and wall are marked with Roman numbers. These damage evaluation are quantified based on "Guideline for Post-earthquake Damage Evaluation and Rehabilitation"<sup>1)</sup> with residual ratio of seismic performance. The building had many columns with severe shear failure in longitudinal direction. These shear failure of extremely short columns and walls are shown in Fig.6. Residual ratio of seismic performance are shown in Table.2. The longitudinal direction of 1<sup>st</sup> floor had most severe damage.

Shear failure of extremely short column and wall      Axial failure      Cracks of the wall  
 Fig.6 Damage of columns and walls

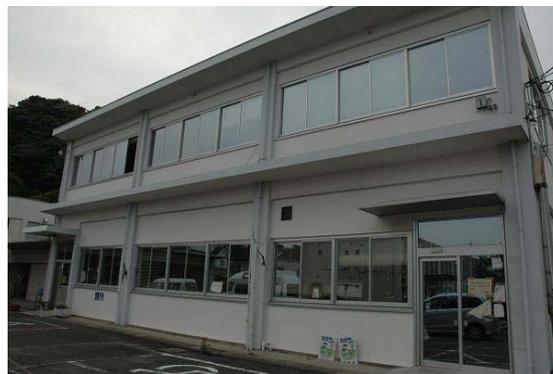
Fig.20 Building (B)

Building (B) has two story as shown in Fig.20. The dimension and reinforcement of typical columns are shown in Table.6. The 1<sup>st</sup> floor plan is shown in Fig.21 and framing elevation of the A line is shown in Fig.22. The reinforcement arrangement and concrete strength used in several analysis is based on the field work and results of compression test as shown in Fig.23 and Table.7. Because there is no design information when the building was built, it is confirmed that the building has been built in 1964 approximately by interviews. It has 3 span on longitudinal direction and 1 span on lateral direction. The building is formed of rigid frame with the concrete-block walls. The height of 1<sup>st</sup> floor is 4.50m, 2<sup>nd</sup> is 3.40m. Strong ground motion which had observed at distance of 250m from building (B) and acceleration response spectrum are shown in Fig.24. The maximum acceleration are  $524.7\text{cm/s}^2$  in NS direction and  $588.1\text{cm/s}^2$  in EW direction. Acceleration response spectrum peaks at 0.4s and 1.0s in EW direction. It is guessed that ground motion in EW direction is stronger than one in NS direction.
