## [V-514] Concrete Cracked by Expansion Agent Filled Pipes in Bond Test Specimens with Stirrups Concrete Cracked by Expansion Agent Filled Pipes in Bond Test Specimens with Stirrups

キーワード：鉄筋腐食、静的破砕剤、ひび割れ幅、付着、横補強筋

Concrete Cracked by Expansion Agent Filled Pipes in Bond Test Specimens with Stirrups

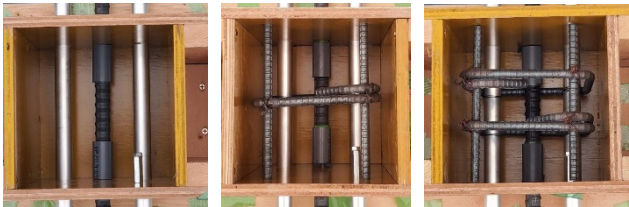
Fig. 2 Specimen framework

(a) Series S0 (b) Series S1 (c) Series S2

The reinforcement is a deformed bar of a nominal diameter of 19 mm. The specimen framework is also shown in Fig.2.

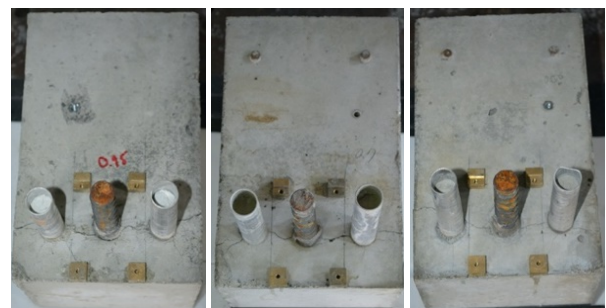
Fig. 5 Example of cracking by EAFP

Fig. 5 shows an example of crack patterns after filling the expansion agent. The side split type cracks took place in all specimens. The maximum induced crack width ranges from 0.15 to 0.95 mm in S0 specimens, 0.15 to 1.40 mm in S1 specimens, 0.15 to 0.70 mm in S2 specimens.

(S0-C-0.95mm) (S1-C-0.70mm) (S2-C-0.60mm)
