**Study on Bond Degradation of Reinforced Concrete
Members with Induced Cracks due to Rebar
Corrosion**

March 2023

SYLL AMADOU SAKHIR

Graduate School of Science and Technology
Degree Programs in Systems and Information Engineering
University of Tsukuba

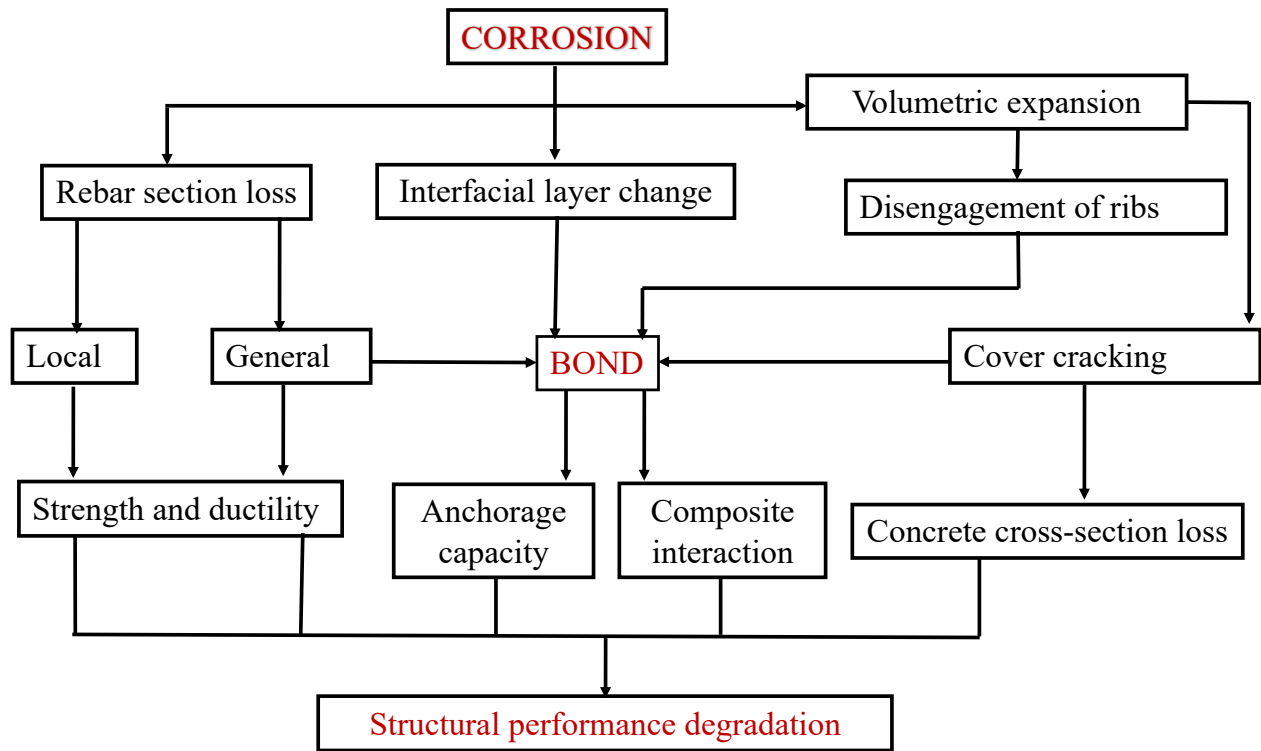
Figure 1.1 Corrosion effect on RC structural performance

The reinforcing steel bar (rebar) corrosion is considered the most common and severe cause of RC structure degradation. In recent years, the RC structures durability has been a major concern, particularly for structures under aggressive environments. Figure 1.1 overviews the consequences of corrosion on the RC structures. Advanced corrosion can cause various damage to RC structures, including loss of effective concrete section due to concrete cracking and cover spalling, loss of rebar tensile performance due to reduced cross-section, and deterioration of bond strength between corroded rebar and concrete. Corrosion directly reduces cross-sectional rebar area and produces rust that expands in volume. Localized or pitting corrosion comes from chloride ingress. It often concentrates at a point or in a limited rebar area, whereas uniform corrosion is related to carbonation. The reduction in rebar cross-section and pitting deteriorates the strength and ductility of corroded rebar. The rust volumetric expansion causes cover concrete cracking which leads to cover delamination and spalling. As a result, the bond strength between concrete and rebar is seriously affected by the concrete cover cracking and rebar cross-section loss. At the structural level, bond strength degradation can affect the structural performance of RC structures, such as failure mode, stiffness, strength, and deformation capacity.

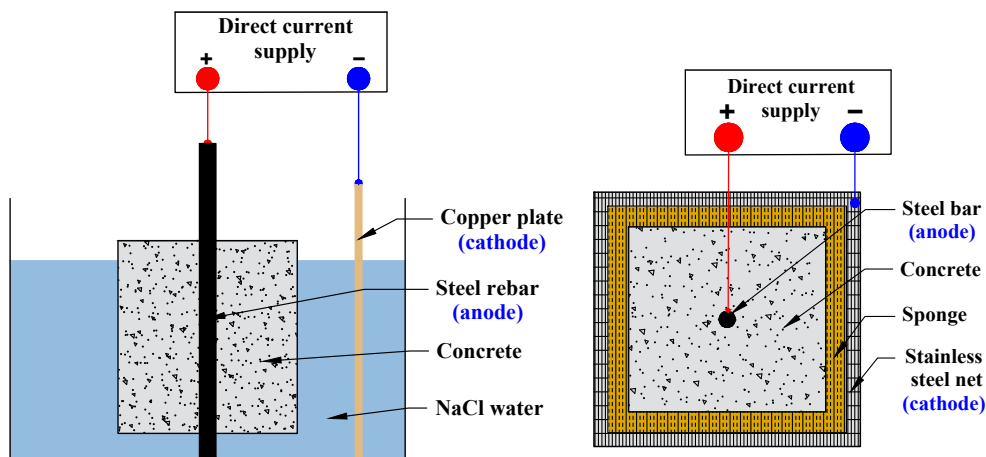
Figure 2.5 Accelerated electrical method

frequently used to study the bond performance of corroded RC because of its benefits. (short time, controllable current density, and portable test equipment) [22]. The approach is primarily electrochemical, with rebar as the anode and stainless steel or copper plate as the cathode. The corrosion of the rebar is then accelerated by applying a direct current. To ensure the normal conduct of the electric accelerated corrosion test, approximately 5% sodium chloride is often added to fresh concrete. The specimen is either immersed in a salt solution or wrapped with a humidified sponge, as illustrated in Figure 2.5.

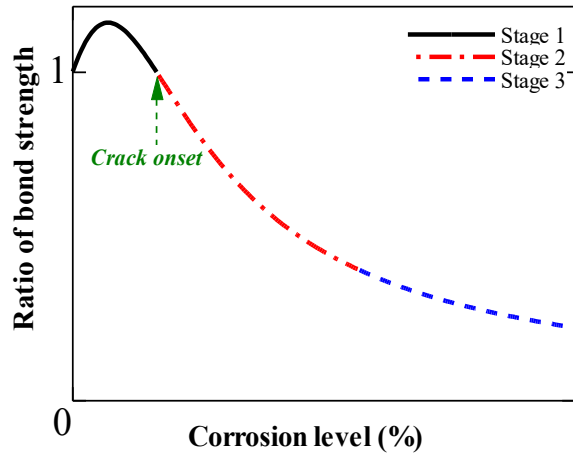
Figure 2.11 Degradation of bond strength with corrosion level

corrosion), the bond strength did not alter with increasing mass loss, asymptotically approaching a limit. Significant rib deterioration would result in friction-type behavior comparable to plain bars [37–40]. As a result, the bond strength slowly decreases in stage 3.

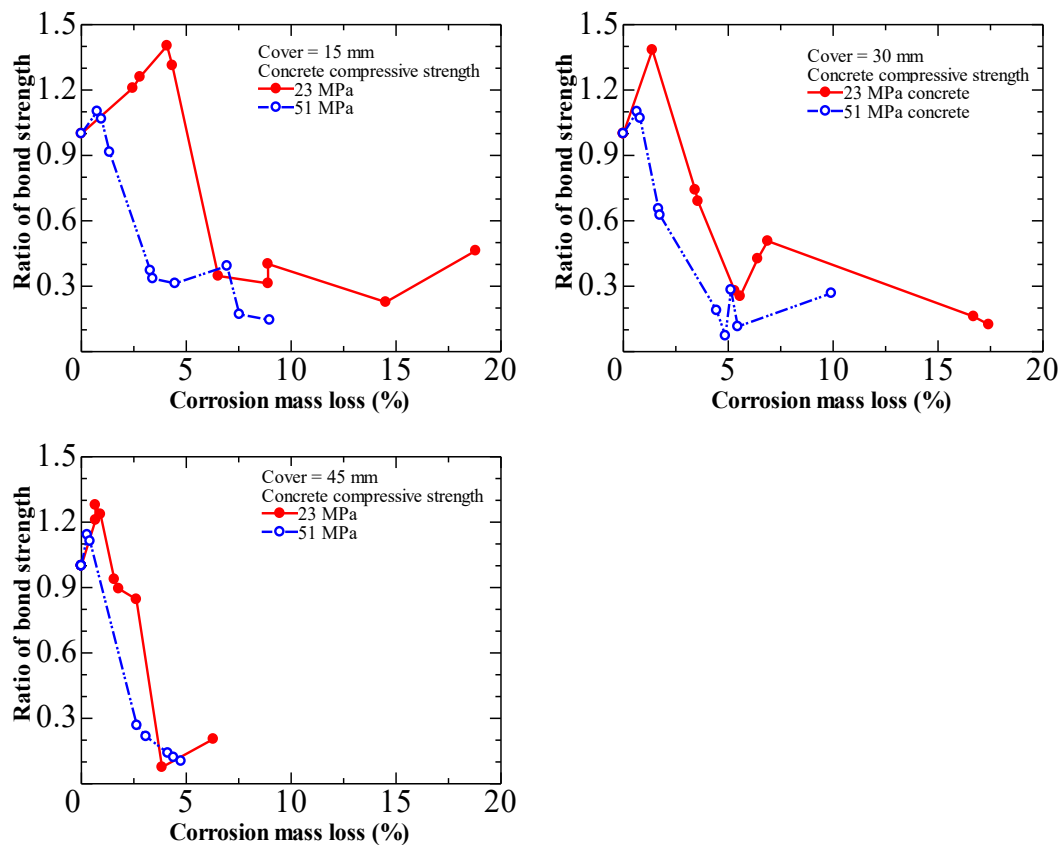
Figure 2.12 Influence of concrete strength on bond deterioration from Yalciner et al.

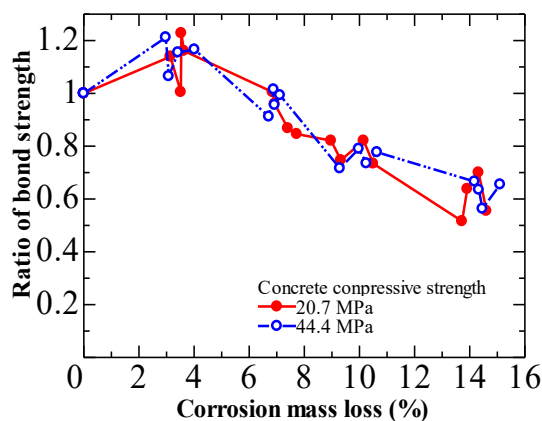
Figure 2.13 Influence of concrete strength on bond deterioration from Zhou et al.

Figure 2.13 shows the results of Zhou et al. [45,46]. They examined the effect of concrete strength on bond degradation using two different concrete mixes (20.7 MPa and 44.4 MPa) in specimens with stirrups. In contrast, they discovered that the compressive strength of the concrete did not affect the bond degradation trend. They emphasized that mixing different failure modes can complicate the observation of the concrete strength effect.

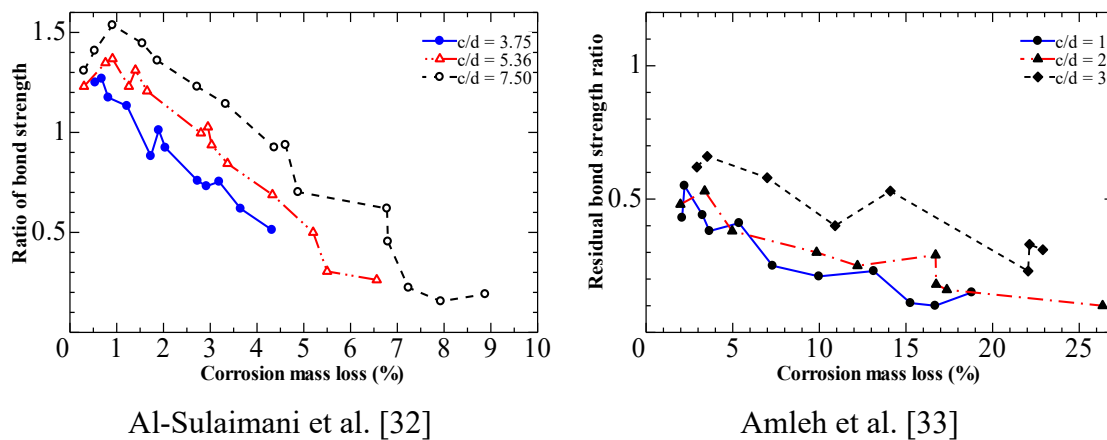
Figure 2.14 Influence of the cover-to-diameter ratio on bond deterioration

Furthermore, Al-Sulaimani et al. [32] showed that bond deterioration is more severe in specimens with a smaller c/d , as shown in Figure 2.14. The results of Amleh et al. [33] shown in Figure 2.14 are consistent with those of Al-Sulaimani et al. concrete can still transfer stress across cracks. As a result of the residual confinement, the specimens with a more significant concrete cover demonstrated stronger bond strength.

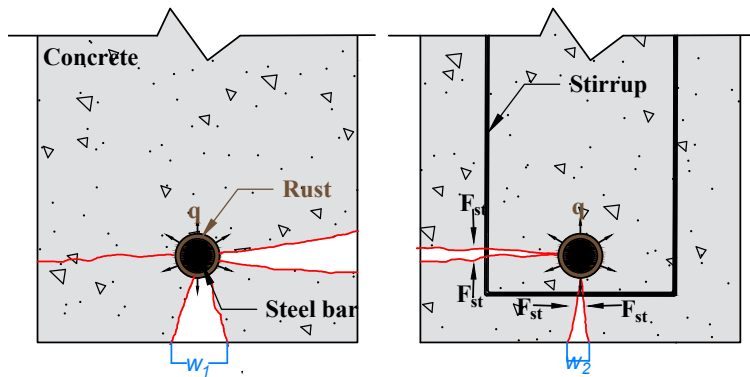
Figure 2.15 Effect of stirrups on corrosion-induced cover cracking

They concluded that the bond strength improved when the degree of stirrup corrosion was less than 10%. However, bond degradation was observed when the degree of stirrup corrosion reached 15%. These findings are likely related to the corroded stirrup that produces hoop stress that acts inside and outside. This stress can crack the cover and add more confinement to the core concrete where the tested rebar is located [54–56]. As a result, the bond strength can increase.

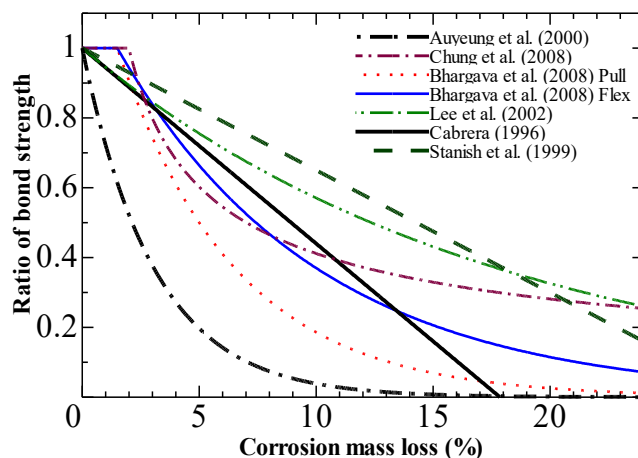
Figure 2.16 Comparisons of model predictions based on mass loss

However, it is found that this model, where mass loss is the main parameter, is likely challenging to implement. The mass loss of corroded rebar is not easily measurable in real situations. Therefore, to implement these models, engineers would first need a model to correlate the measurements of surface crack widths with the “hidden” internal corrosion. However, many uncertainties associated with each model can seriously weaken its effectiveness and accuracy.

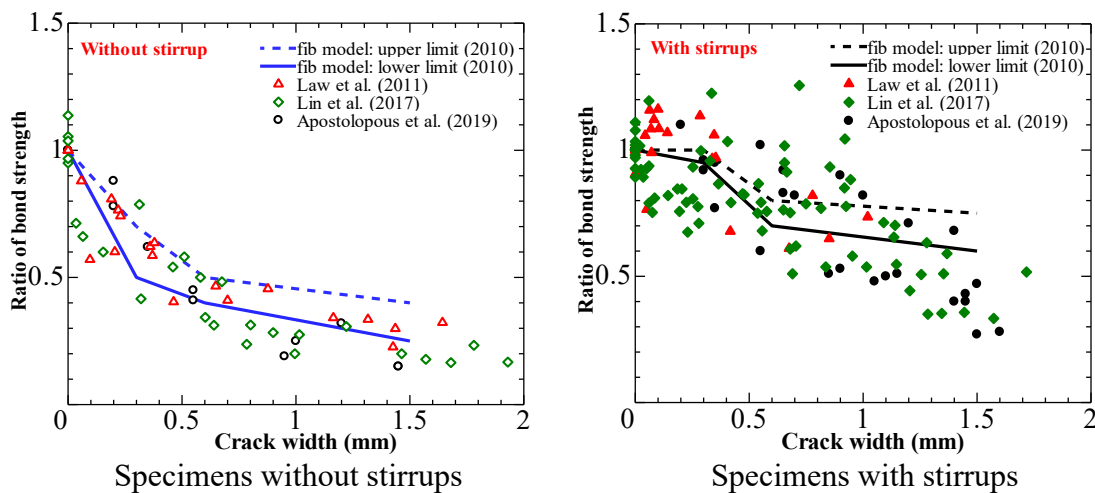
Figure 2.17 Comparisons of fib model with test results in the literature

Figure 2.16 indicates a strong correlation between induced crack widths and bond deterioration in unconfined specimens. Furthermore, fib model code estimations for specimens without stirrups are well predicted. The data scatter is higher for specimens with stirrups. The fib model fails to predict the increase in bond strength caused by stirrups, resulting in an overestimation.

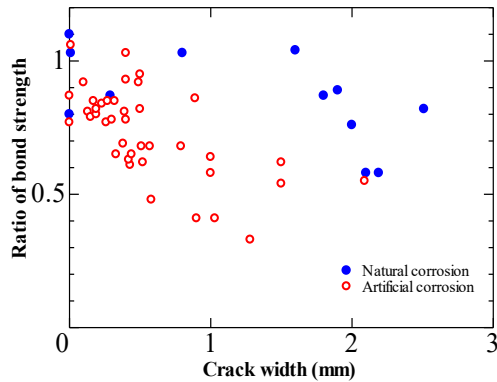
Figure 2.18 Influence of corrosion rate on bond strength deterioration

On the other hand, researchers investigated the bond deterioration of corroded specimens extracted from decommissioned RC bridges [17–20]. Tahershamsi et al. [18] examined the bond degradation due to corrosion-induced crack widths of 32-year-old naturally corroded RC girders. They found more significant crack widths for given levels of corrosion than previous researchers using accelerated corrosion. Figure 2.18 shows that the reduction in bond strength in the naturally corroded specimen was less significant than the results of artificial corrosion. They attributed the disparity to the difference between natural and accelerated corrosion and the cumulative effects of freeze-thaw and corrosion. In conclusion, they stated that estimating bond deterioration using accelerated corrosion would be safe.

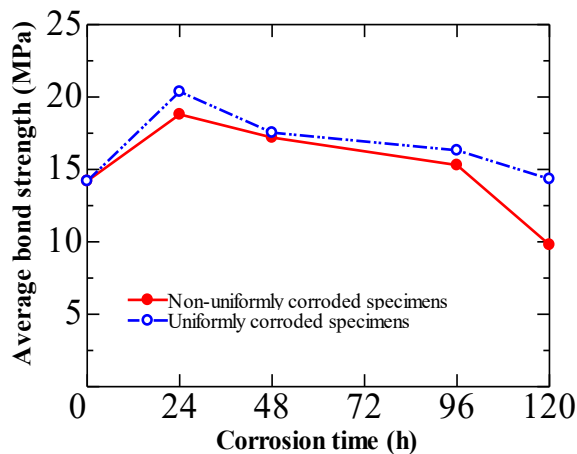
Figure 2.19 Influence of corrosion type on bond strength

Previous investigations on the effect of corrosion on the bond strength of RC specimens were conducted by accelerated corrosion using impressed currents. As a result, the tested rebars were uniformly corroded. In this way, only mechanical interlocking and friction contributed to the bond strength of the corroded specimens. However, the natural corrosion of steel is typically non-uniform around the surface of the rebar [24]. Therefore, the interfaces of the corroded and non-corroded sections contribute to the bond. To address this, studies [86–88] focused on the influence of the rebar's non-uniform corrosion on the bond strength's deterioration. Fu et al. [87] adopted two corrosion modes for corroded RC specimens to induce non-uniform and uniform corrosion. Figure 2.19 shows that the bond strength degradation was generally more severe in non-uniformly corroded specimens than in the case of uniform corrosion. Deterioration becomes more noticeable as the corrosion level increases. This is likely related to the stress concentration within the interface.

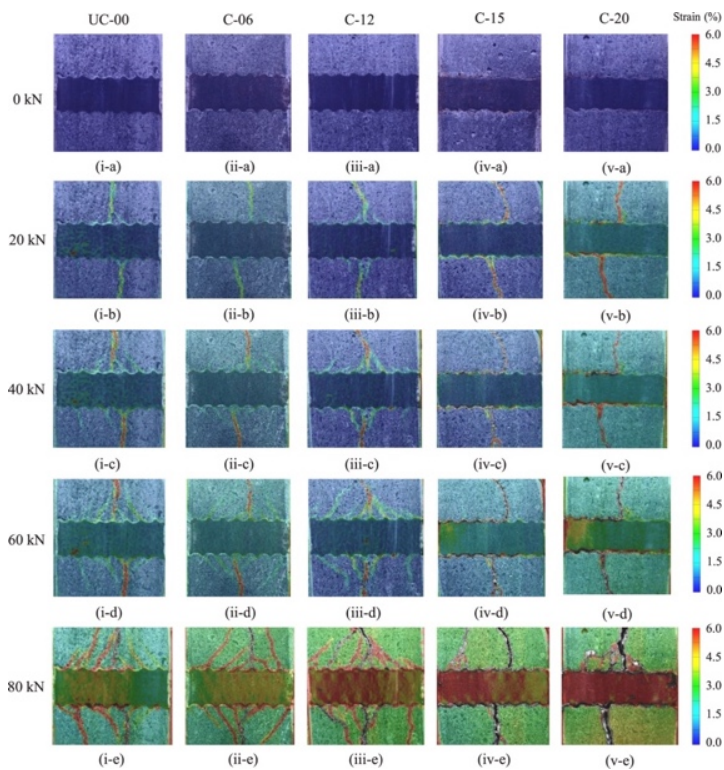
Figure 2.20 Change in strain distribution with loading [87]

Many factors affect the bond between rebar and concrete, leading to a complicated interaction. Recently, researchers have attempted to clarify damage using acoustic emission [89], ultrasonic technology [90], or digital image correlation (DIC) [91,92]. Ouglova et al. [92] used DIC to examine the beginning of bond failure in corroded specimens. They found that the increase in corrosion level slows the beginning of bond failure. Furthermore, the average bond stress at the start of the slippage is smaller than the bond strength during the pull-out test. Avadh et al. [91] used corroded specimens with a window to observe the rebar and concrete interface during the uniaxial tension test. The corroded rebars were cast in new concrete to eliminate the hindrance caused by the corrosion-induced cracks. They performed a DIC to examine the influence of rib height reduction and rust's presence on bond failure. Figure 2.20 shows the change in strain distribution with loading adopted from Avadh et al. [86]. The onset and progression of diagonal cracks are observed in uncorroded specimens and specimens with degrees of corrosion up to 12% (Specimens UC-00, C-06, and C-12). Furthermore, failure-cracking observations revealed that the increased corrosion led to faster debonding between the rebar and the concrete. Diagonal cracks were not observed in specimens with higher degrees of corrosion despite having ribs (Specimens C-15 and C-20).

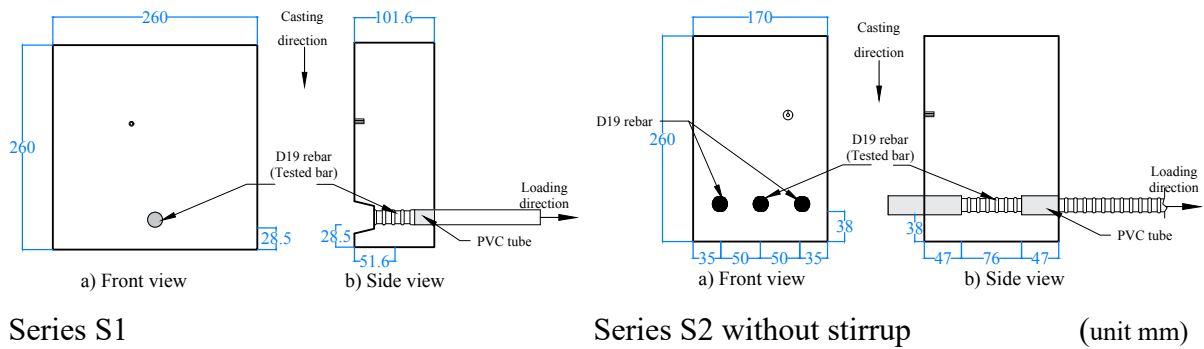
**Figure 3.6 Specimen details**

Figure 3.6 shows the specimen details. The dimensions of the specimen are 260×260×101.6 mm for S1 Series and 260×170×170 mm for S2 Series. The concrete was cast with the main longitudinal D19 rebar horizontally positioned at the bottom of the framework. A small concrete cover of 28.5 (1.5 Ø) and 38 mm (2 Ø) for S1 and S2, respectively. A short bond length was placed in the central part of the specimen to focus on the local bond behavior. To avoid cone failure during pull-out loading, unbonded parts were set at the loaded and free ends by inserting PVC tubes. Specimens without and with stirrups over the bonded length were prepared. S2 Series includes specimens with two stirrups (D6) with a 50 mm spacing. Figure 3.7 shows an example of frameworks. All specimens were produced in the same sequence and using the same materials to reduce the discrepancy.

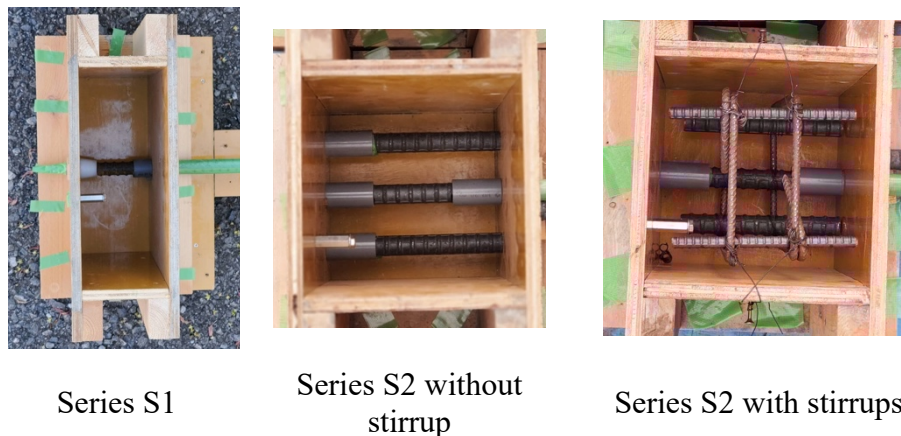
**Figure 3.7 Framework of specimens**

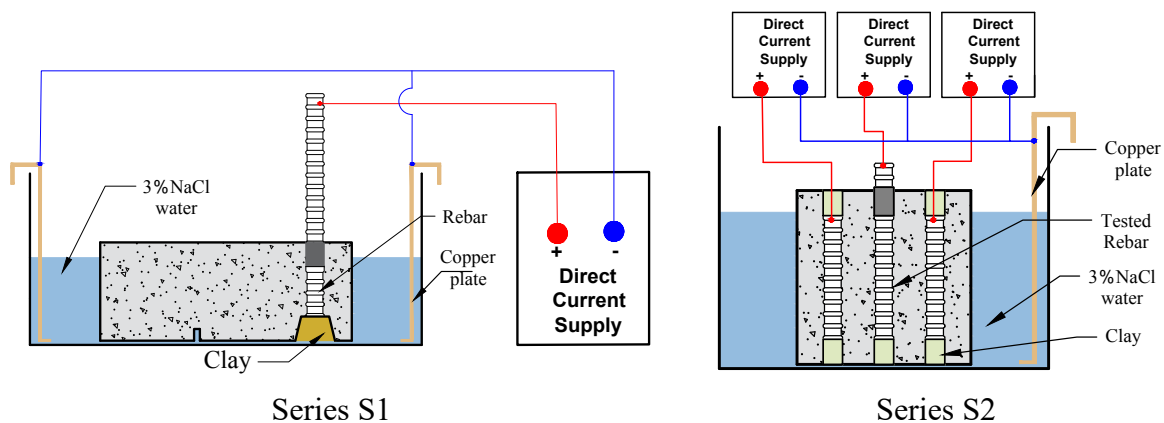
Figure 3.8 Electrical corrosion setup

Figure 3.8 shows the installation for electrical corrosion. The specimen was immersed in a 3% NaCl solution and a direct current was introduced to induce corrosion. One current supply was used for S1 Series. However, the current was separately impressed in the three rebars using three different current supplies in the S2 series. To simulate corrosion reasonably, a constant current intensity of 0.08 A and 0.3 A was applied to S1 Series and S2 Series, respectively. The specimens were divided into three groups according to corrosion time (3, 7, and 14 days for S1 and 4, 6 and 14 days for S2). A group includes three corroded specimens and one uncorroded specimen (reference). The current density used in this test was approximately $900\mu\text{A}/\text{cm}^2$ (a current intensity of 0.08A for D19 rebars), which was greater than the highest corrosion rate obtained in the natural corrosion ($100\mu\text{A}/\text{cm}^2$), as reported by Andrade [103] Although current density has been shown to influence the development of surface crack width [85,104], no definitive findings have been made regarding its influence on crack pattern. As a result, a high current density was used to quickly induce corrosion-related cracks, as reported in earlier studies [105,106].

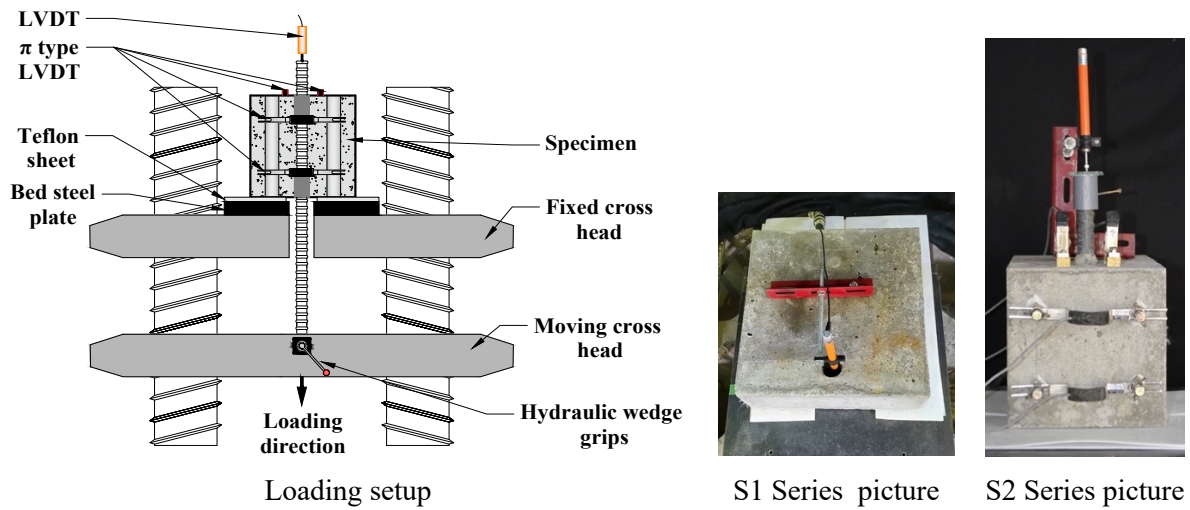
Figure 3.9 Loading and measurement of pull-out test

Figure 3.9 shows the test setups for the pull-out test. The specimen was placed on the Teflon sheet to limit friction. Also, not to restrict the lateral deformation of concrete, the loading plate included a hole with a diameter corresponding to the concrete cover. The tested rebar (D19) was subjected to monotonic pull-out loading at a speed of 0.5mm/min, as recommended by ASTM234-91A. Measurement items are pull-out load and slippage at the free end.

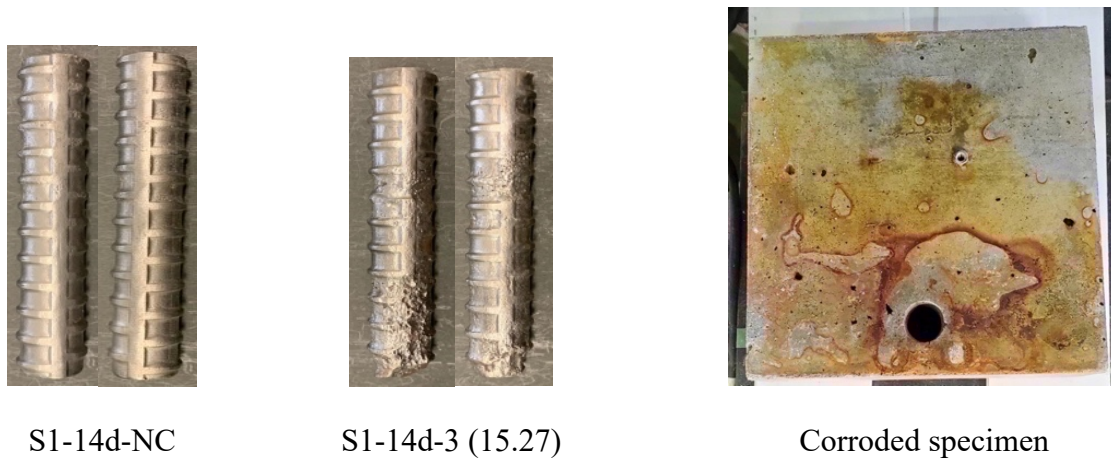
Figure 3.10 Example of corroded specimen in S1

Figure 3.10 shows an example of the corroded rebar surface and specimen. The mass loss ratio ranged from 3.85% to 15.27 %. Figure 3.10 shows that the rebar corrosion was non-uniform and more severe at the rebar free end. However, the corrosion did not crack the concrete. This is likely because rust did not build up enough hoop pressure to crack the cover when the length of the specimen is small. The rust flowing out at the end of the rebar was observed.

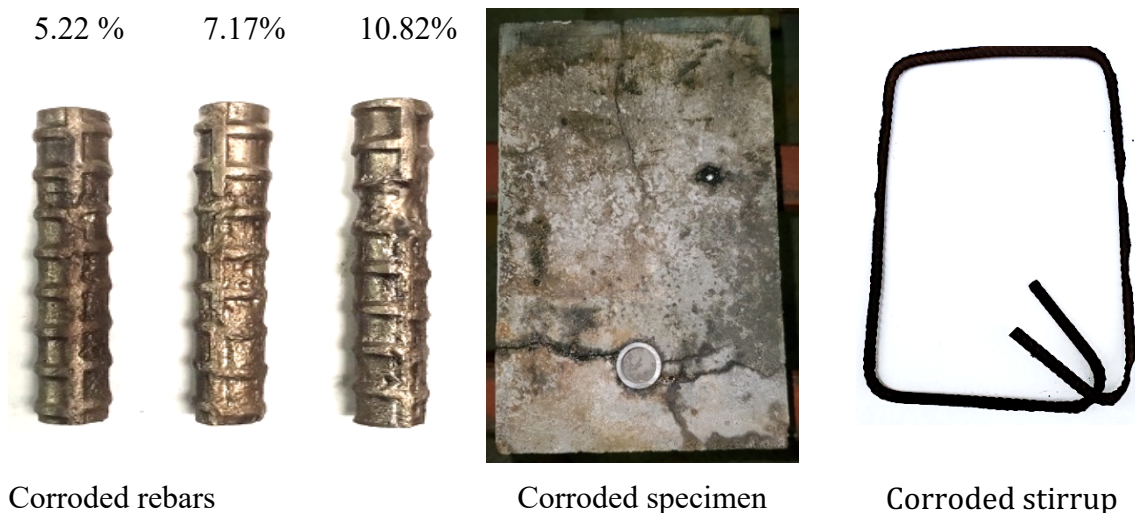
Figure 3.11 Example of corroded specimen in S2

Figure 3.11 shows an example of corroded rebars and specimens. The mass loss ratio varied from 5.00 % to 13.18 % in specimens without stirrups and 0.43% to 14.08 % in specimens with stirrups. For the same corrosion time, the specimens without stirrup have higher corrosion levels than specimens with stirrup. The stirrups have a minor concrete cover and are the most vulnerable to corrosion. The corrosion time for S2-S-14d-1, S2-S-14d-2, and S2-S-14d-3 was extended to induce severe corrosion. Side-splitting cracks perpendicular to the rebars was observed in all specimens. Their maximum widths range from 0.15 mm to 0.60 mm and from 0.15 to 1 mm for specimen without stirrup and with stirrup, respectively.

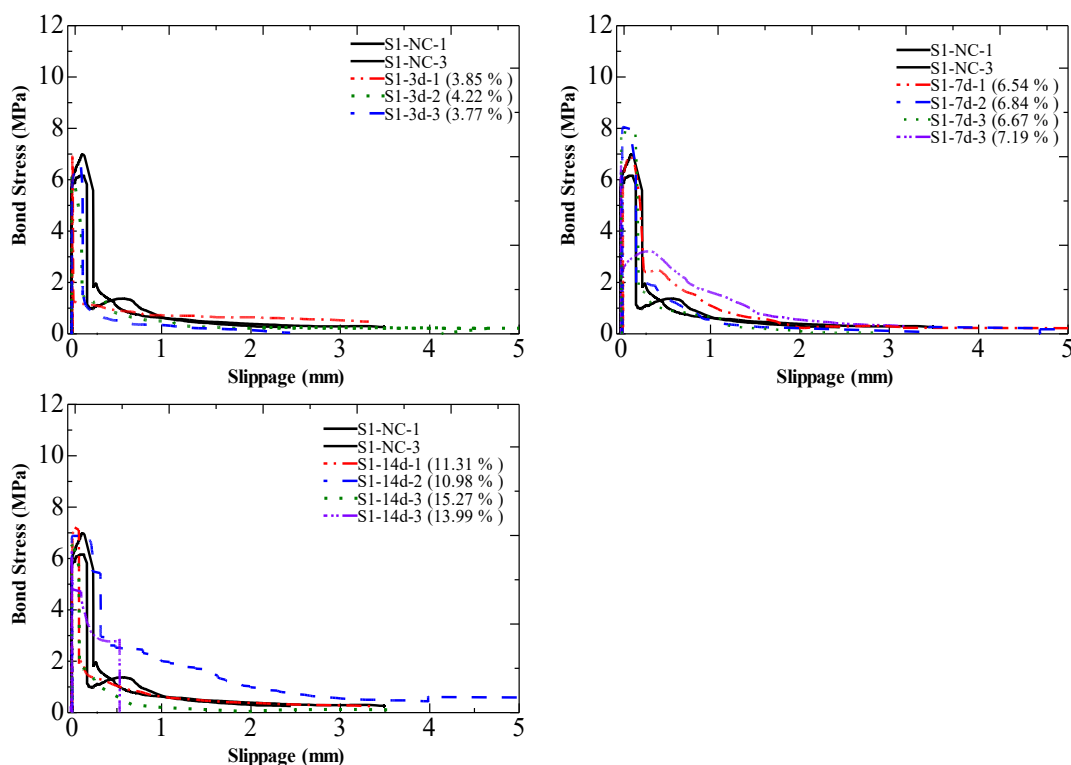
Figure 3.12 Bond stress versus slip curves in S1 Series

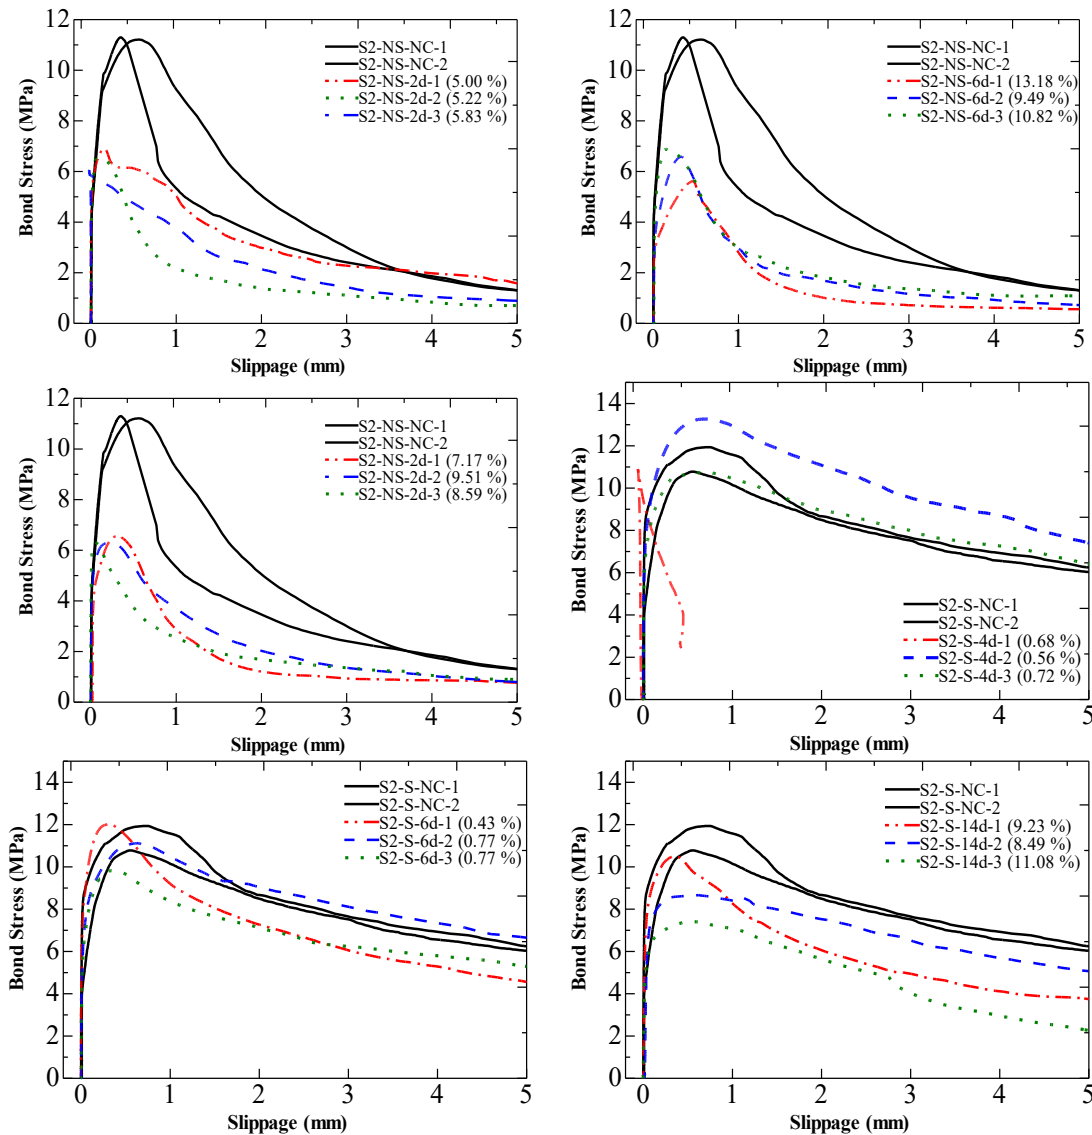
Figure 3.13 Bond stress versus slip curves in S2 Series

The influence of stirrup corrosion is clearly shown in Figure 3.13. The bond strengths are mostly not affected by corrosion of around 0.77%, which may be due to the confinement provided by the stirrup. However, when the specimen was severely corroded (S2-S-14d-1, S2-S-14d-2, and S2-S-14d-3), the bond strength was lower than that of the uncorroded specimens.

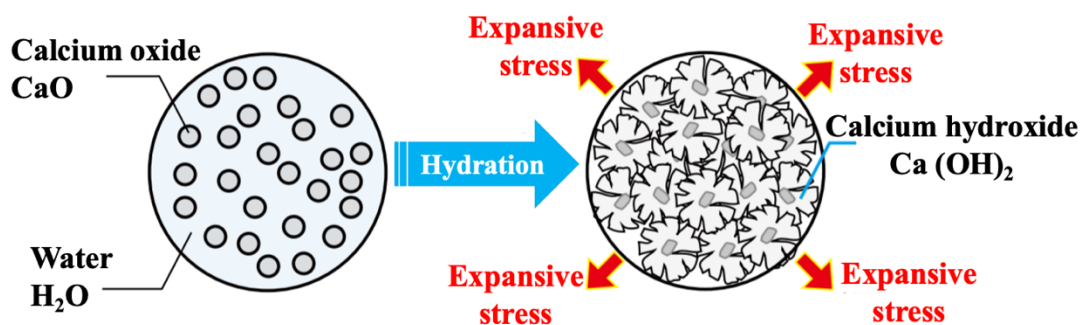
Figure 4.1 Expansion pressure generation [112]

Expansion agent is also known as a non-explosive demolition agent or soundless cracking demolition agents. It is mainly used to destroy rocks and RC structures. In powder form, it expands when humidified. The volumetric expansion is mainly caused by hydration of CaO producing Ca(OH)_2 leading to a gradual development of expansive pressures (Figure 4.1) [112].

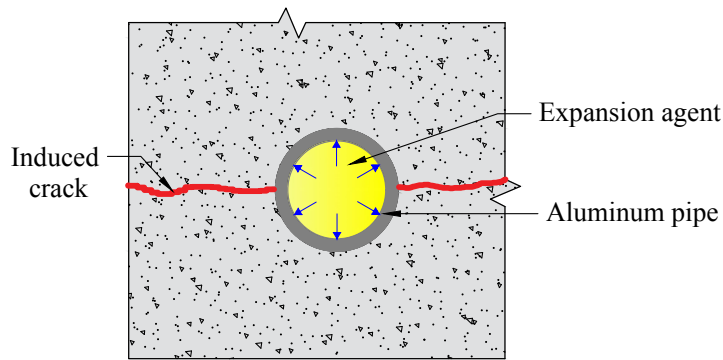
Figure 4.2 Concrete cracking with an EAFP

EAFP allows one to focus on the effect of the cracking itself while ignoring the other effect of corrosion (section loss or rust around the rebar). It is also beneficial in quickly controlling the cracks (width and position). The following subsections highlight this method.

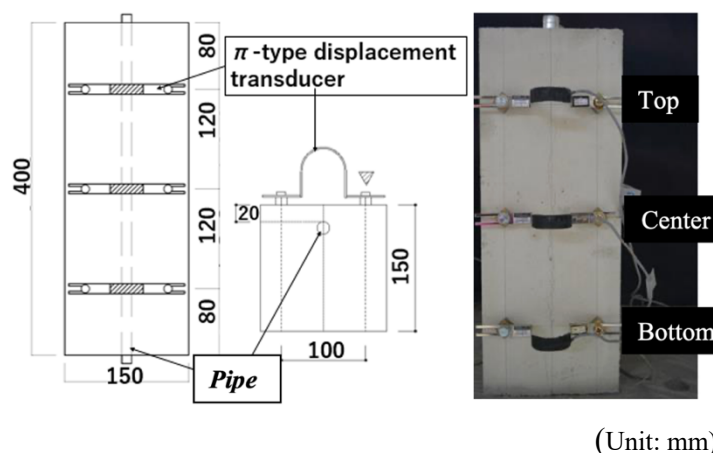
Figure 4.3 Specimen for cracking confirmation (S-20)

No.	Specimen	Common factors	Concrete cover C (mm)
1	S-15	Pipe thickness 1mm	15
2		Pipe diameter 18 mm	
3			
4	S-20	Water to expansion agent ratio W/B=30%	20
5		Concrete strength 25.3 MPa	
6

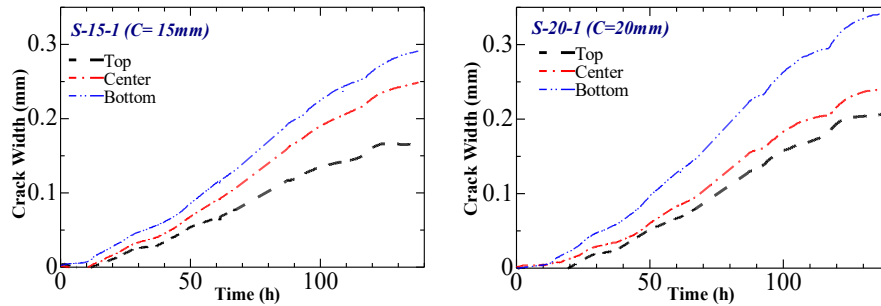
Figure 4.5 Crack width over elapsed time

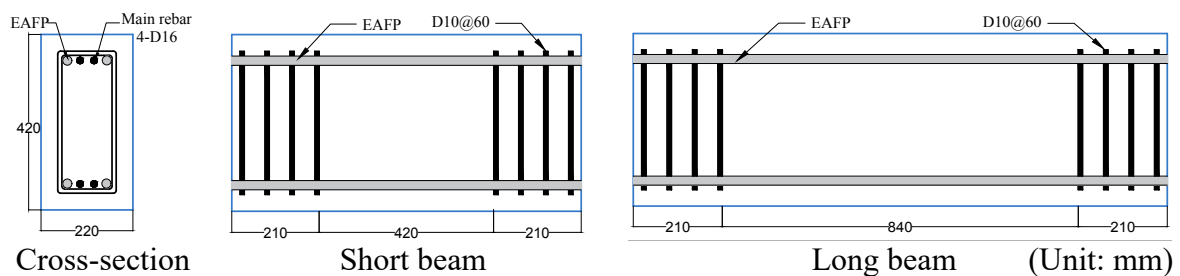
Figure 4.6 Detail of specimen

Researchers commonly conduct structural tests of beams, columns, or slabs to assess the deterioration of RC structures. They designed the size of their tested structural elements according to their objective. Thus, it will be useful to observe the development of cracks induced by EAFP in RC beam. To achieve this, four RC beam specimens with different length are prepared to investigate the surface and internal cracking due to EAFP. EAFPs replaced the main rebars at the corner of the beam. Figure 4.6 shows a specimen with a 220 mm x 420 mm cross-section. The specimen length was 840 mm (short beam) and 1260 mm (long beam). Aluminum pipes with an outer diameter of 22 mm and a thickness of 1 mm were placed at the four corners of the beam. Two deformed reinforcing bars, D19, were placed at the top and bottom of the cross-section. Both specimen (short and long) were reinforced with D10@60 stirrups at their ends. The specimen framework is shown in Figure 4.7.

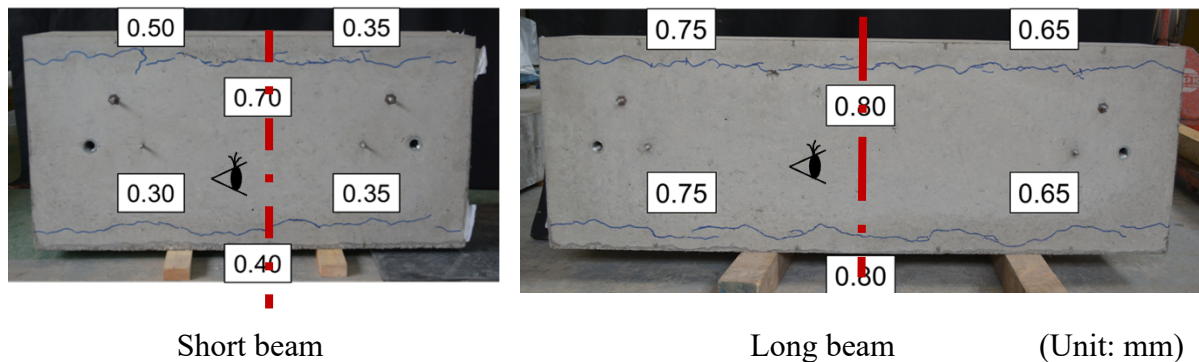
Figure 4.8 Surface crack induced by EAFP

Figure 4.8 shows the pattern of surface crack induced by EAFPs. Hours after filling, longitudinal cracks parallel to the reinforcement bars were measured and recorded, as shown in Figure 4.8. The longitudinal cracks are marked in blue, and the maximum crack widths of the picture are measured in each section.

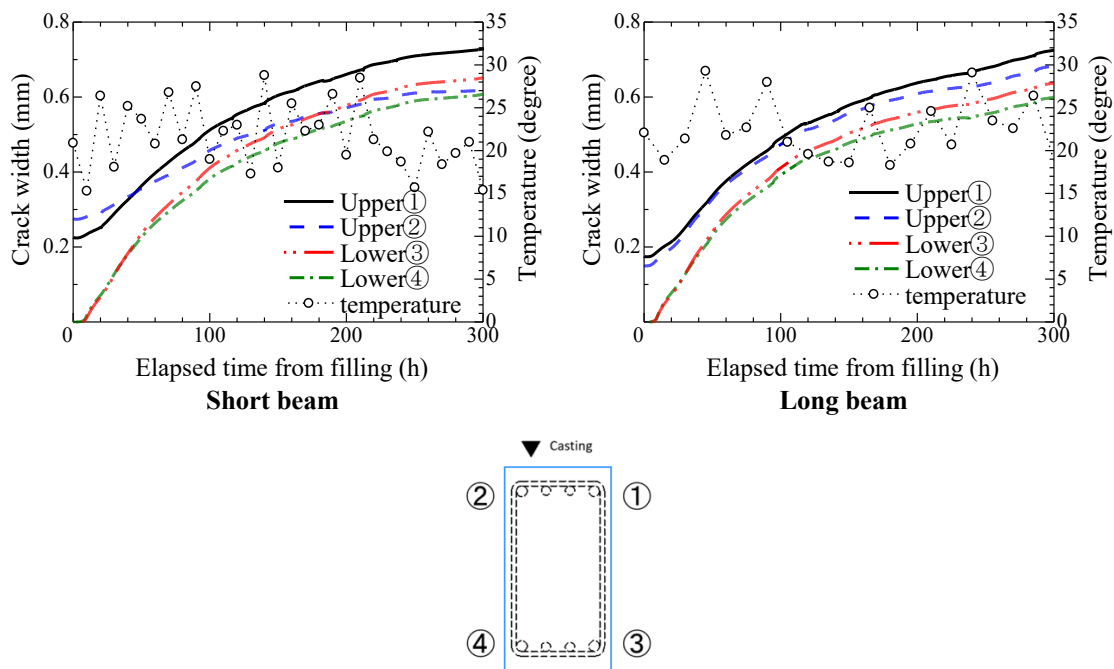
Figure 4.9 Crack width and elapsed time relationship

the cure of the concrete. Additionally, the specimen length and the temperature did not significantly influence the cracking process.

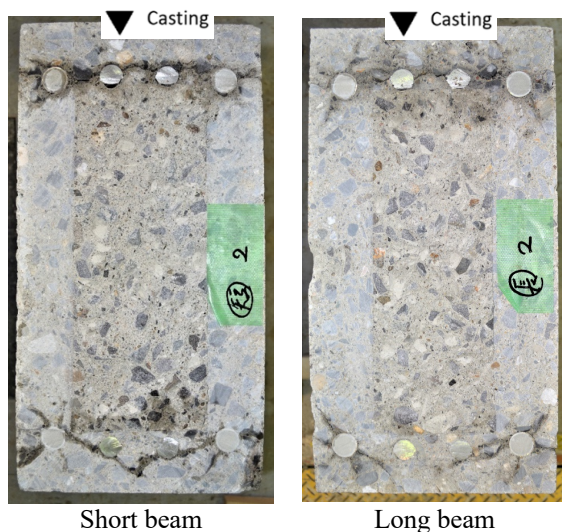
Figure 4.10 EAFP crack pattern observation

After measuring the surface crack width (Figure 4.8), the specimens were half-cut to observe internal cracking, as shown in Figure 4.10. EAFP also induces internal cracks in the specimens. In the short beam, side-splitting cracks developed at the top and bottom of the beam ends. In the long beam, side-split-type cracks occurred in the upper part, and corner-splitting cracks occurred in the bottom of the beam. Therefore, we can assume that EAFP mainly induces a side-splitting crack inside the RC beam through this thesis.

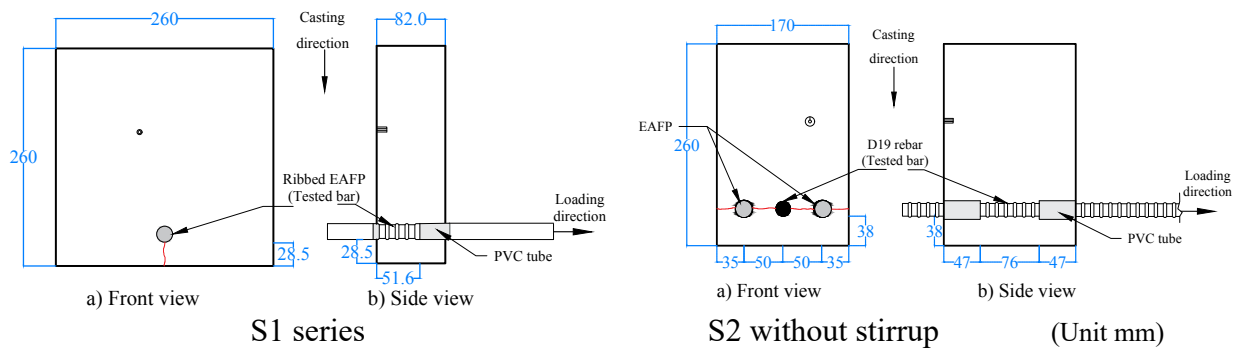
Figure 4.11 Specimen detail

Series	S1	S2	
Splitting mode	Single	Side	
Stirrup diameter (mm)	No	No	8
Induced crack range (mm)	No-cracked reference		
	0.08 to 0.85		
Tested rebar	EAFP with ribs	D19 rebar

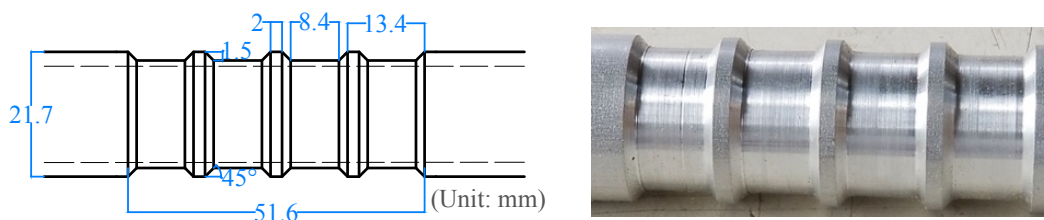
Figure 4.13 Aluminum pipe with ribs

Figure 4.13 shows an overview of a machined aluminum pipe with ribs geometry set according to JIS G 3112. An aluminum pipe with a 21.7 mm as outer diameter and 2.5 mm thickness was used to mimic the D19 rebar.

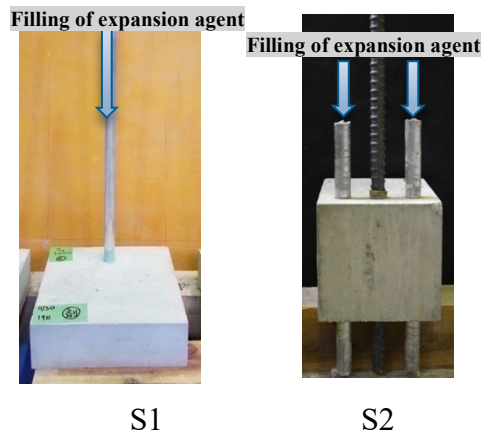
Figure 4.14 Crack simulation with an EAFP

pipe. Crack width increases over the time that has elapsed after filling. Thus, this time is controlled to obtain the target crack width.

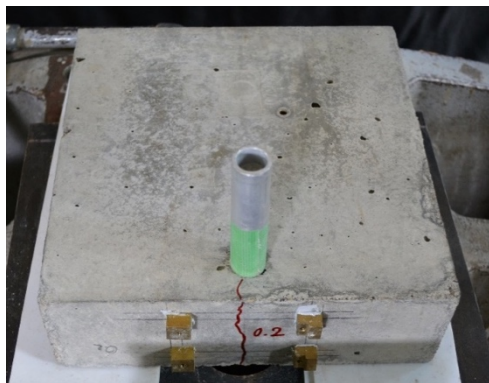
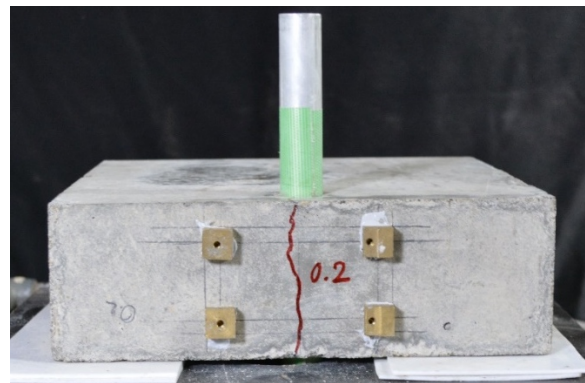
**Figure 4.15 Crack induced by EAFP in S1 specimens**

Figure 4.15 and 4.16 shows examples of crack patterns after filling the expansion agent. The maximum crack width before pull-out loading in every specimen can be seen in Table 4.4.

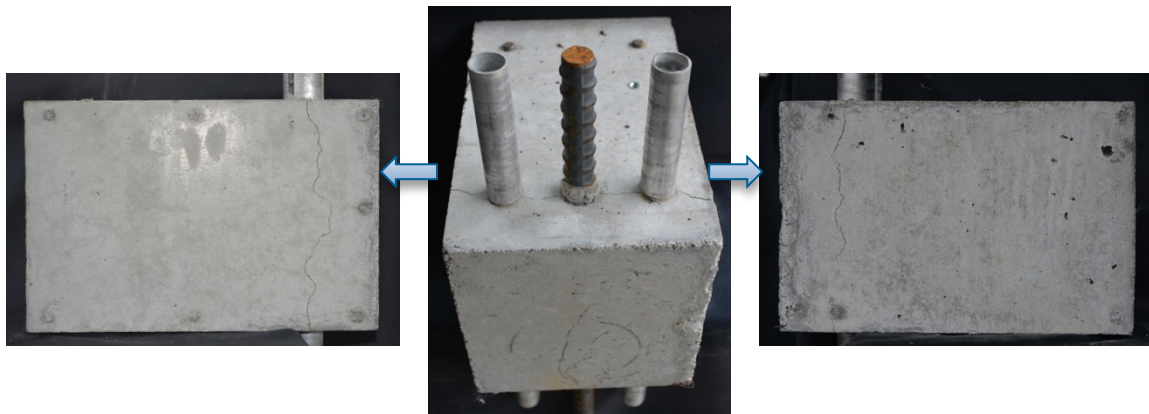
Figure 4.16 Crack induced by EAFP in S2 specimens

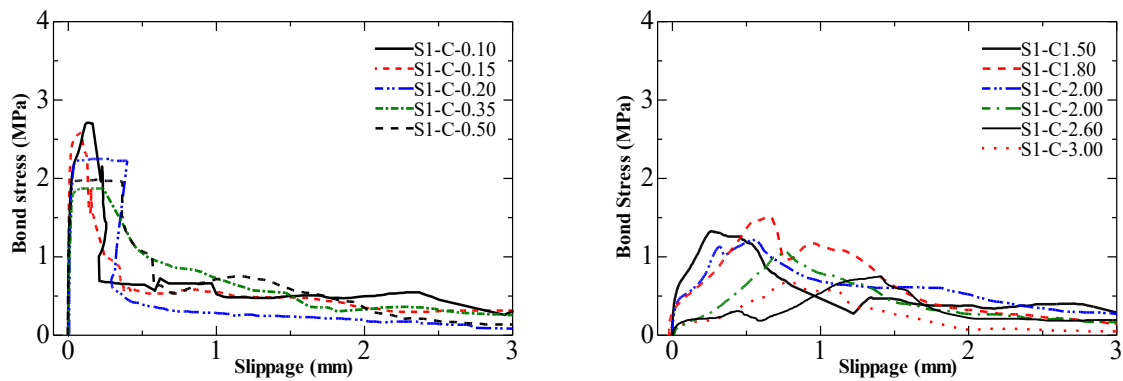
Figure 4.17 Bond stress versus slip curves in S1 Series

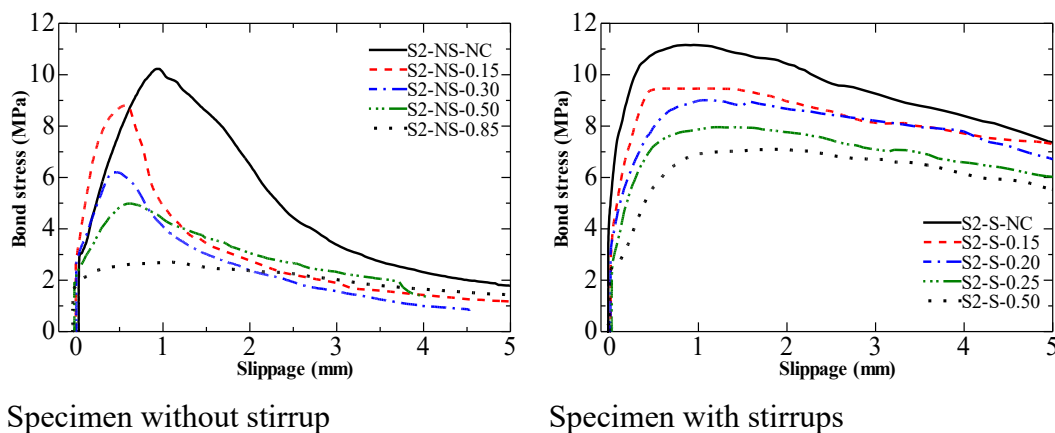
Figure 4.18 Bond stress versus slip curves in S2 Series

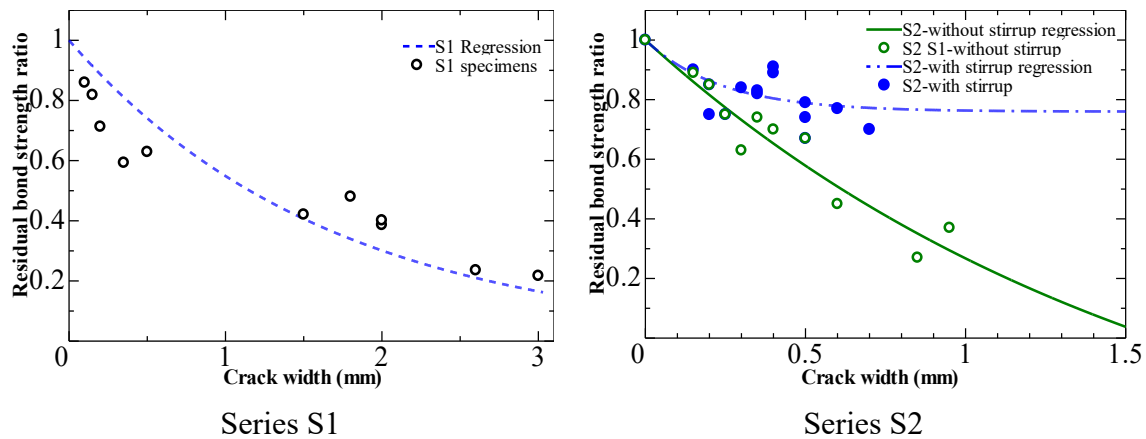
Figure 4.19 Residual bond strength ratio and crack width

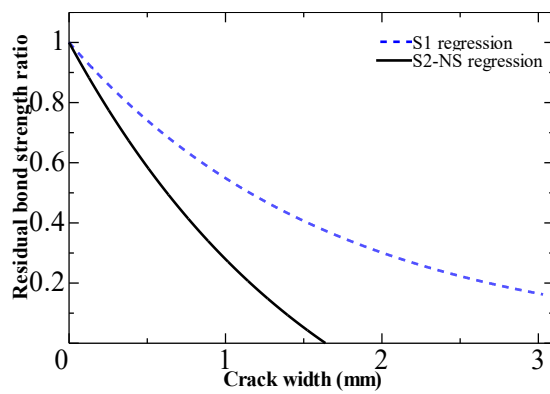
Figure 4.20 Comparison of residual bond strength ratio of S1 and S2

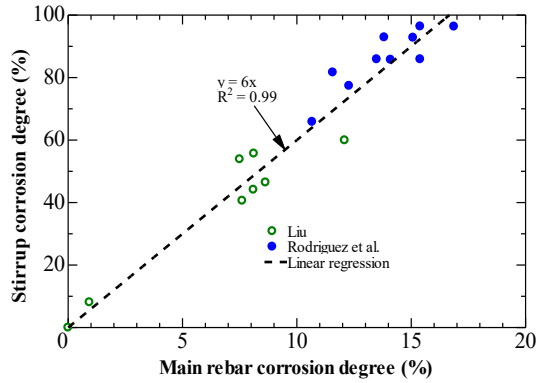
Figure 5.1 Corrosion of main rebar versus stirrup

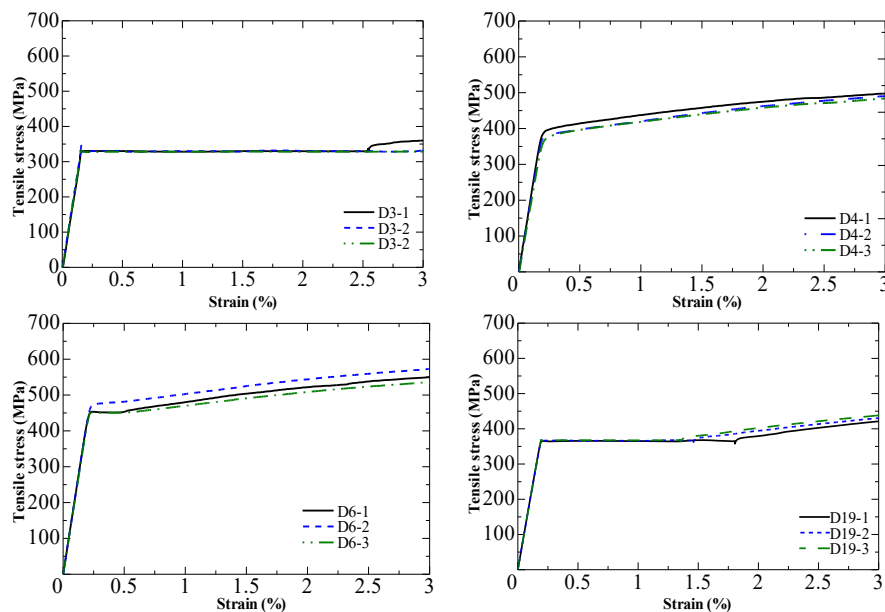
**Figure 5.3** Stress-strain relationship of the steel rebar
