**Study on Bond Degradation of Reinforced Concrete
Members with Induced Cracks due to Rebar
Corrosion**

March 2023

SYLL AMADOU SAKHIR

Graduate School of Science and Technology
Degree Programs in Systems and Information Engineering
University of Tsukuba

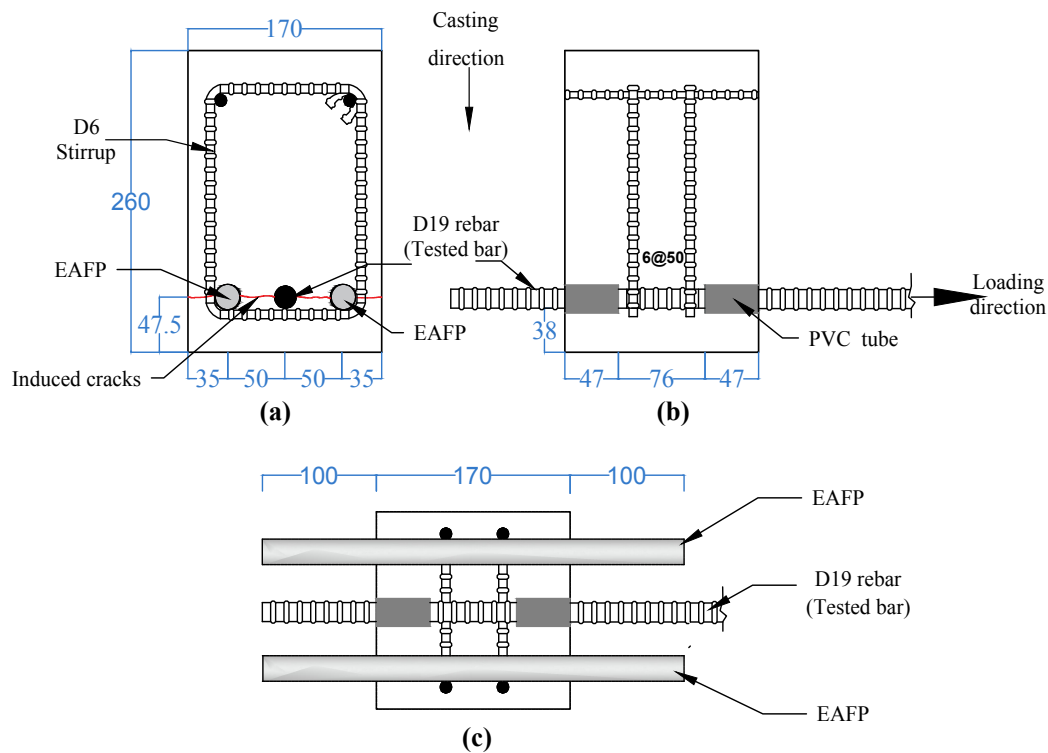
Figure 5.4 Specimen details (Series S3)

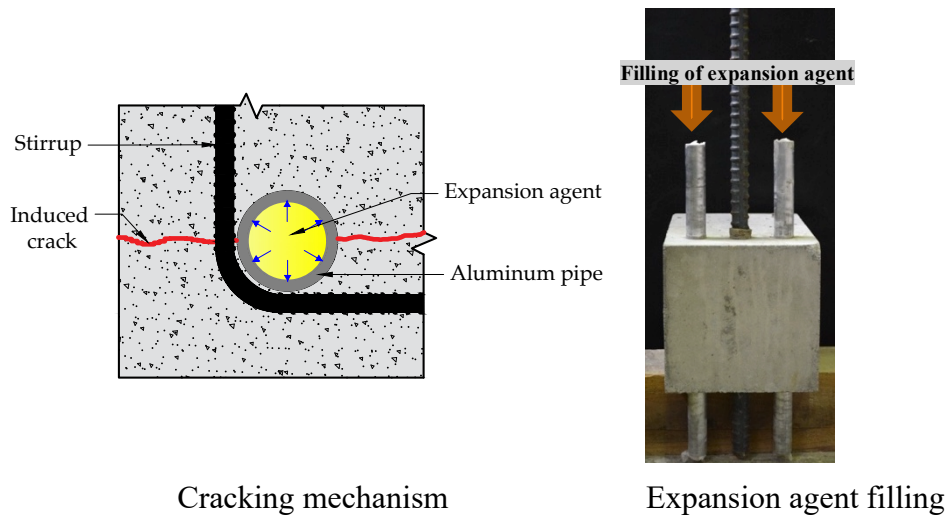
Figure 5.6 Crack simulation with an EAFP

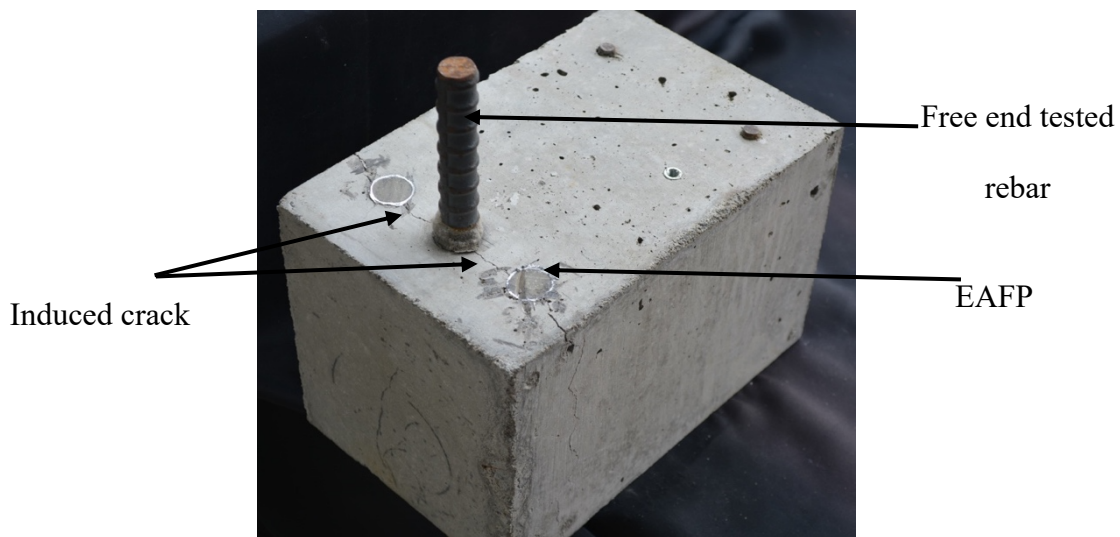
Figure 5.8 Specimen cracked by EAFP

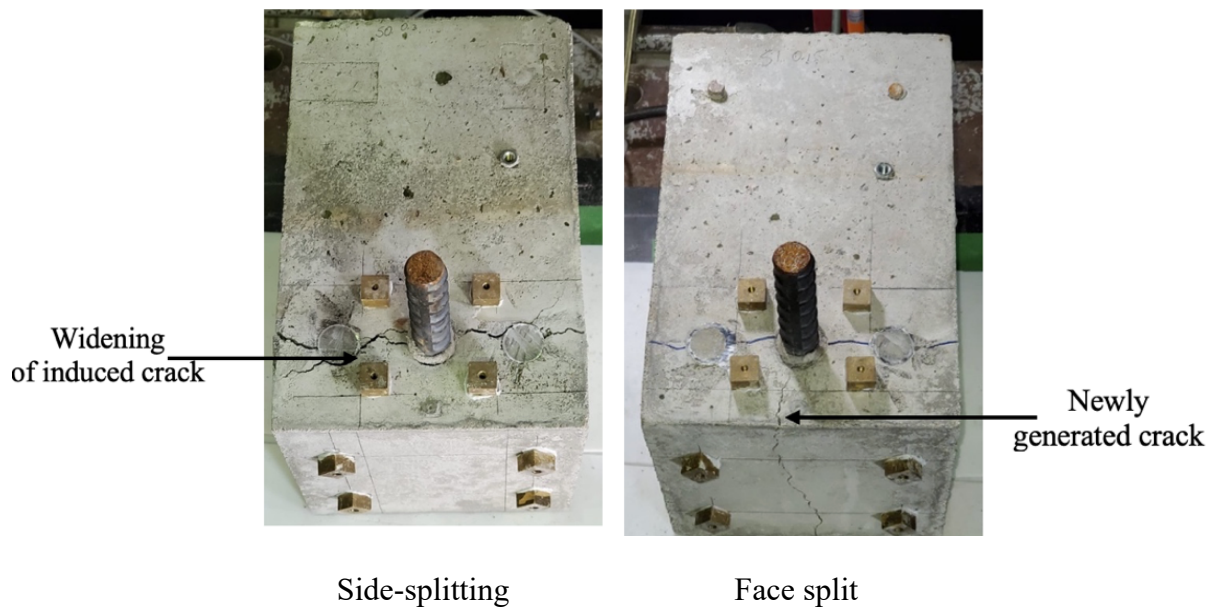
Figure 5.9 Mode of failure

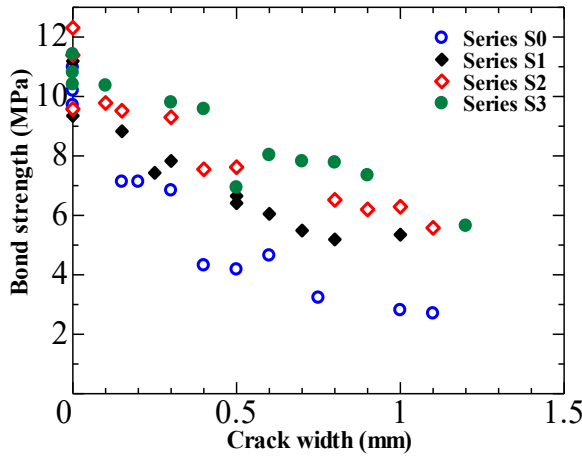
Figure 5.11 Bond strength vs. induced crack width relationship

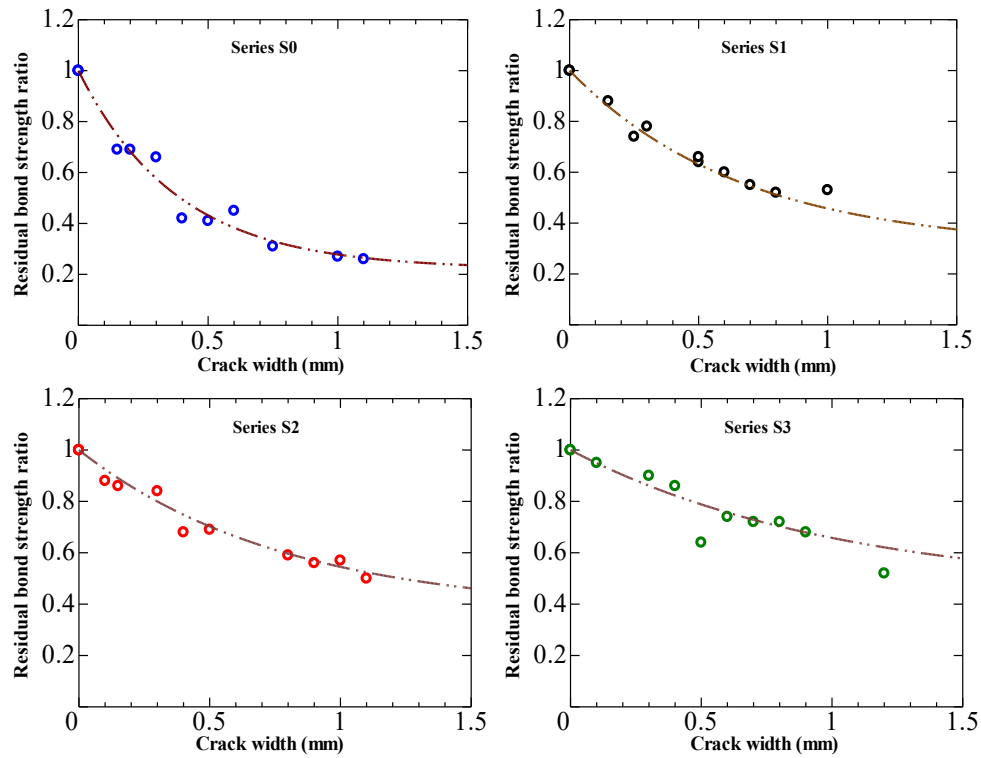
Figure 5.12 Residual bond strength ratio versus crack width

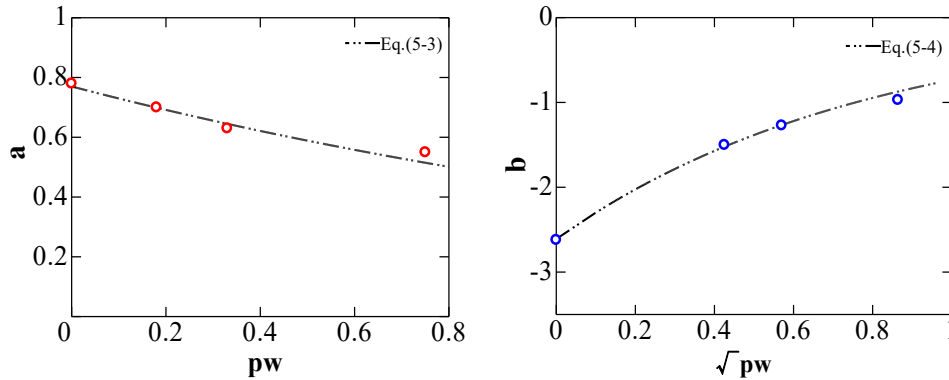
Figure 5.14 Influence of p_w on empirical coefficients a and b

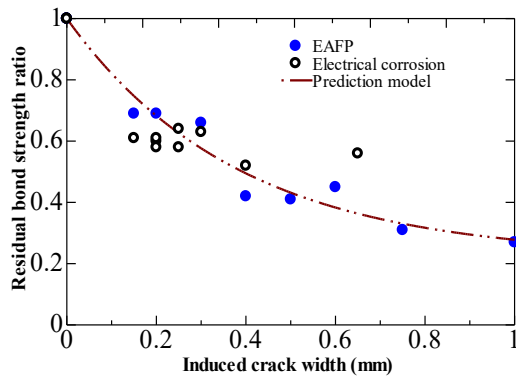
Figure 5.15 Bond strength degradation in electrical corrosion and EAFP specimen

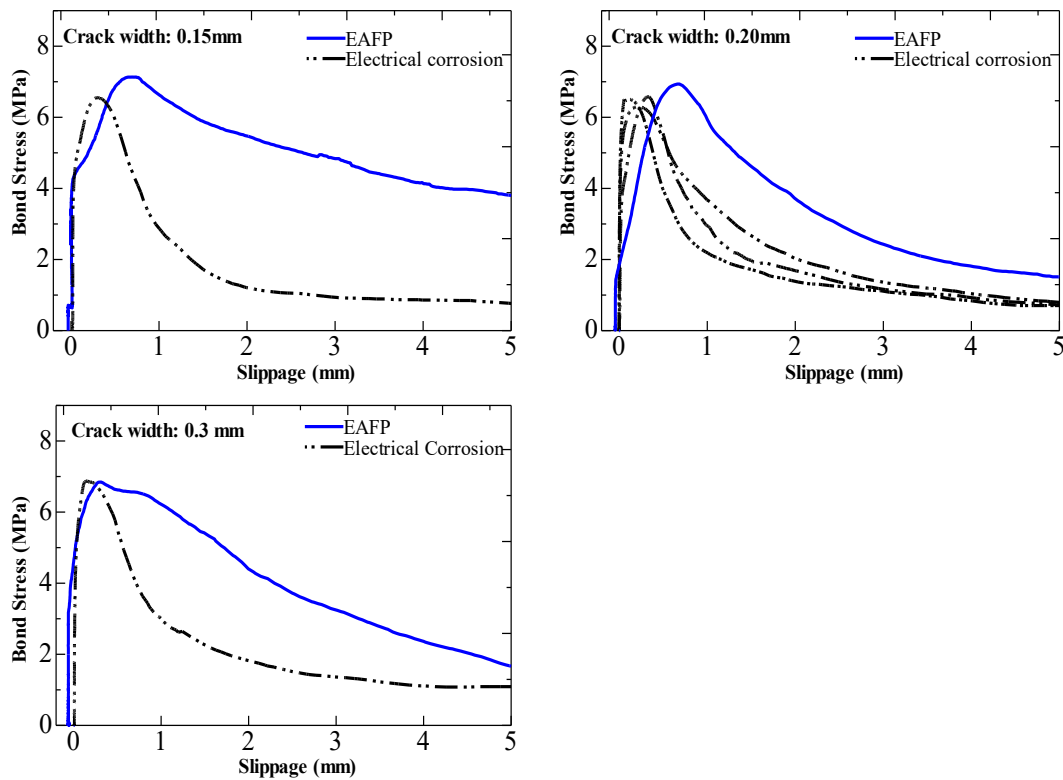
Figure 5.16 Bond-slip relationship in specimen crack by electrical corrosion and EAFP

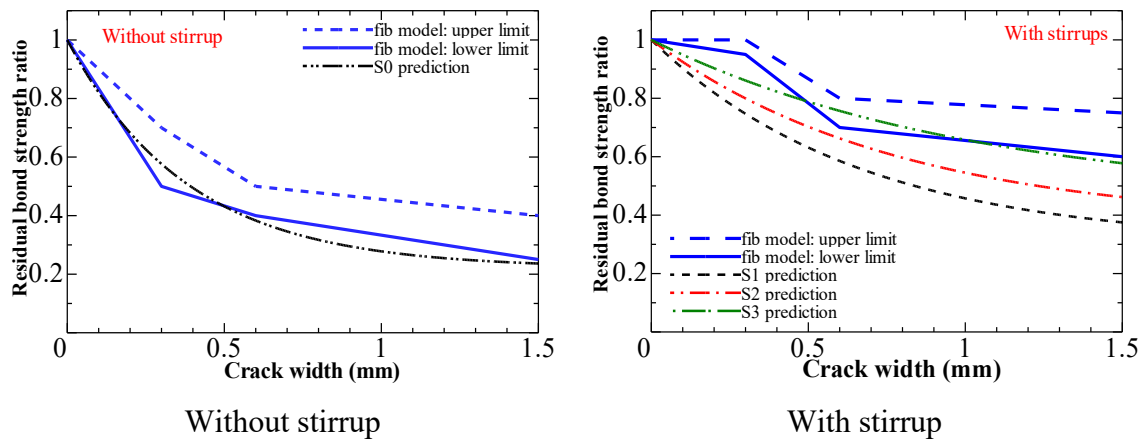
Figure 5.17 Results compared with the fib model

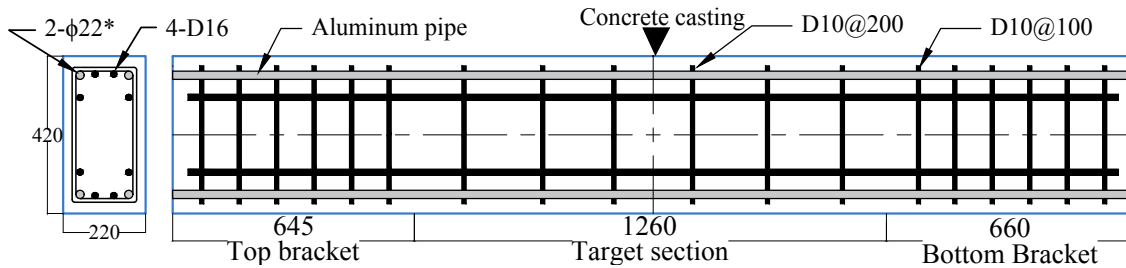
Figure 6.1 S_{hear} specimen detail

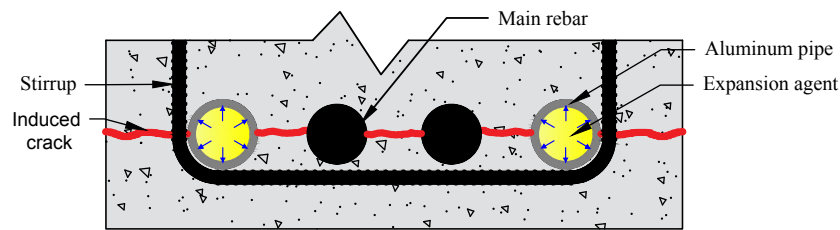
Figure 6.5 Crack induced by EAFP

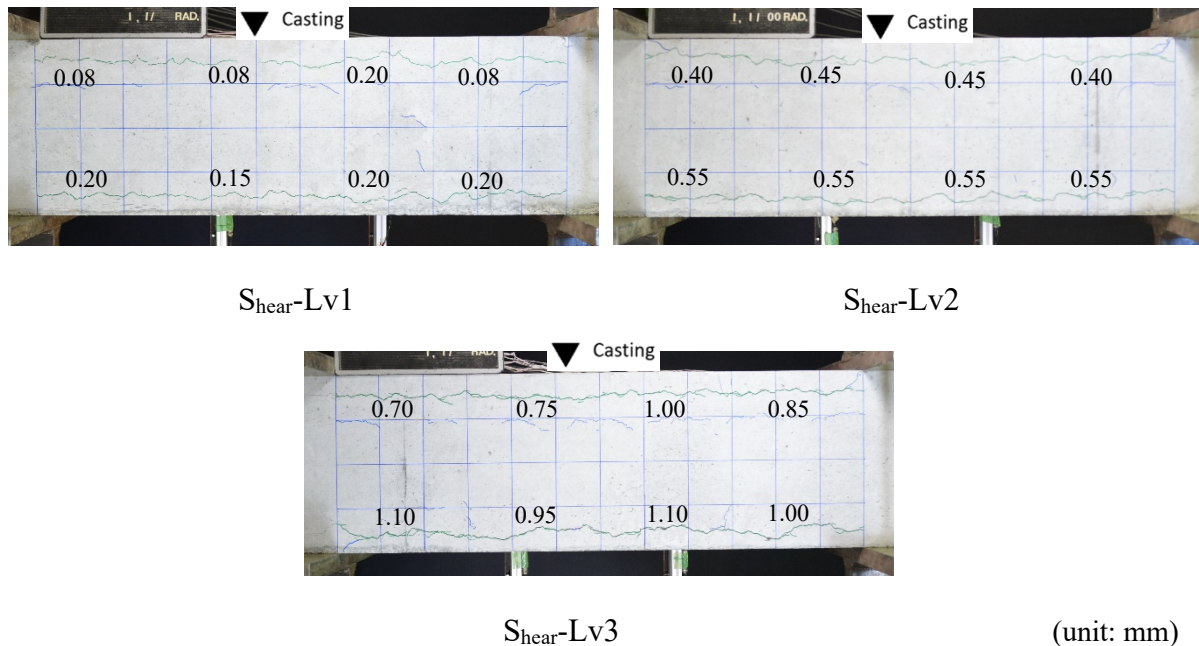
Figure 6.8 Example of crack simulated by EAFP

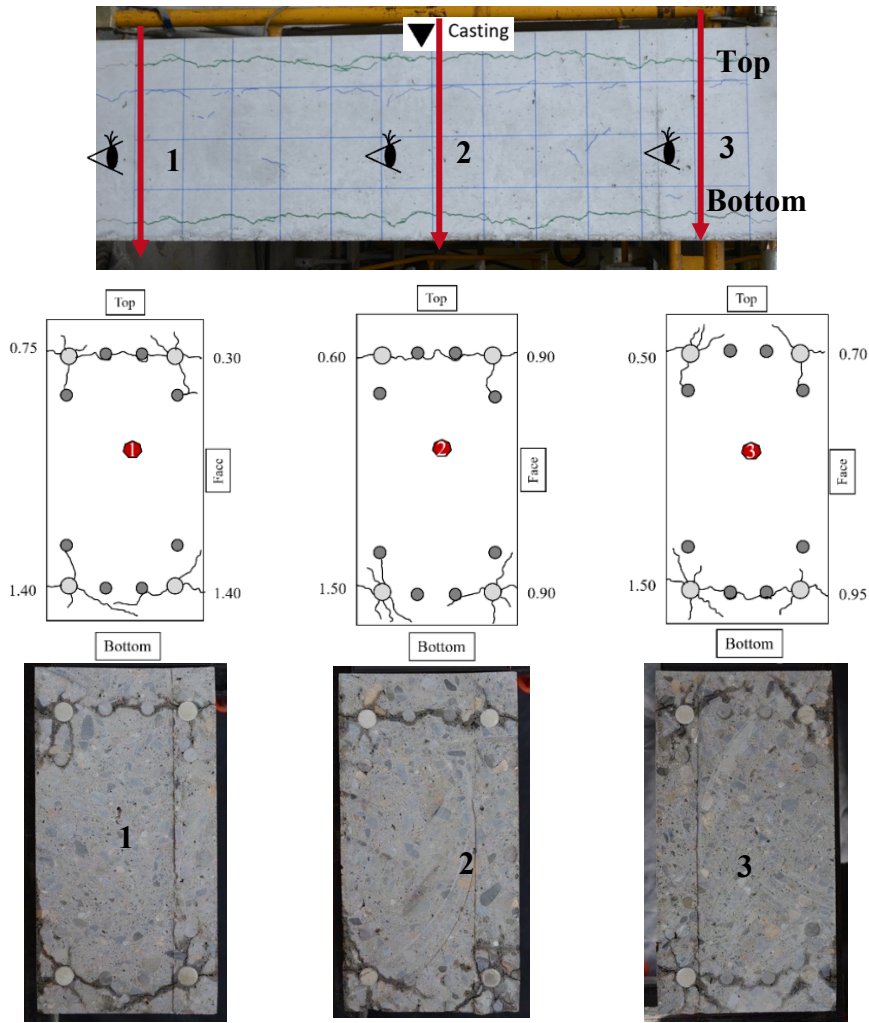
Figure 6.9 Detail of internal cracking

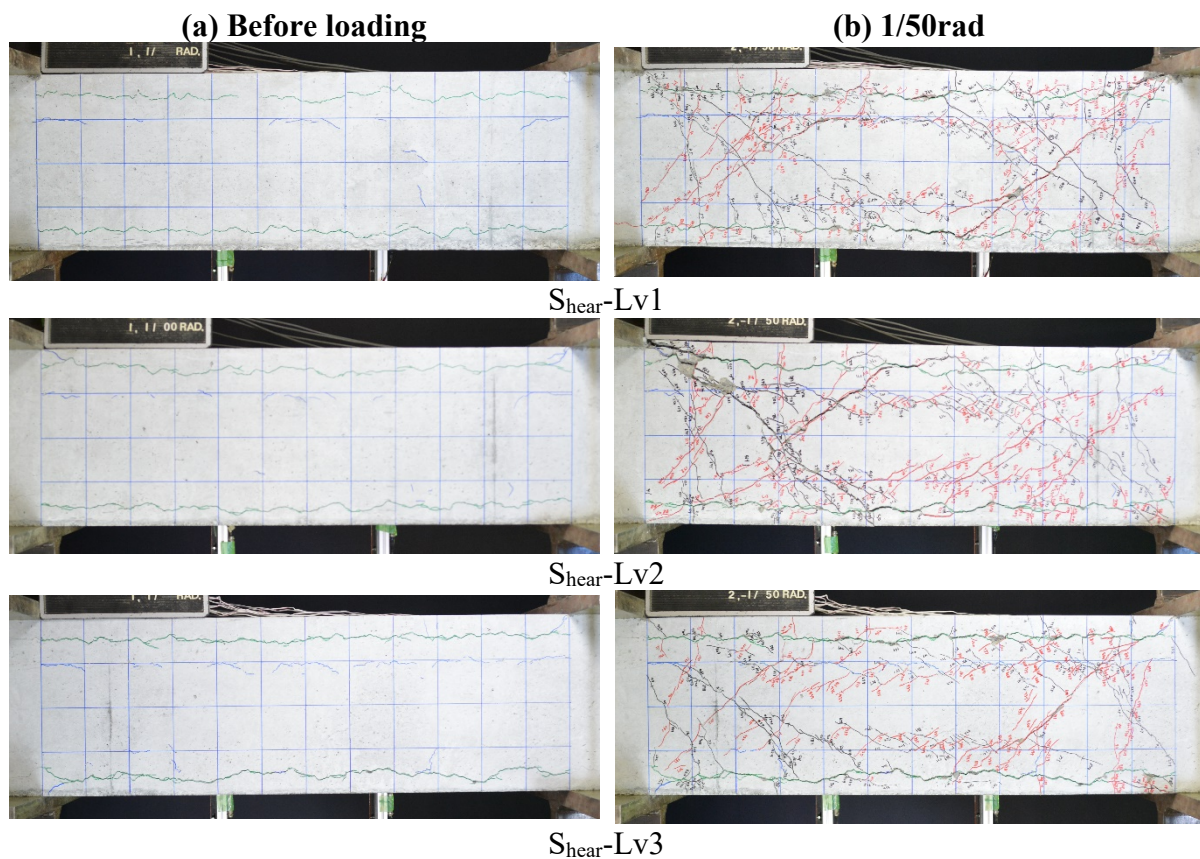
Figure 6.10 S_{hear} specimens

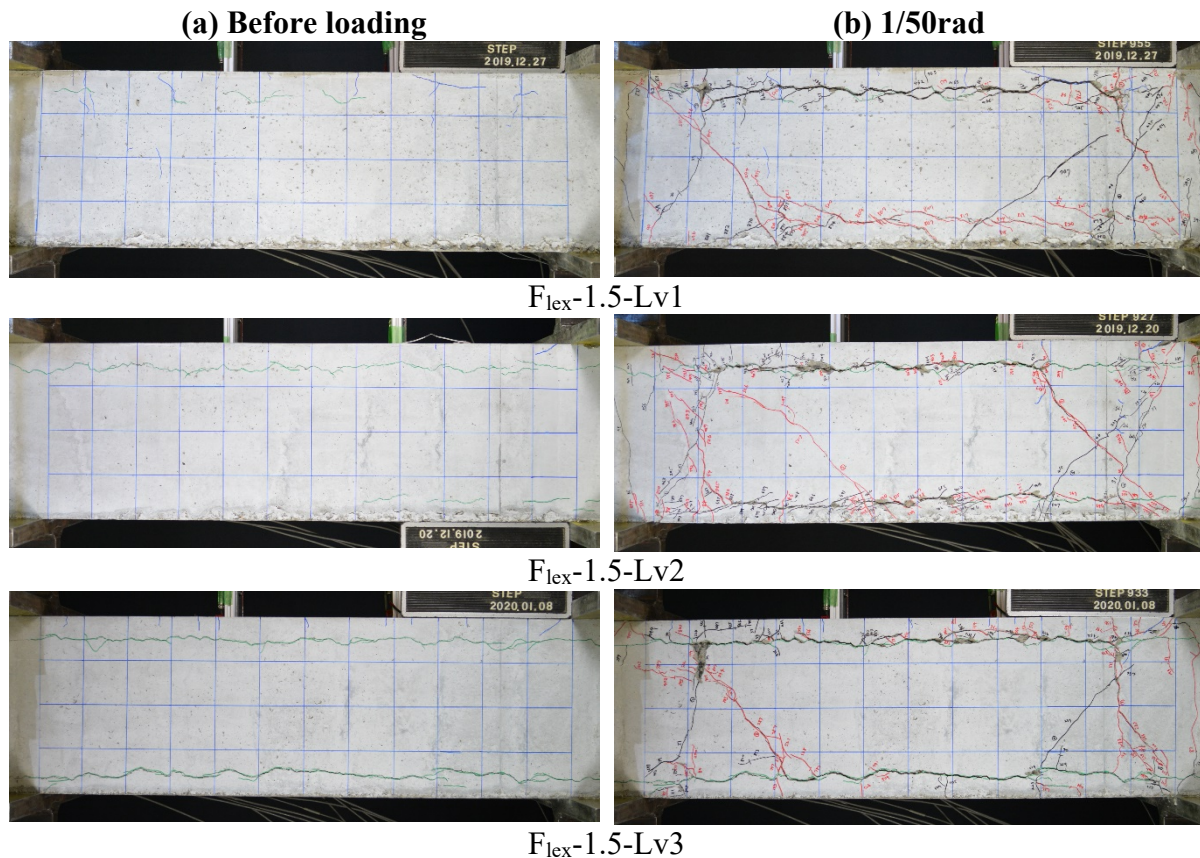
Figure 6.11 $F_{lex-1.5}$

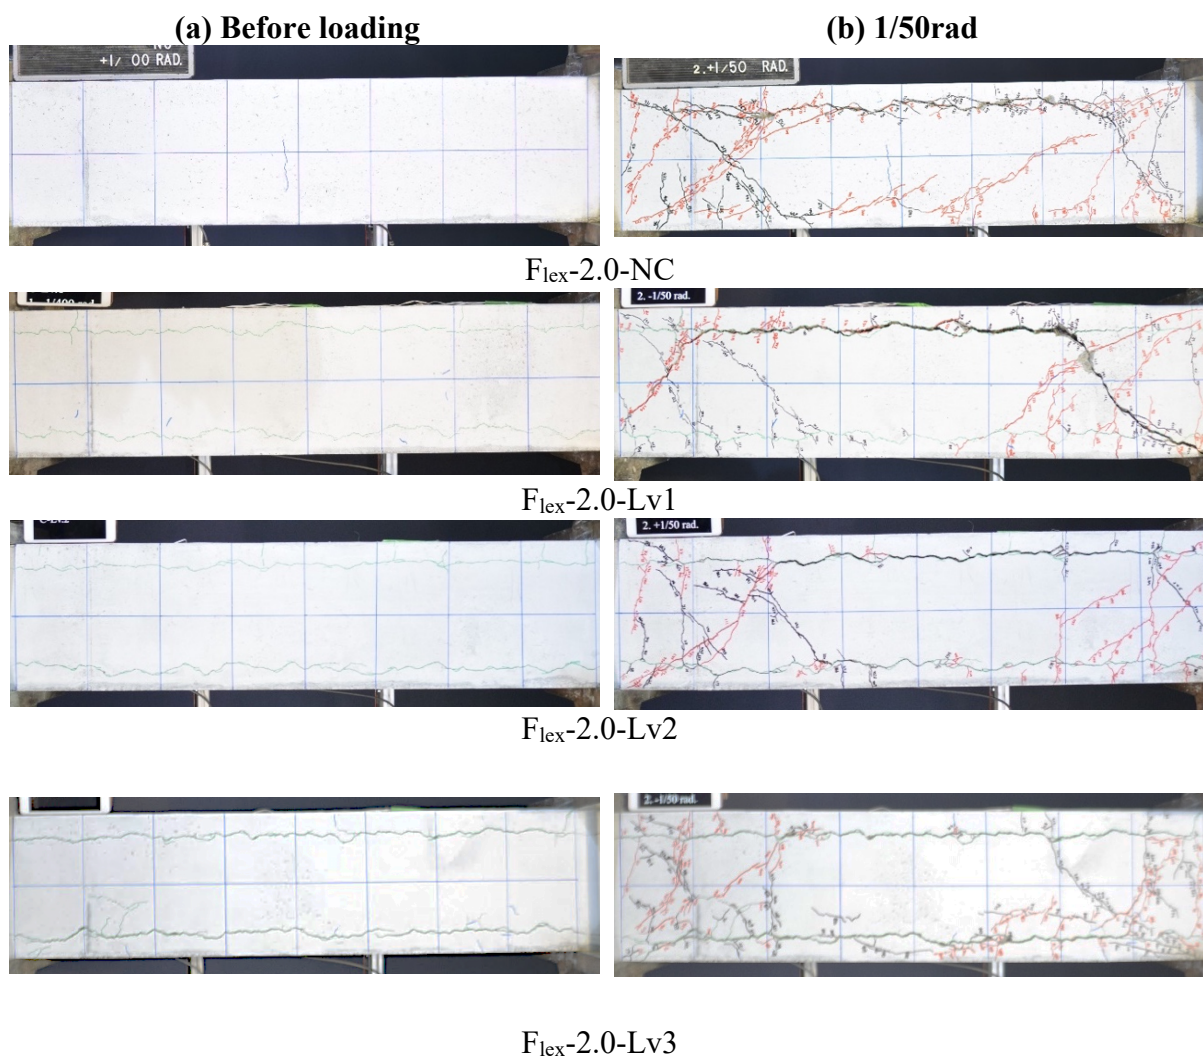
Figure 6.12 $F_{lex-2.0}$

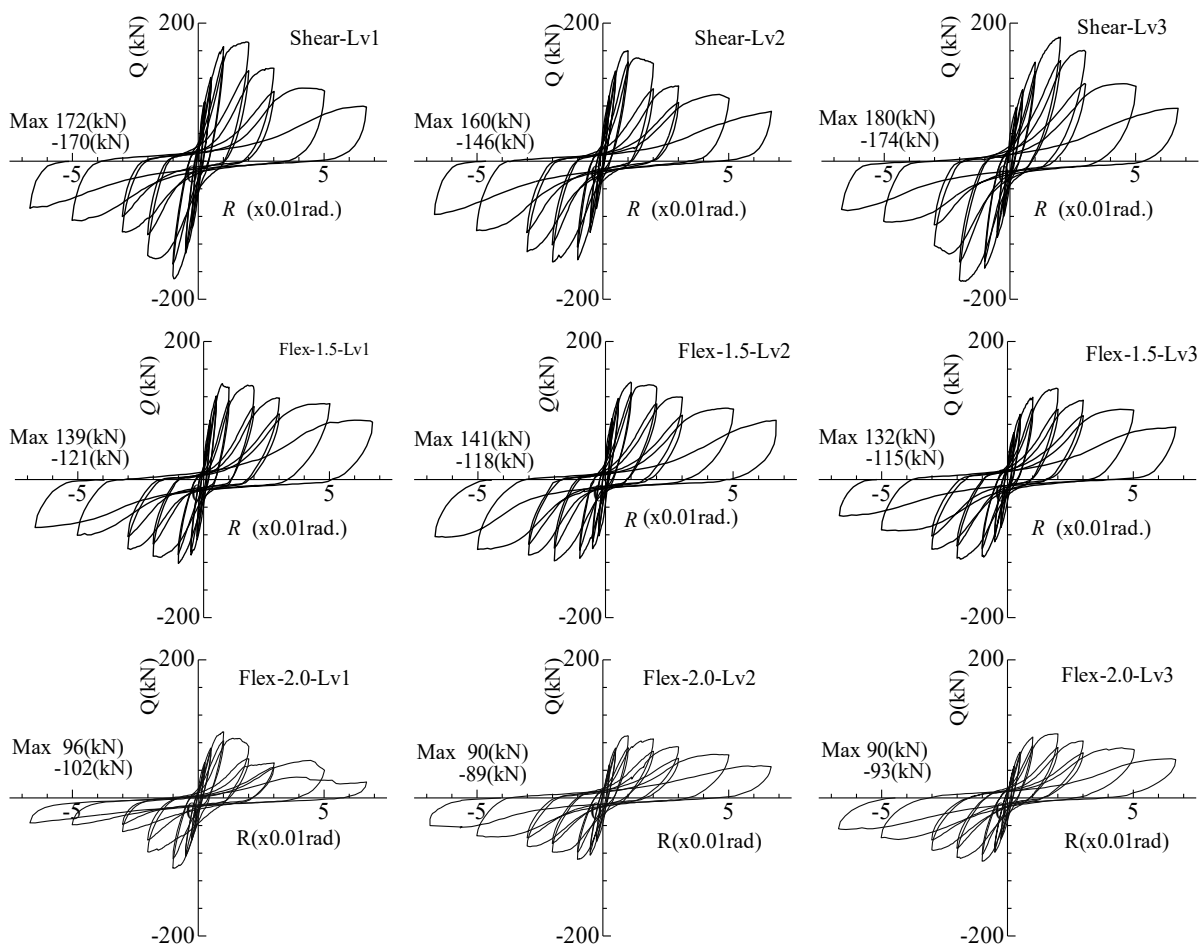
Figure 6.13 Hysteresis curve

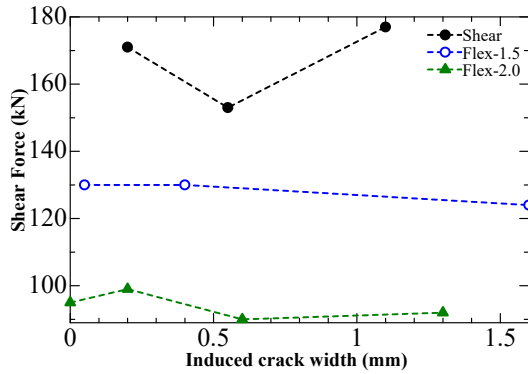
Figure 6.14 Maximum shear - induced cracks width relationships

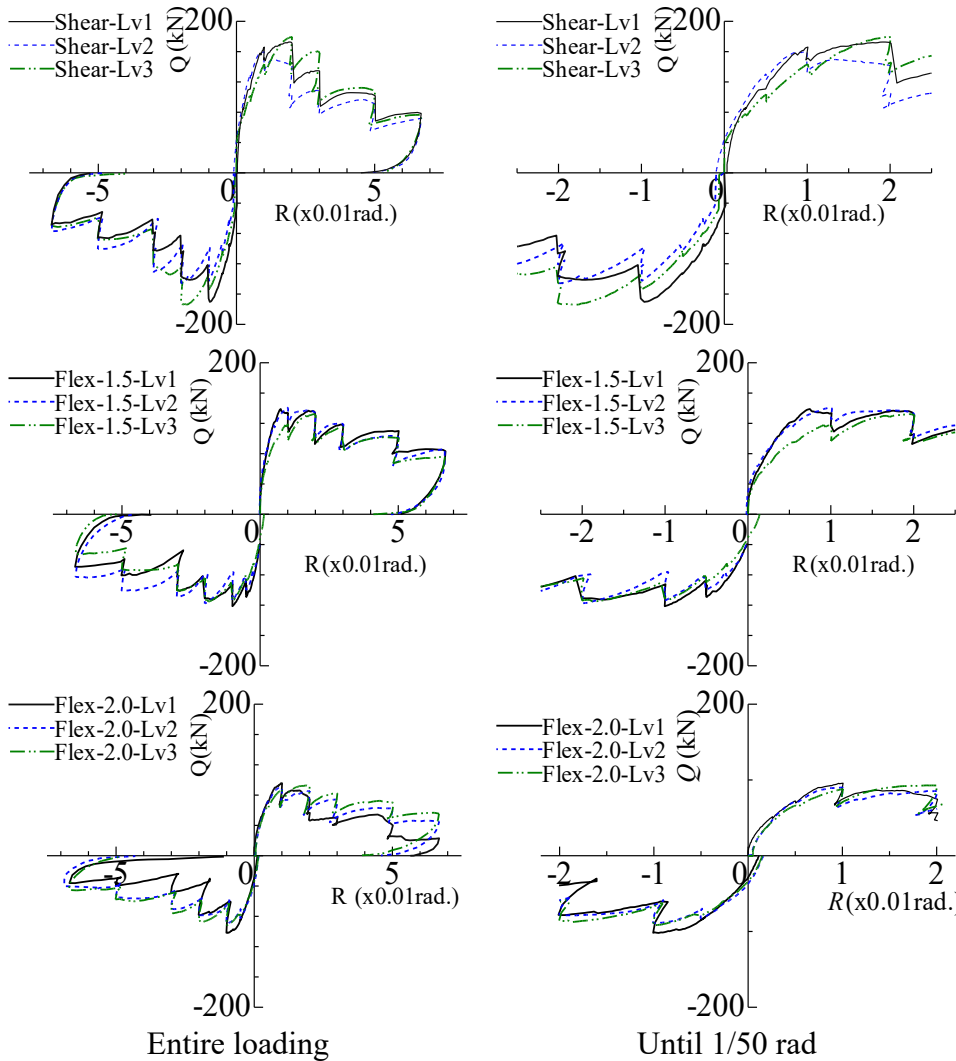
Figure 6.15 Skeleton curve

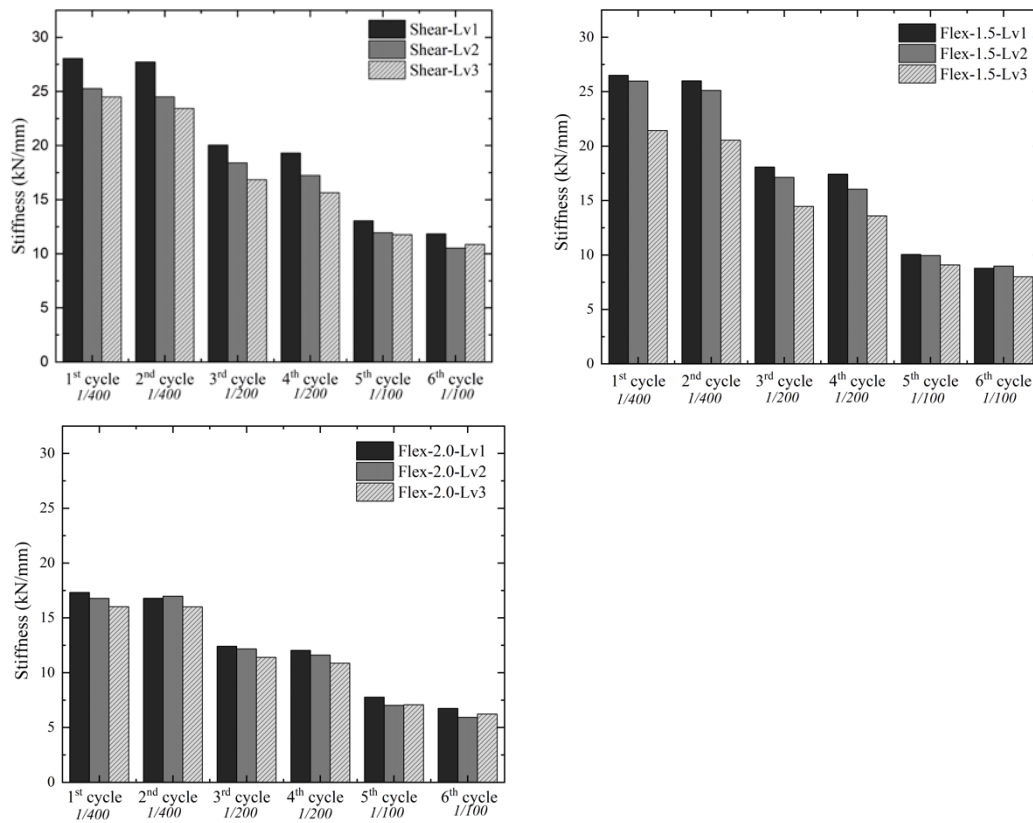
Figure 6.16 Stiffness of cracked beams

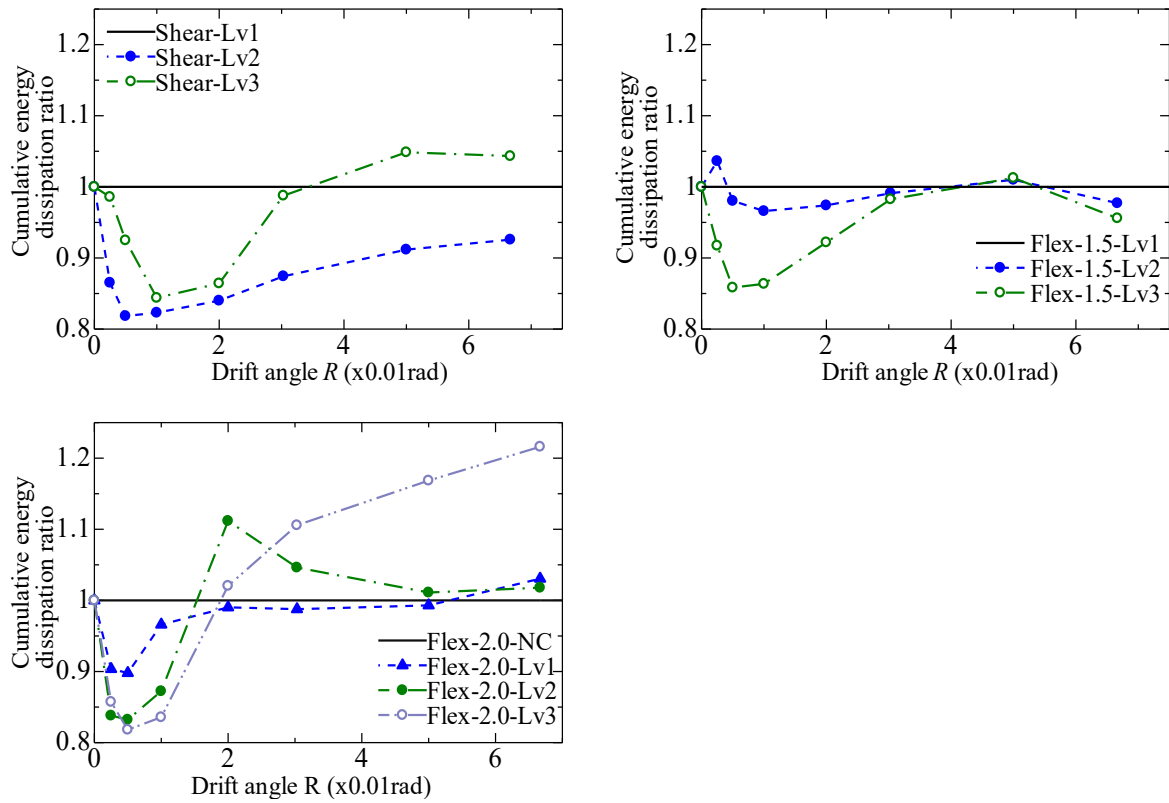
Figure 6.17 Energy dissipation
