# **Study on Bond Degradation of Rebars in Cracked Concrete due to Bar Corrosion**

**SYLL AMADOU SAKHIR**

Submitted to the Graduate School of  
Systems and Information Engineering  
in Partial Fulfillment of the Requirements  
for the Degree of Master of Engineering  
at the  
University of Tsukuba

March 2020

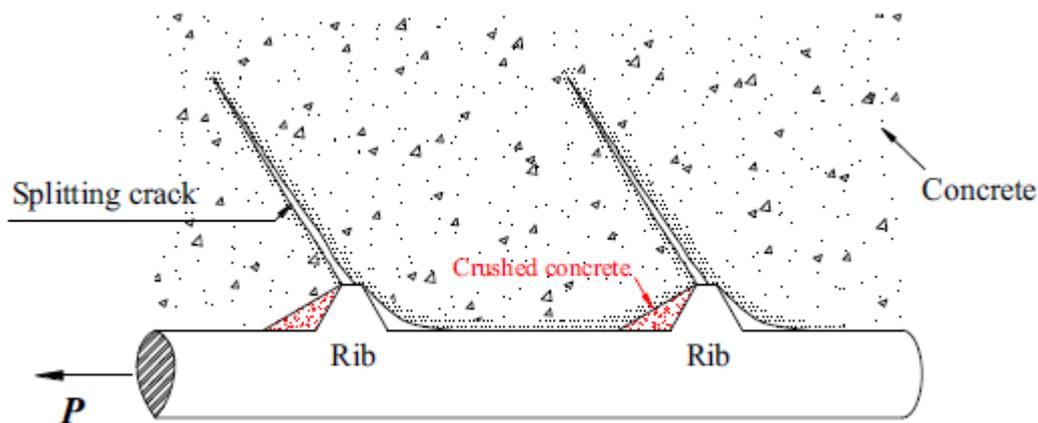
**Fig. 1.1 Mechanical interaction between concrete and deformed steel bar**

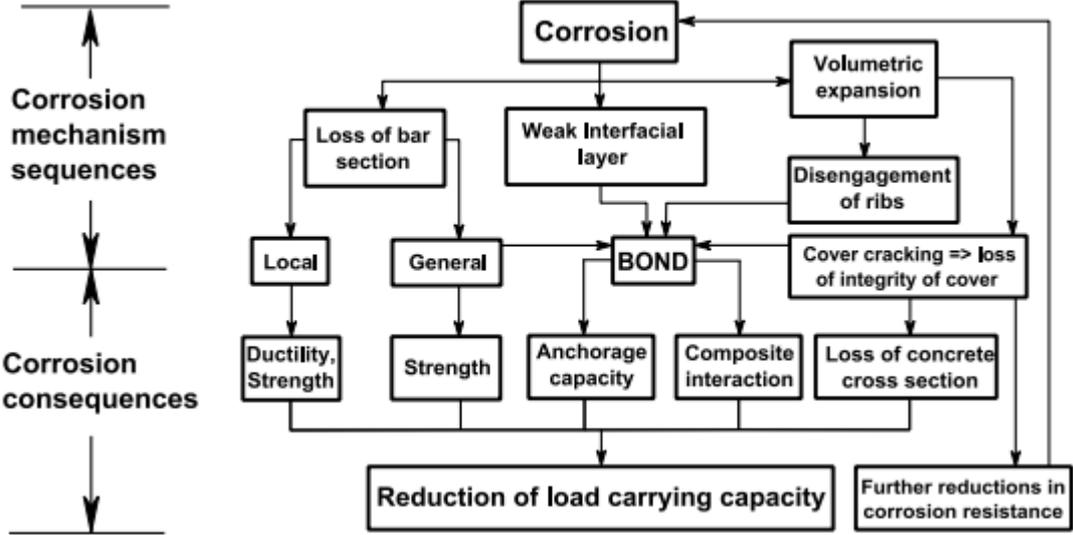
Fig. 1.2 Sequences and consequences of corrosion on reinforcements[2]

In recent decades, lots of RC structures are threatened by corrosion worldwide, causing huge direct and indirect costs annually. As shown in Fig. 1.2 [2], bond deterioration can negatively affect the structural properties of RC structures. This was confirmed in many studies. To better estimate the mechanical properties of corroded RC structures through theoretical analysis or numerical modeling, it is essential to fully understand how corrosion affects bond.

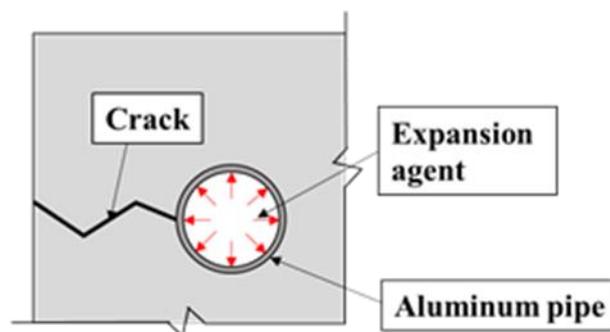
Fig. 2.1 Concrete cracking with expansion agent

An expansion agent is mainly used for the destruction of rocks and RC structures. In powder form, it expands when humidified. Due to this expansion, cracks are generated in the concrete (see Fig. 2.1).

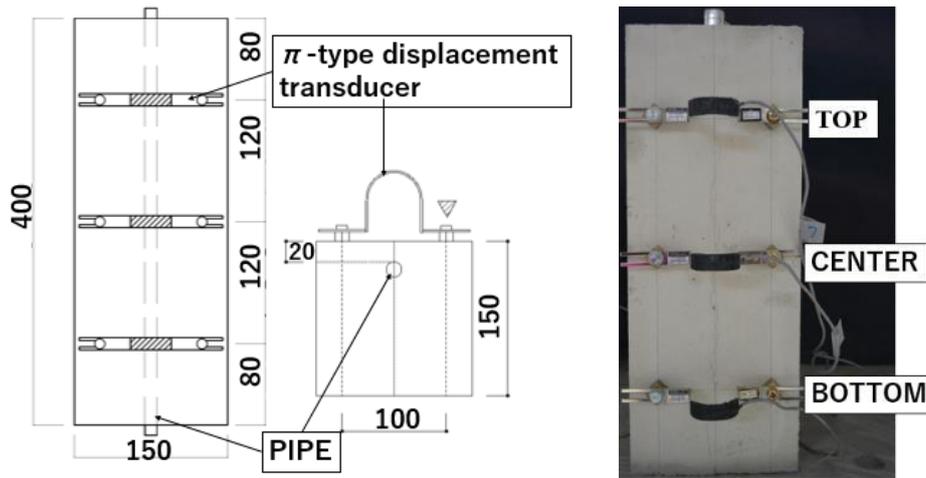
**Fig. 2.2 Specimen for cracking confirmation**

Fig.2.2 shows the specimen used in order to confirm the possibility of crack simulation [7]. An aluminum pipe with 18 mm as outer diameter and 1 mm thickness was embedded in the concrete. The compressive strength of the concrete was 25.3 MPa and the ratio of the water to expansion agent was 30%. The specimen was placed as the axial direction of the pipe was set vertically, and an expansion agent was filled from the top of the pipe

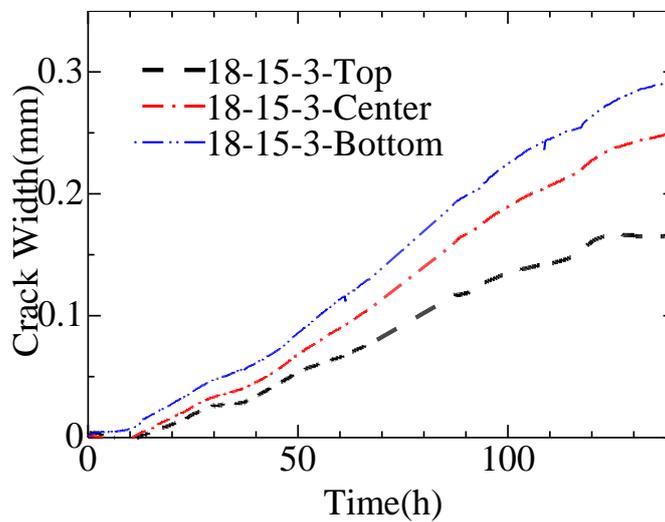
**Fig. 2.3 Crack width over time**

As can be seen in Fig.2.3, the possibility to simulate the cracking of concrete due to corrosion of reinforcing bars in the laboratory in a relatively short time was confirm. Also, it was found that the crack width can be easily targeted due to the fact that cracks width increases over time.

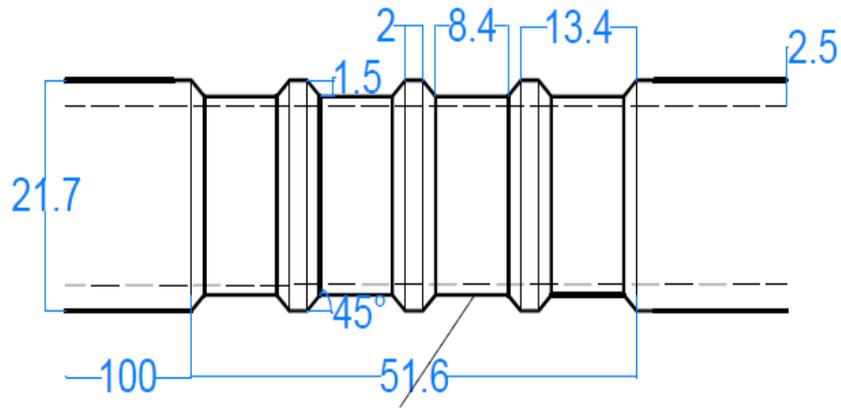
**Fig. 2.4 Scheme of aluminum pipe with rib**

According to JIS G 3112 (Steel bars for concrete reinforcement), the ribs were machined on an aluminum pipe. In order to simulate a deformed bar D19 with an aluminum pipe with an outer diameter of 21.7mm and a thickness of 2.5mm was used. The details of the aluminum pipe with ribs are shown in Fig.2.4 and Table 2.1. Table 2.2 summarizes the list of specimens. The test was conducted on specimen filled with an expansion agent or not. For specimens without expansion agent, three with ribs and three without ribs were set. 5 specimens with ribs were filled with an expansion agent and a target strain before loading was taken as the main parameter.

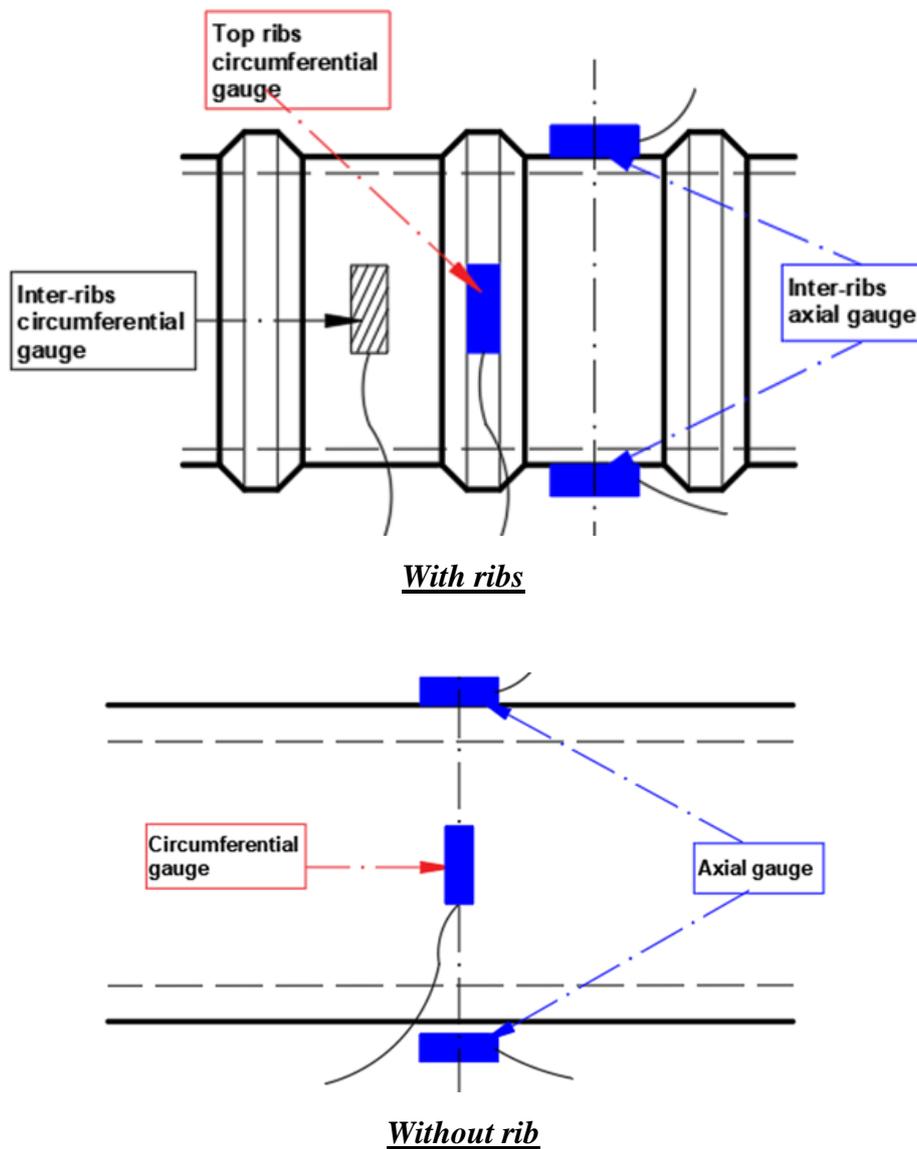
Fig. 2.6 Position of strain gauges

As shown in Fig.2.6, strain gauges were fixed, and the time course of axial strain after expansion agent filling and circumferential strain on and between ribs were measured. The variable factor was the target axial strain at the start of the tensile test, with a range of 0.3% to 1.2%.

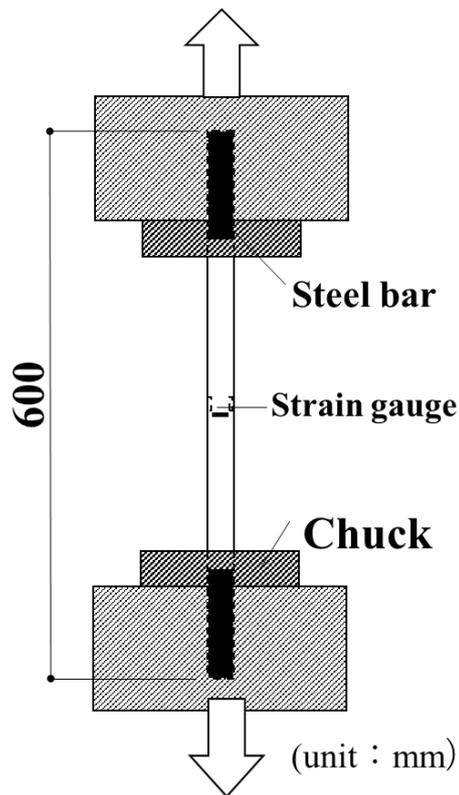
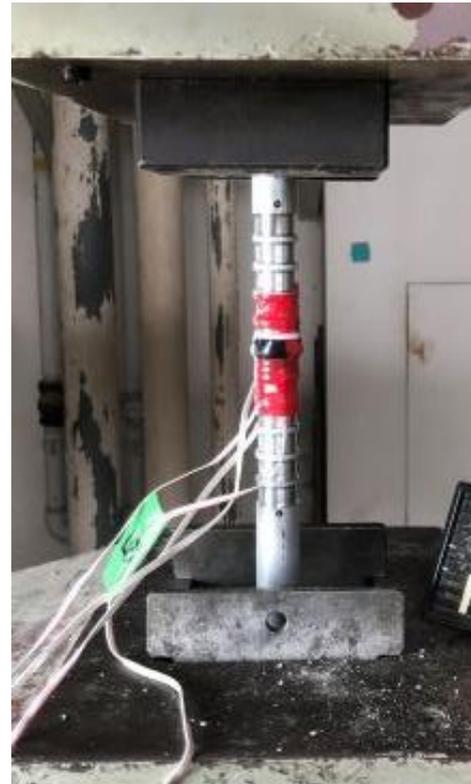
**Fig. 2.7 Loading setup**

Monotonic tensile loading was carried out using a universal testing machine of 500 kN capacity. Fig.2.7 shows the loading and measurement method for tension tests. To prevent the deformation of the grasped part by the chuck, round steel bars having a length of 80 mm were inserted into the specimen ends. In addition to the load, the axial and circumferential strain were measured.

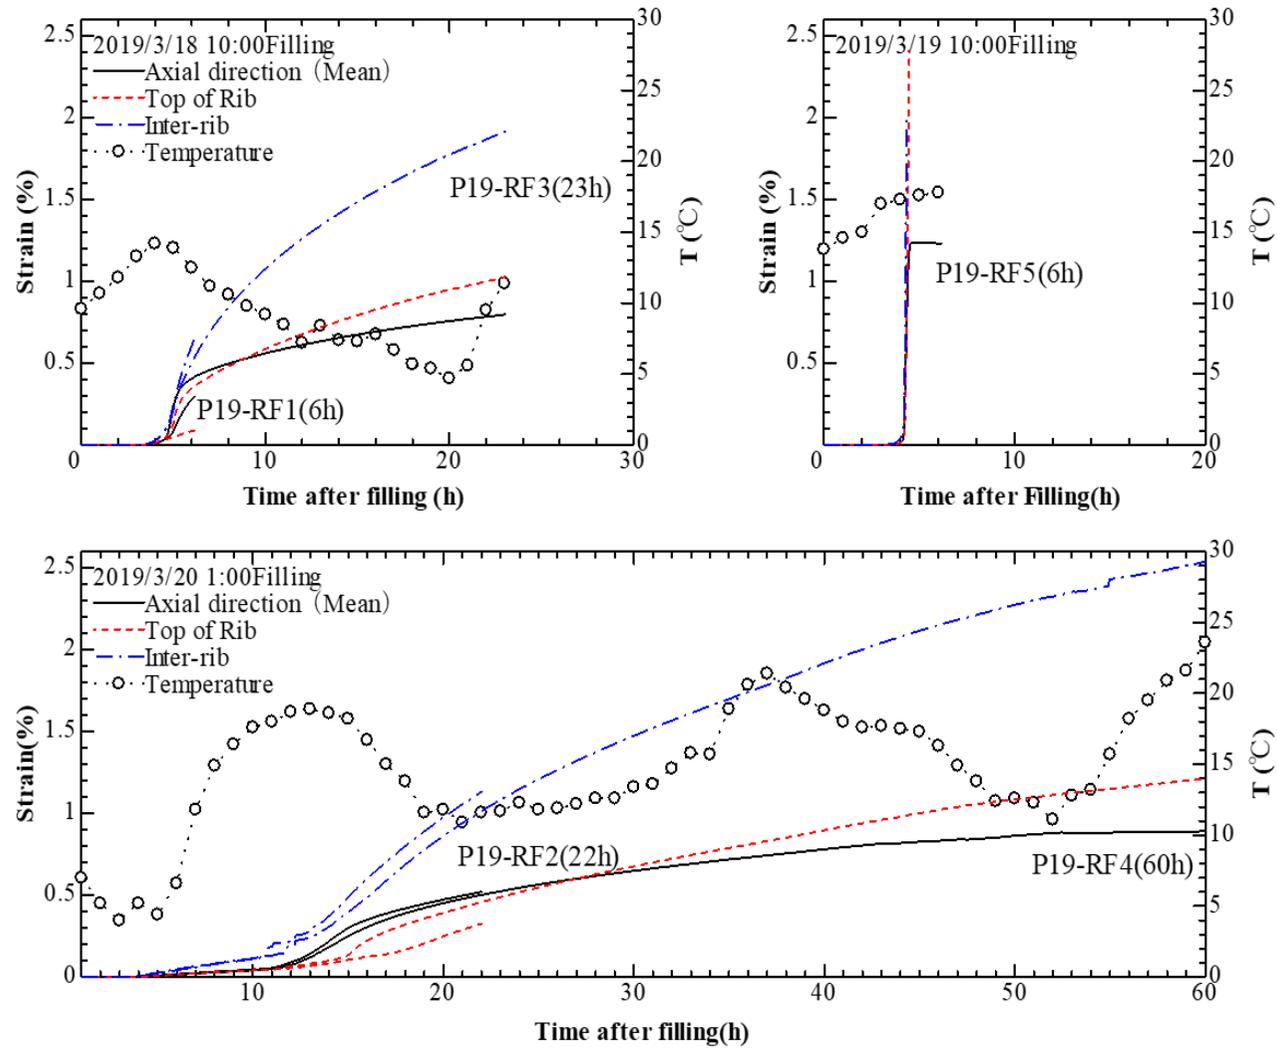
**Fig. 2.8 Strain and time relationship after filling the expansion agent**

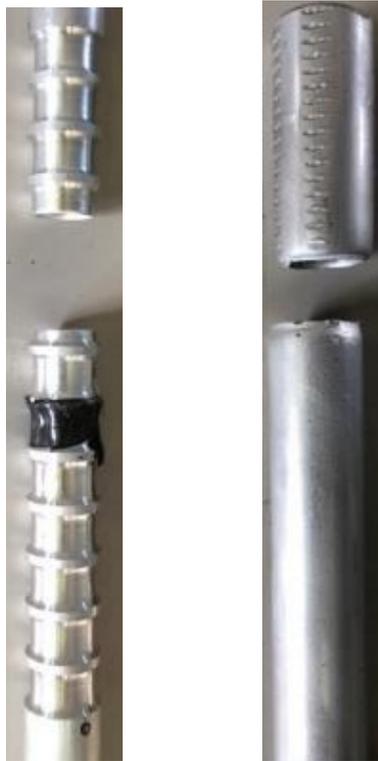
**Fig. 2.9 Failure of the specimen**

The tensile test results are shown in Table 2.4. Fig.2.9 shows examples of the fracture of the specimen after loading.

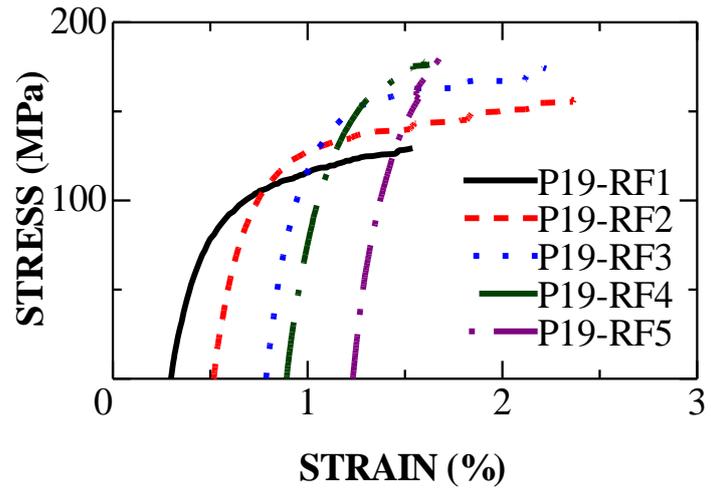
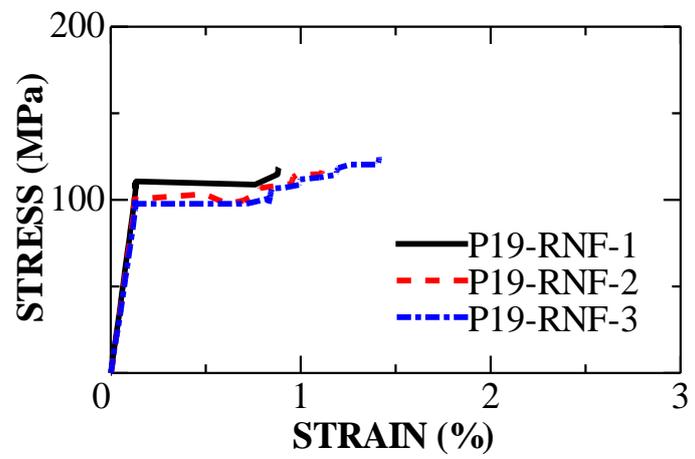
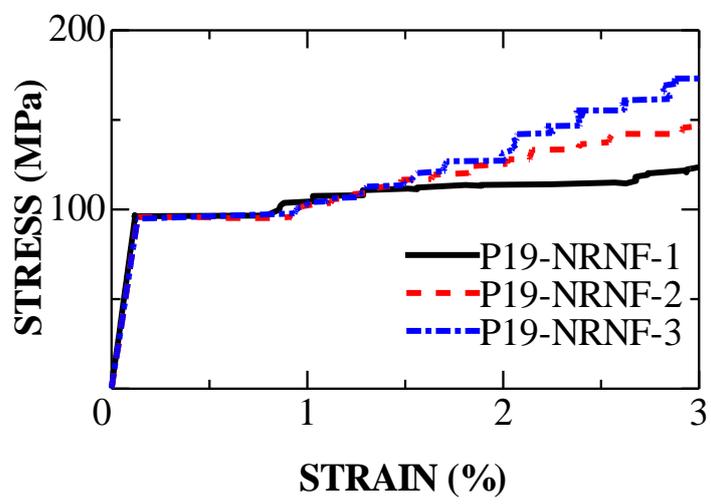
**Fig. 2.10 Stress-strain relationship**

The modulus of elasticity was calculated by the least-squares method in a section that can be regarded as the elastic zone in the stress-strain curve. Similarly, the absolute value of Poisson's ratio was calculated using the inter-ribs strain. It was obtained by dividing the elastic modulus by the lateral elastic modulus. Two gauges points were marked at the specimen before loading. The percentage of elongation after failure was determined by dividing the deformation distance by the initial distance before loading.

At the beginning of the loading, with the increasing of the axial strain, the yield strength and modulus of elasticity of the pipe filled with an expansion agent increase too. However, the elongation at failure tended to decrease. The tensile strength was not affected.

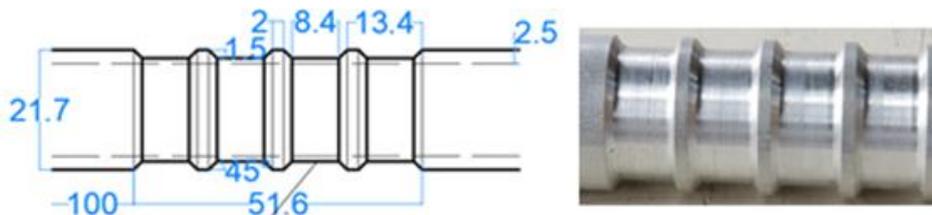
Fig. 3.1 Aluminum pipe with ribs

Fig. 3.1 shows an overview of a processed aluminum pipe with ribs set according to JIS G 3112. An aluminum pipe with 21.7 mm as outer diameter and 2.5mm thickness was used to imitate the D19 rebar. The fundamental properties of the aluminum pipe and the expansion agent filled pipe have been reported in Chapter 2.

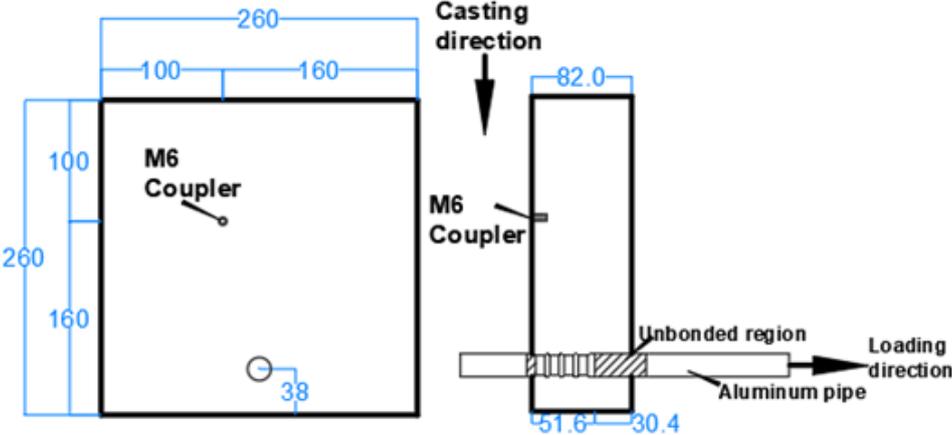
Fig. 3.2 Specimen detail

The pull-out specimen was designed as shown in Fig.3.2. The dimensions of the specimen were 260×260×82mm and the aluminum pipe with ribs was embedded at 38mm from the specimen side. The framework is shown in Fig. 3.3. The bond length of 51.6mm was chosen to avoid the rupture of the pipe by tensile force. Moreover, an unbonded part was set to avoid cone failure of concrete. The M6 coupler was fixed 100×100 mm at the up left position to set a LDVT for measuring the slip of pipe. A  $\pi$ -type displacement transducer was placed on the concrete cover to measure the opening of crack during loading. Table 3.1 shows the mix proportion of used concrete and Table 3.2 shows the mechanical properties of concrete obtained from the concrete cylinder test on the day of filling of expansion agent. Table 3.3 shows the list of specimens. The test variable was set on the level of crack width induced by expansion agent

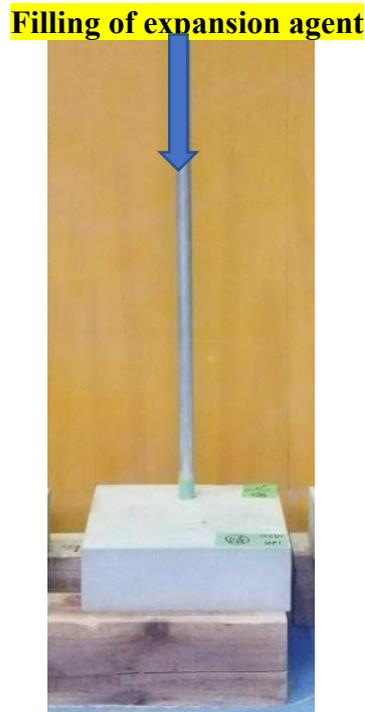
**Fig. 3.4 Filling of expansion agent**

The ratio of the water to an expansion agent was set to 30%. The specimen was placed as the axial direction of the pipe was set vertically, and an expansion agent was filled from the top of the pipe as shown in Fig.3.4. With the increase of the crack width over elapsed time after filling of expansion agent, a target crack width was easily obtained by using the time after filling as a parameter.

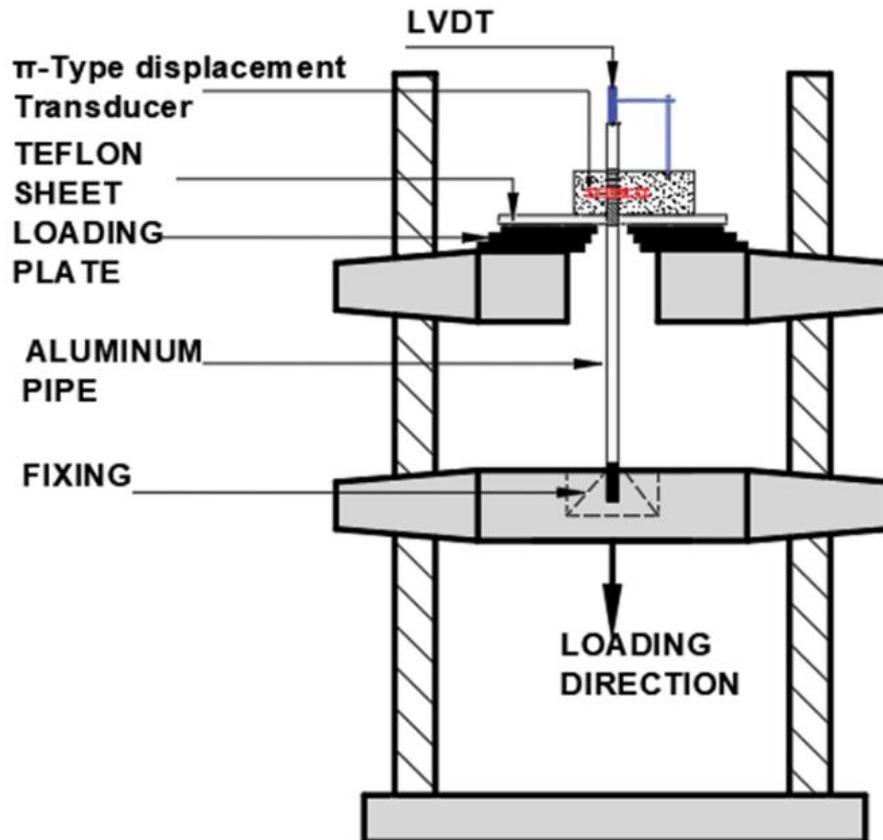
Fig. 3.5 Loading and measurement setup

The loading was carried out at Kanakubo lab in the University of Tsukuba. Fig. 3.5 shows the general set-up for the pull-out test. The specimen was placed on the Teflon sheet and the loading plate on which the hole with the same diameter corresponding to concrete cover in order to not restrict the lateral deformation of concrete. This detail can be seen from Fig 3.6 and Fig.3.7 The pipe was subjected to monotonic pull-out loading at a speed of 0.5mm/min with a Universal Testing Machine. The measurement items are pull-out load, crack opening and slippage of the pipe at the free end.

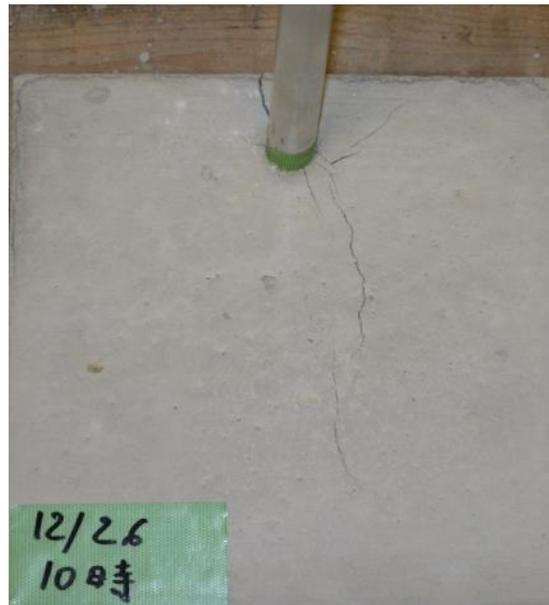
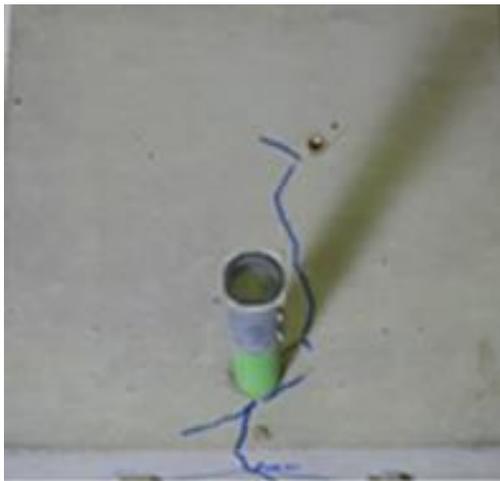
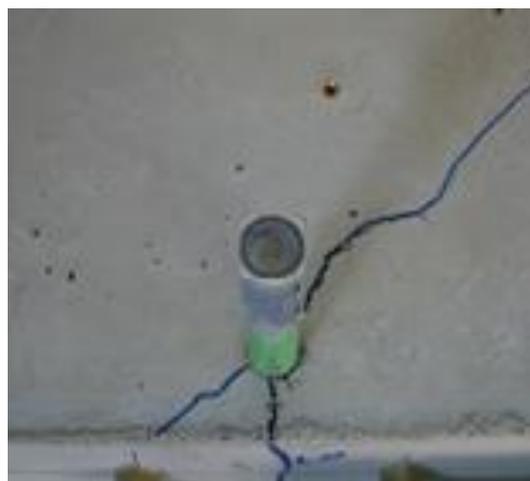
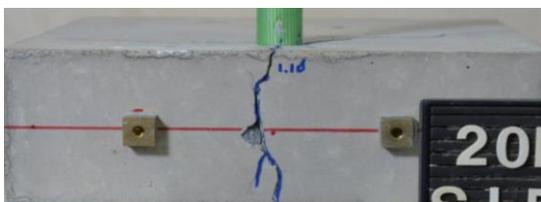
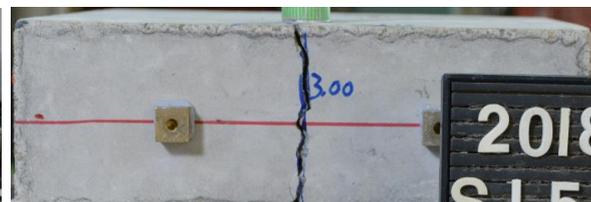
**Fig. 3.8 Cracking of concrete after filling the expansion agent**

Fig. 3.8 shows an example of crack patterns after filling the expansion agent. The expansion agent reaction was heavily influenced by the ambient temperature, so to control the width of the crack, specimens were placed in variable temperature conditions. Also, because cracks continued to grow after filling the expansion agent, crack width was measured only when growth had stopped fully.

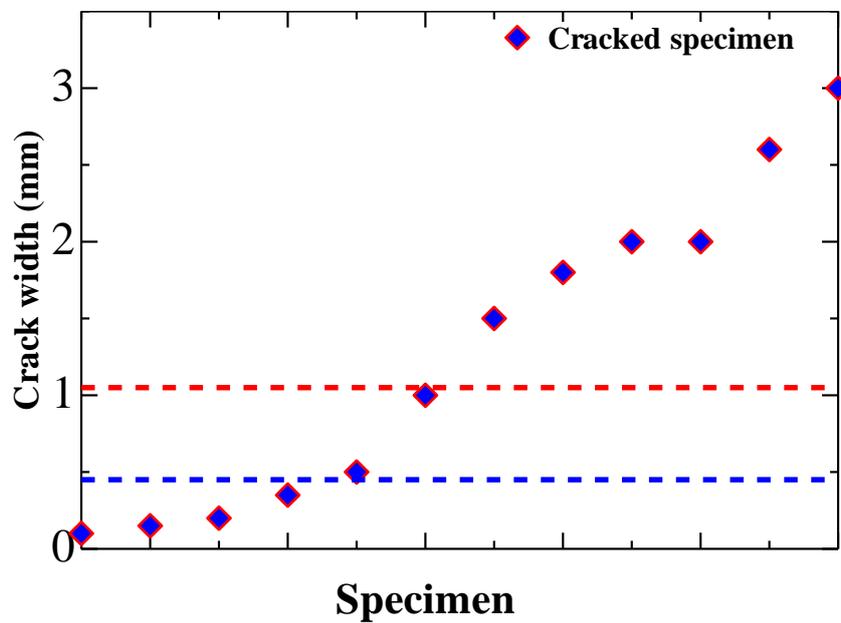
**Fig. 3.9 Distribution of crack width**

Cracks were categorized according to their width, as shown in Table 3.4. The maximum crack width in every specimen is summarized in Table 3.5. To better observe the distribution of cracking among the specimens, the maximum cracks widths are plotted in Fig 3.9.

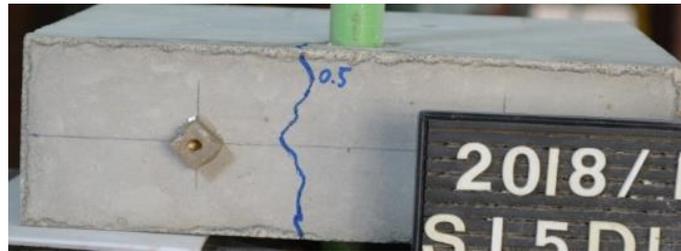
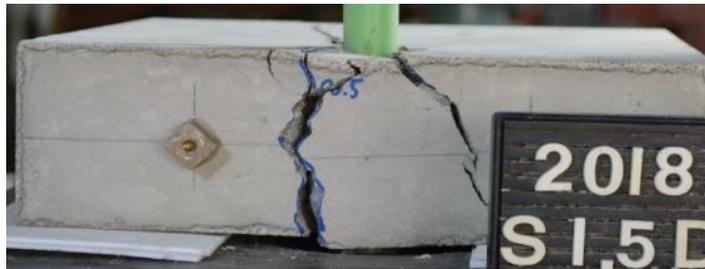
**Fig. 3.10 Splitting with crack opening and newly generated crack**

All specimens experienced failure due to splitting. A group of specimens failed by newly generated splitting crack despite existing longitudinal crack due to corrosion as shown in Fig.3.10 and other specimens failed by widening of existing crack induced by the expansion agent as can be seen in Fig.3.11. The results of pull-out tests are summarized in Table 3.6.

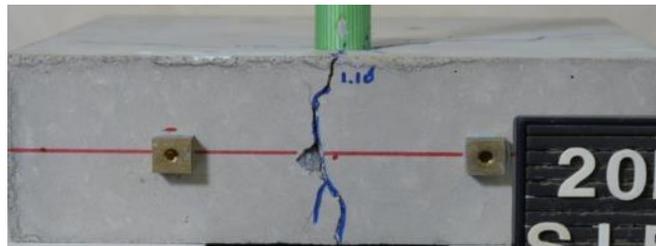
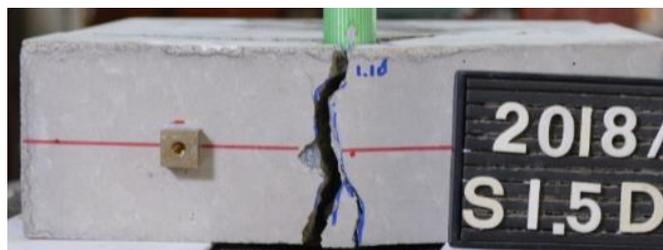
**Fig. 3.11 Splitting with crack opening only**

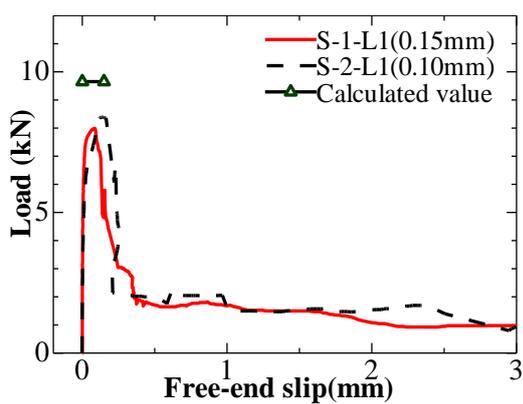
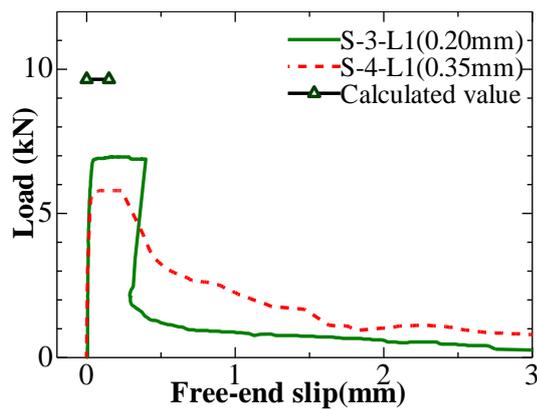
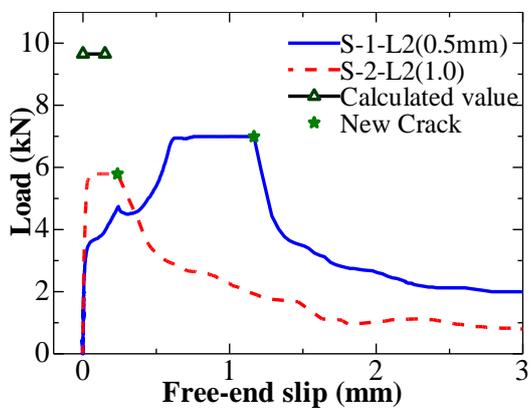
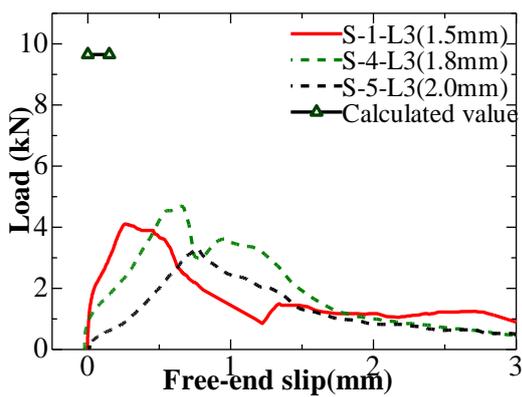
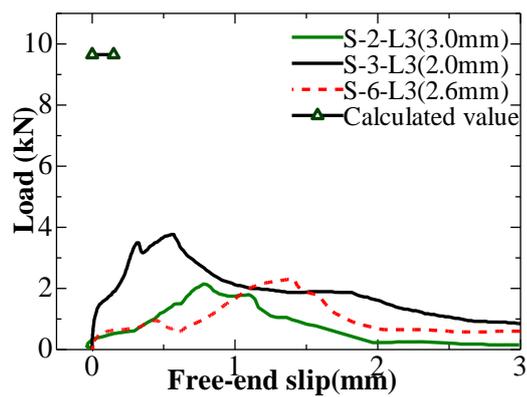
**Fig. 3.12 Load-slippage relationship**

The pull-out load versus slippage relationships are shown in Fig. 3.12. In the case of Level 3 cracks, the load – slippage relationship tends not to results in a severe decrease of load after maximum pull out force. The maximum pull-out load versus crack width relationship is shown in Fig. 3.13. It can be seen that the maximum load decreases as the crack width increases. As expected, there is a significant correlation between residual bond strength and induced crack width.

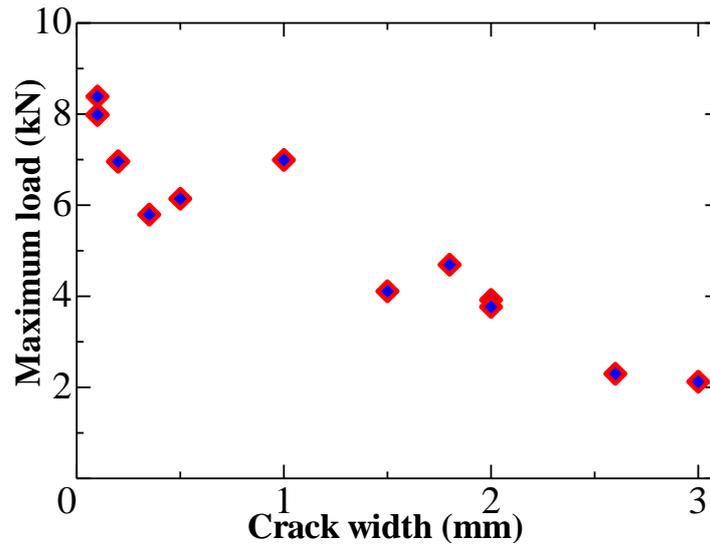
**Fig. 3.13 Maximum pull-out load vs crack width**

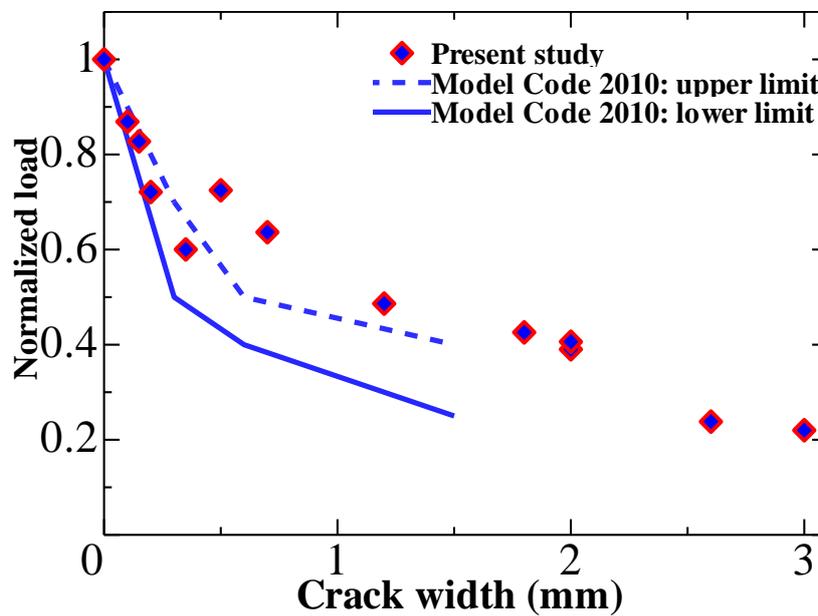
**Fig. 3.14 Result in comparison with fib Model Code 2010**

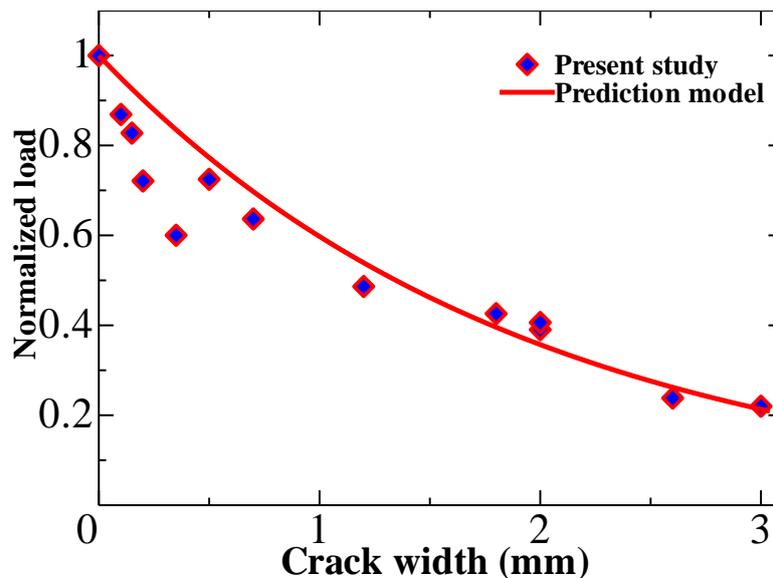
**Fig. 3.15 Result and prediction model**

Analysis	Equations	R <sup>2</sup>
<i>Linear</i>	$-0.306W_{cr}+1$	0.66
<i>Logarithmic</i>	$0.175\ln(W_{cr}) + 0.4916$	0.80
<i>Exponential</i>	$e^{-0.515 W_{cr}}$	0.91

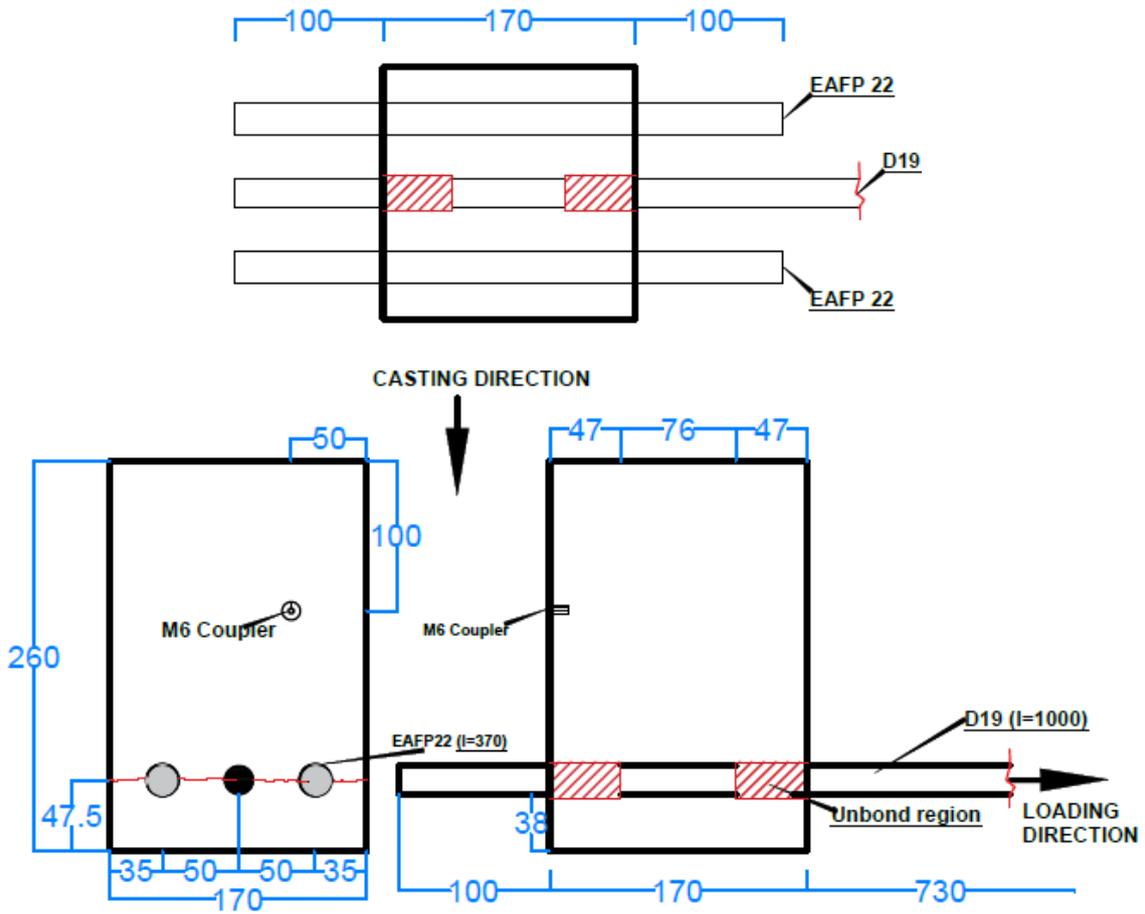
**Fig. 4.1 Specimen details**

The pull-out specimen was designed as shown in Fig.4.1. The dimensions of the specimen were 260×170×170mm and the D19 rebar is embedded at 47.5mm ( $2.5d_b$ ) from the specimen cover side. The framework is shown in Fig. 4.2. A short bond length of 4 times the diameter of the rebar equal to 76 mm was chosen to focus on the local bond. To simulate the cracking of the surrounding concrete of the rebar, 2 aluminum pipes with a diameter of 22mm and a thickness of 1mm were set to 50mm from the rebar. Moreover, an unbonded part was set to avoid cone failure of concrete. The M6 coupler was fixed 100×50 mm at the upright position to set a LDVT for measuring the slip of the free end of the bar. Two  $\pi$ -type displacement transducers were placed on the top and two others on the east and west side of the specimen to measure the opening of crack during loading. Table 4.1 shows the list of the specimens. Table 4.2 shows the mix proportion of used concrete and Table 4.3 shows the mechanical properties of concrete obtained from the concrete cylinder test on the day of filling of expansion agent. The reinforcement is a deformed bar of a nominal diameter of 19 mm. Its mechanical properties are presented in Table 4.4.

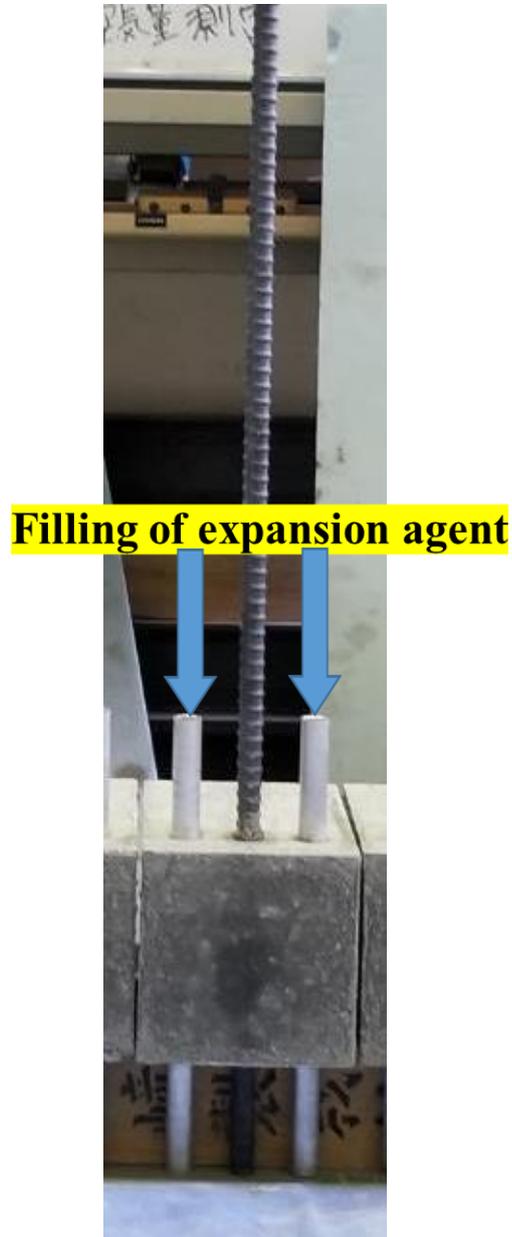
Fig. 4.3 Filling of the expansion agent

The ratio of the water to the expansion agent was set to 30%. The specimen was placed as the axial direction of the pipes was set vertically, and an expansion agent was filled from the top of the pipes as shown in Fig.4 .3.

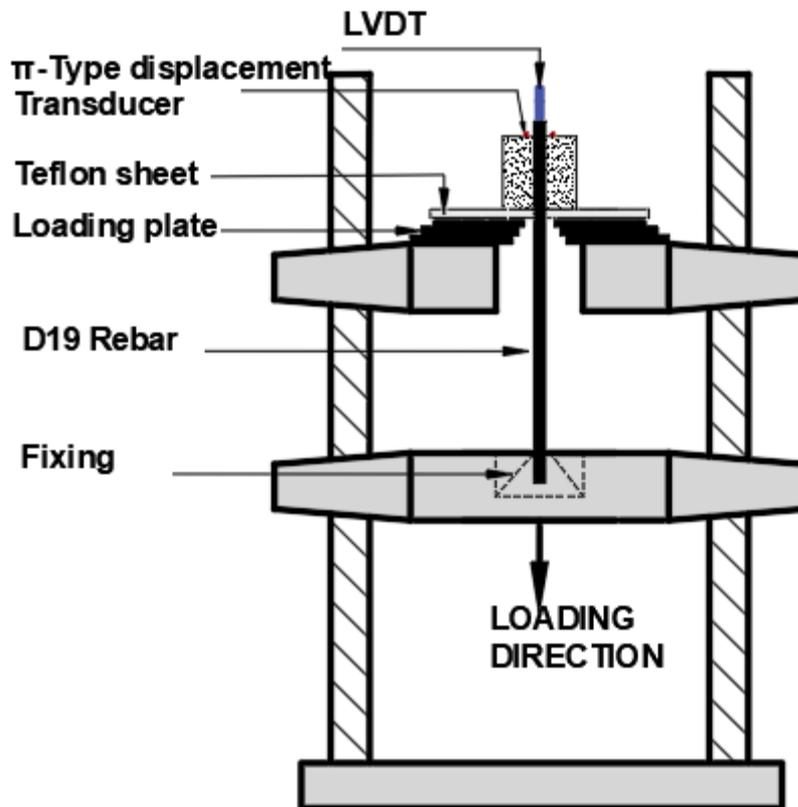
Fig. 4.4 Loading and measurement setup

The loading was carried out at Kanakubo lab in the University of Tsukuba. Fig. 4.4 shows the general set-up for the pull-out test. The specimen was placed on the Teflon sheet and the loading plate on which the hole with the same diameter corresponding to concrete cover in order to not restrict the lateral deformation of concrete. This detail can be seen from Fig 4.5 and Fig.4.6. The D19 rebar was subjected to monotonic pull-out loading at a speed of 0.5mm/min with a Universal Testing Machine. The measurement items are pull-out load, crack opening and slippage of the D19 rebar at the free end.

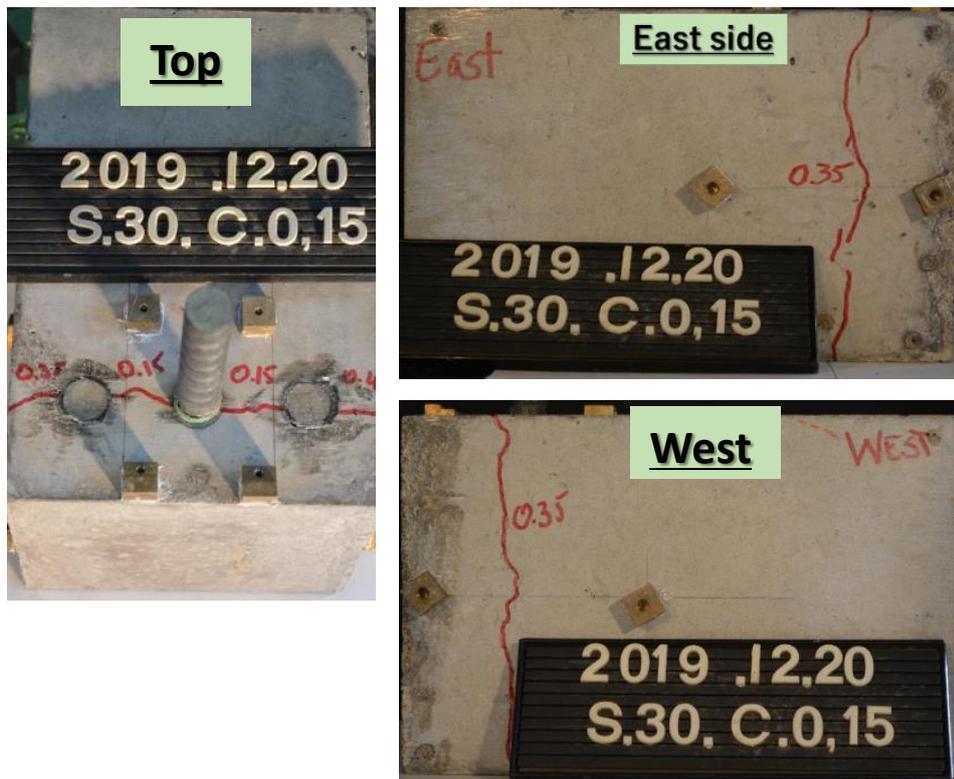
Fig. 4.7 Cracking of concrete after filling the expansion agent

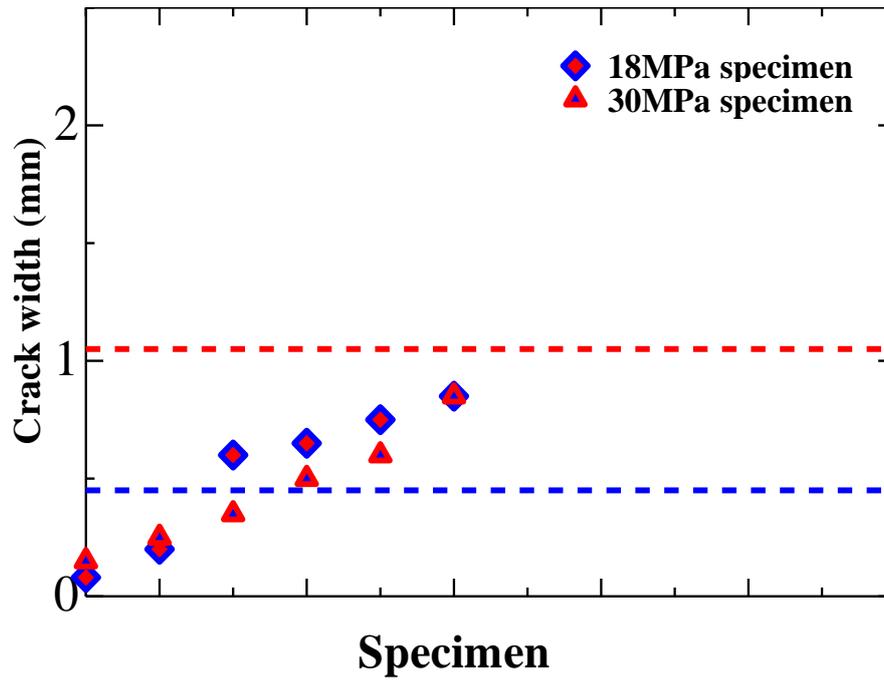
Fig. 4.8 Distribution of crack width

The maximum crack width on the top side (bottom side at the filling) in every specimen is summarized in Table 4.5. To better observe the distribution of cracking among the specimens, the maximum cracks widths was are plotted in Fig 4.8.

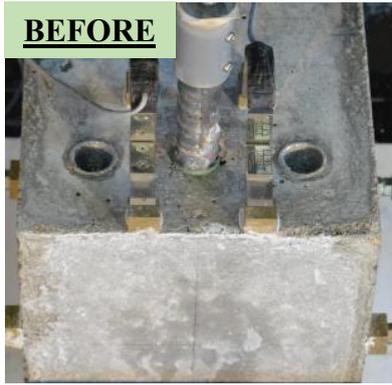
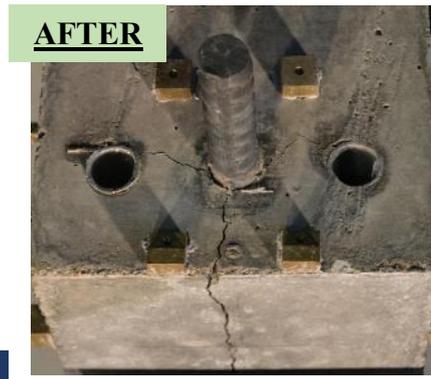
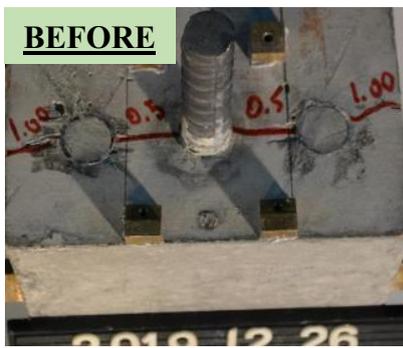
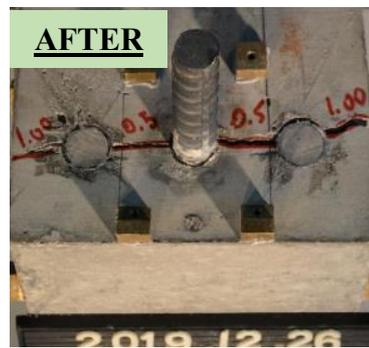
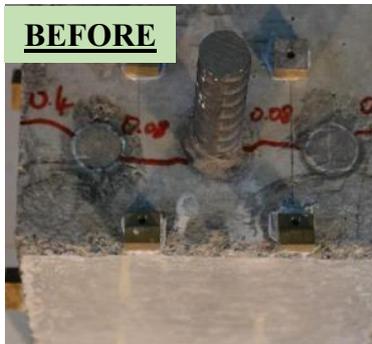
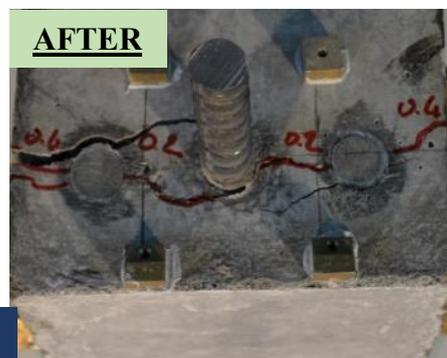
Fig. 4.9 Failure mode

All specimens experienced failure due to splitting. The specimens without crack failed by single splitting due to the limited cover thickness. In the crack induced specimens, most of them failed by side-splitting due to the opening of pre-existent cracks. In side-splitting failure, some specimens presented newly side crack (named N1 with one new crack, named N2 with two new cracks). All the failure modes are summarized in Fig 4.9. Depending on the failure mode, concrete between the ribs was totally damaged or without any damage. This can be seen in Fig 4.10. The results of pull-out tests are shown in Table 4.6.

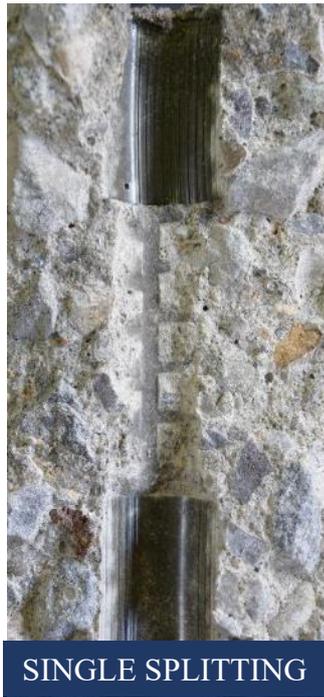
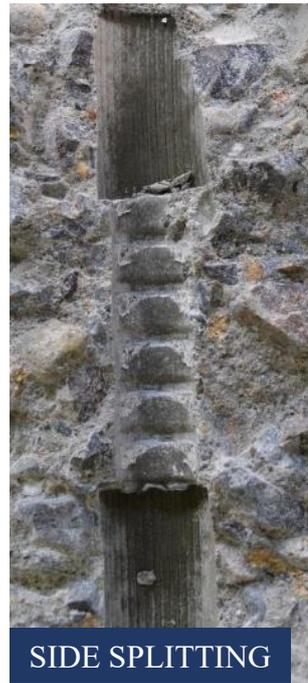
**Fig. 4.10 Damage inside the bond part**
