# **Study on Bond Degradation of Rebars in Cracked Concrete due to Bar Corrosion**

**SYLL AMADOU SAKHIR**

Submitted to the Graduate School of  
Systems and Information Engineering  
in Partial Fulfillment of the Requirements  
for the Degree of Master of Engineering  
at the  
University of Tsukuba

March 2020

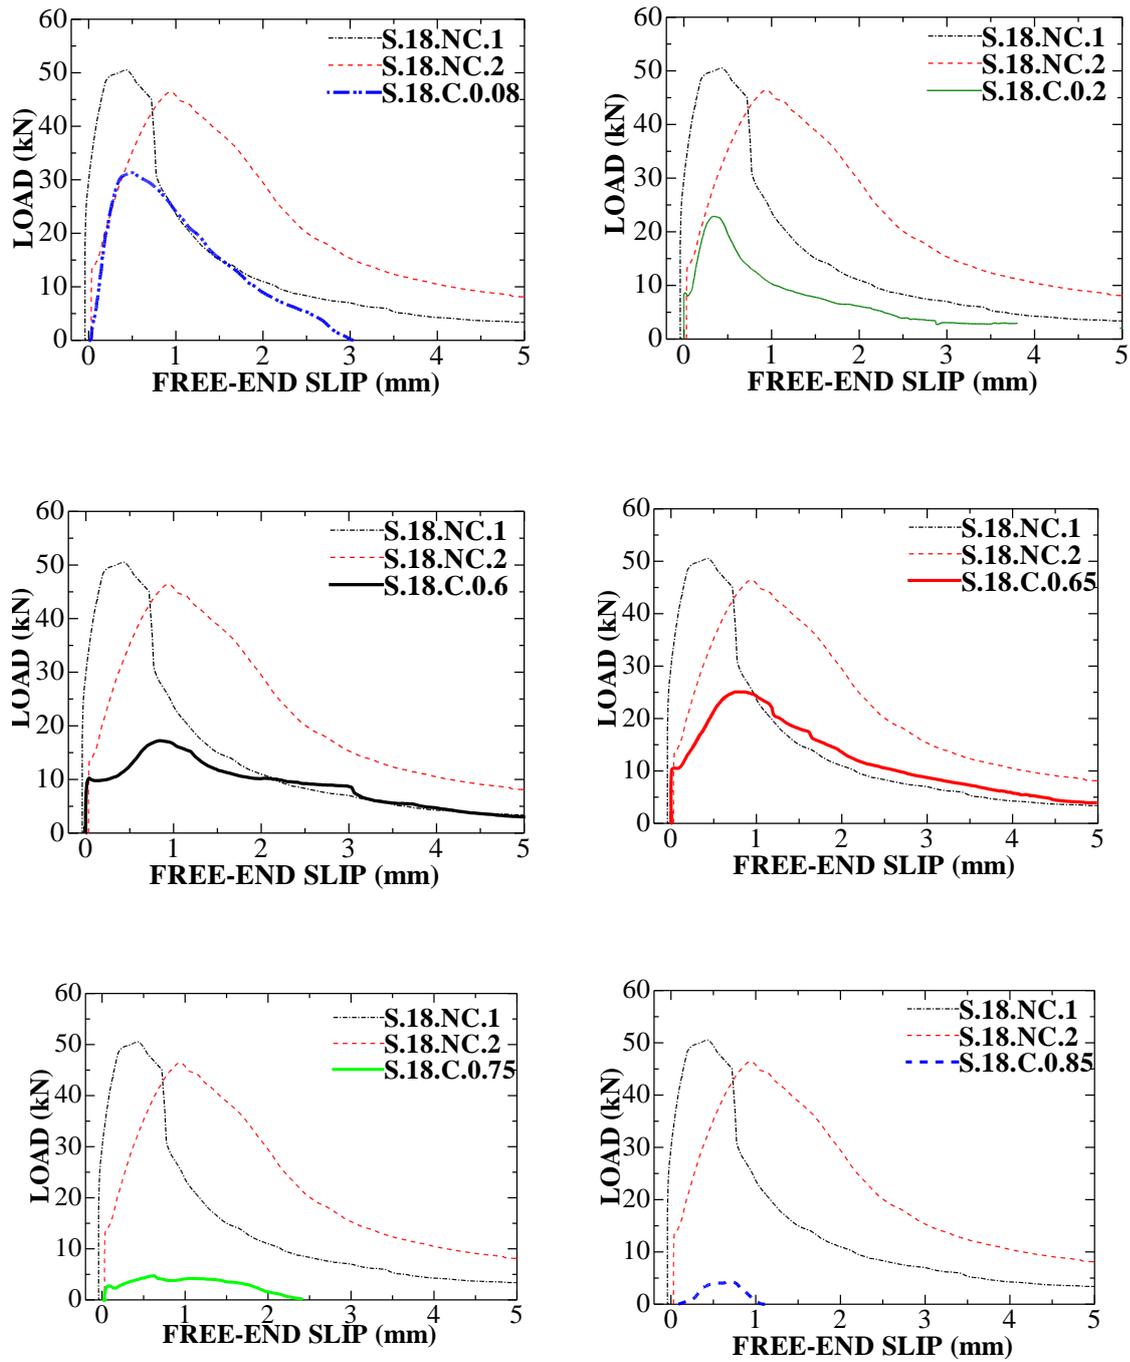
**Fig. 4.11 Pull-out load versus slip at free-end for 18 MPa specimens**

The decrease of the pull-out load is more severe in 18MPa specimens than in 30 MPa specimens. A possible explanation for this might be that the 30MPa concrete has a stiffer response than the 18MPa concrete in both compression and tension therefore the crack opening may be delayed. Another possible explanation for this is that the confinement effect developed by the same concrete cover is perhaps more effective in 30MPa concrete.

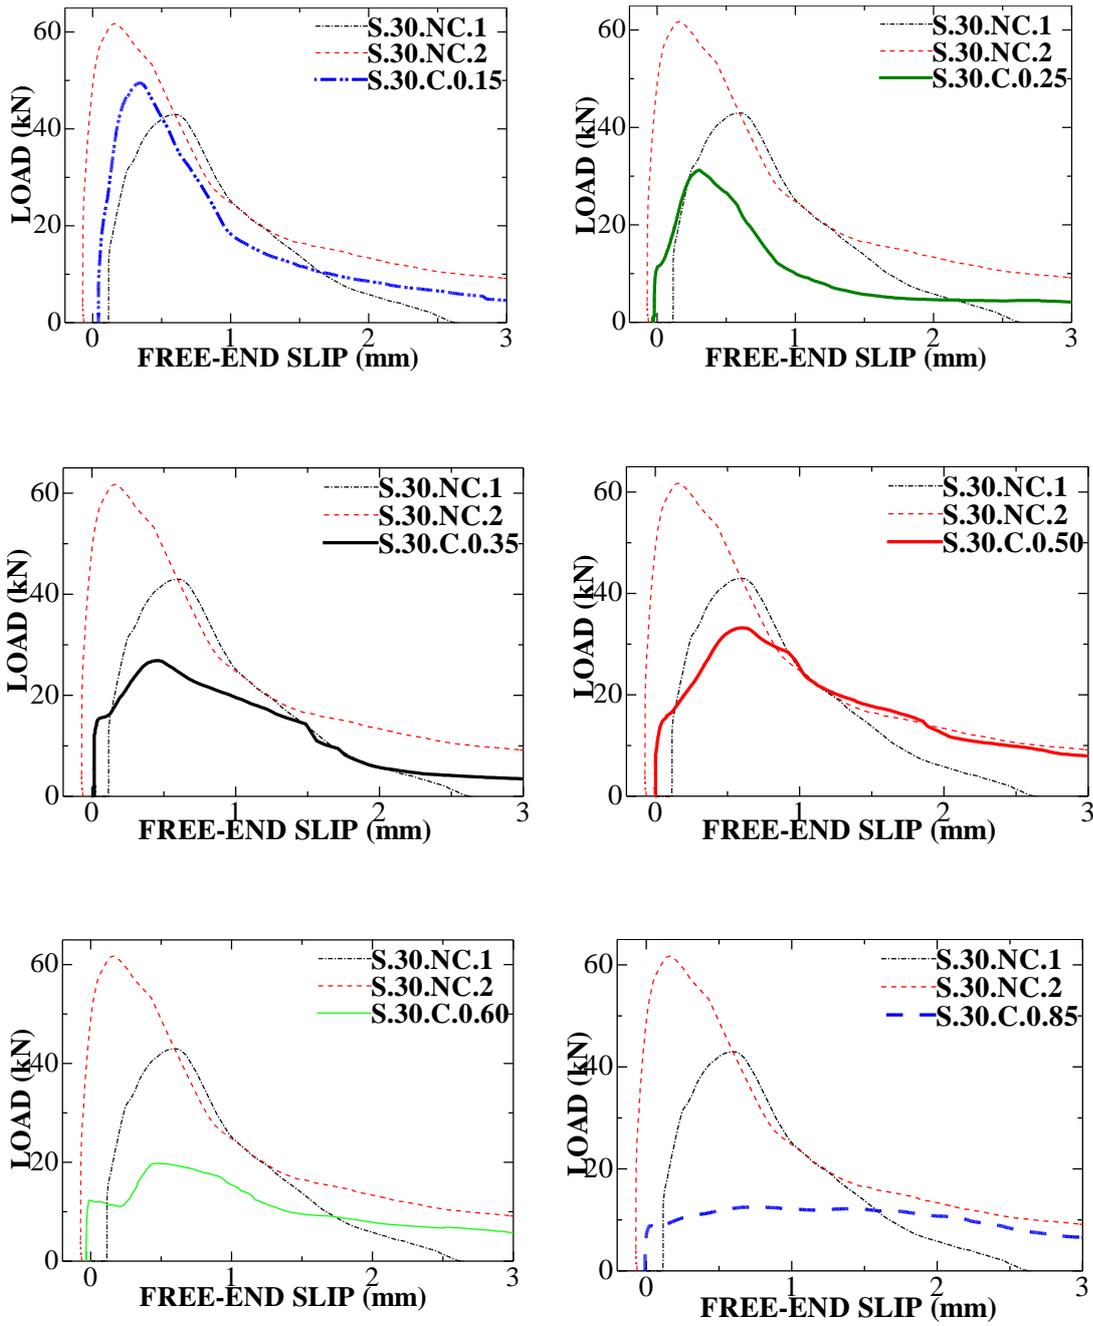
**Fig. 4.12 Pull-out load versus slip at free-end for 30 MPa specimens**

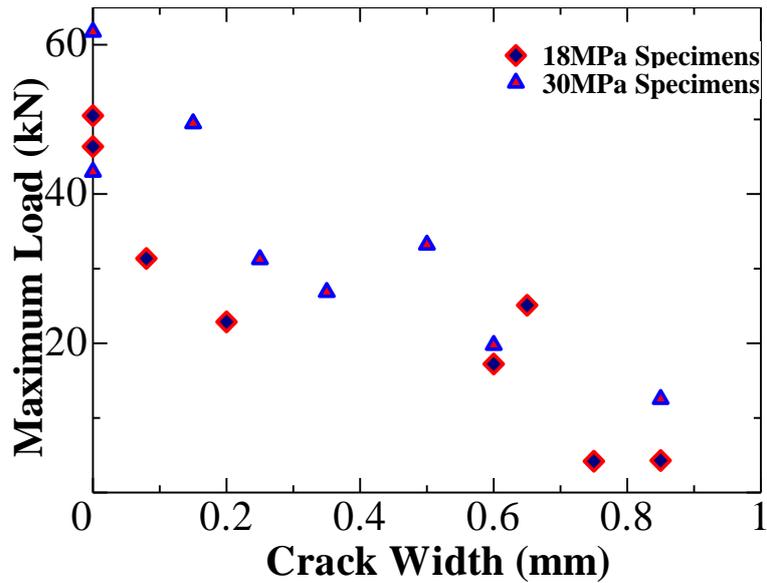
Fig. 4.13 Maximum pull-out load versus crack width before loading

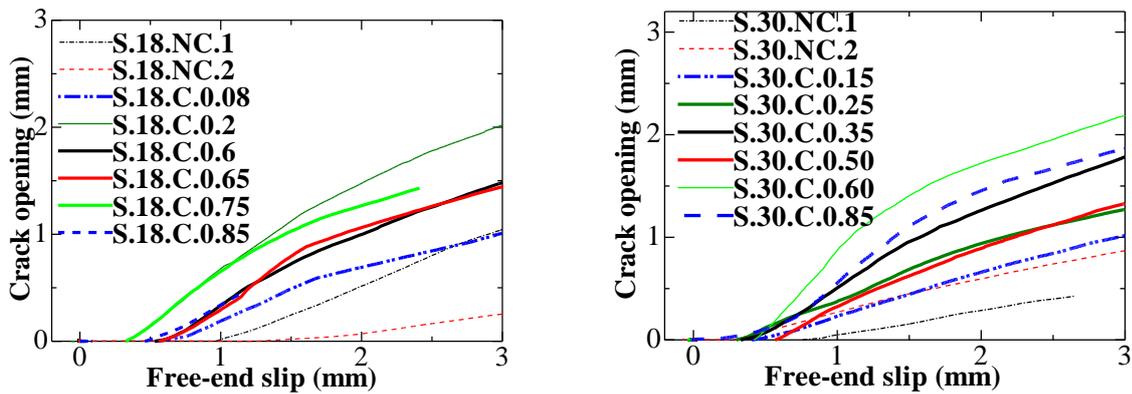
Fig. 4.14 Crack opening versus slip

The Crack opening versus slip is plotted in Fig.4.14. The crack opening is measured by displacement transducers without including crack width before loading. In the case of plural cracks, crack opening shows the summation of the width of cracks that occurred in the gauge length of displacement transducers. With increasing of slip, the opening seems to start earlier and develop faster in case of side-splitting without new crack. In the case of an apparition of new cracks, the opening of the crack is fastest and reaches the highest value compared to other specimens. However, in some specimens, no evidence was found.

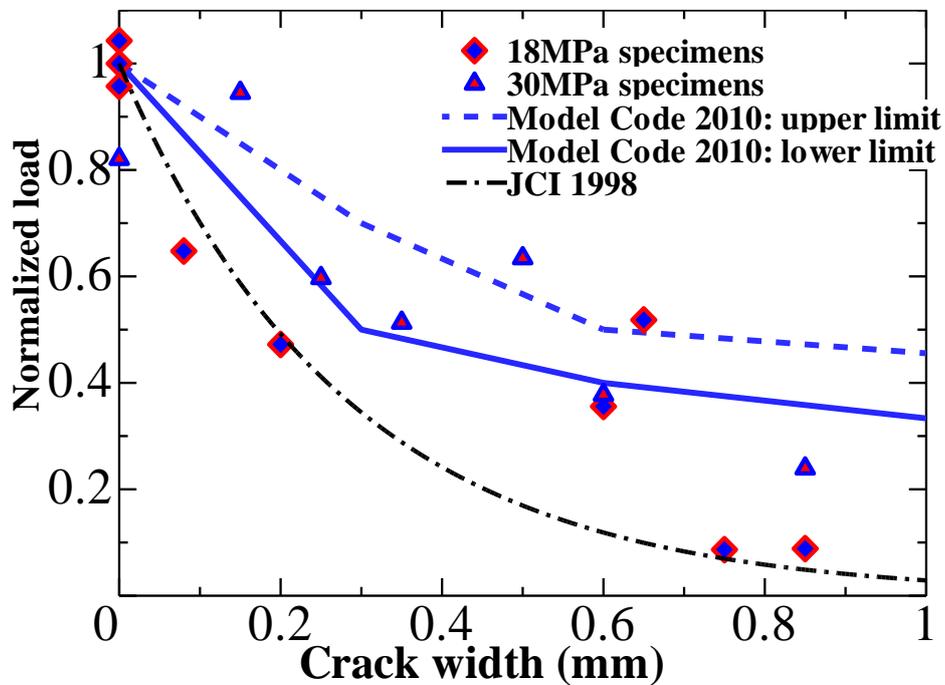
Fig. 4.15 Comparison with fib model 2010 and JCI 1998

The prediction with Japan Concrete Institute 1998 is in good agreement with S.18.C.0.08, S.18.C.0.2, S.18.C.0.75 and S.18.C.0.85. However, our results are overestimated for 30 MPa specimens.

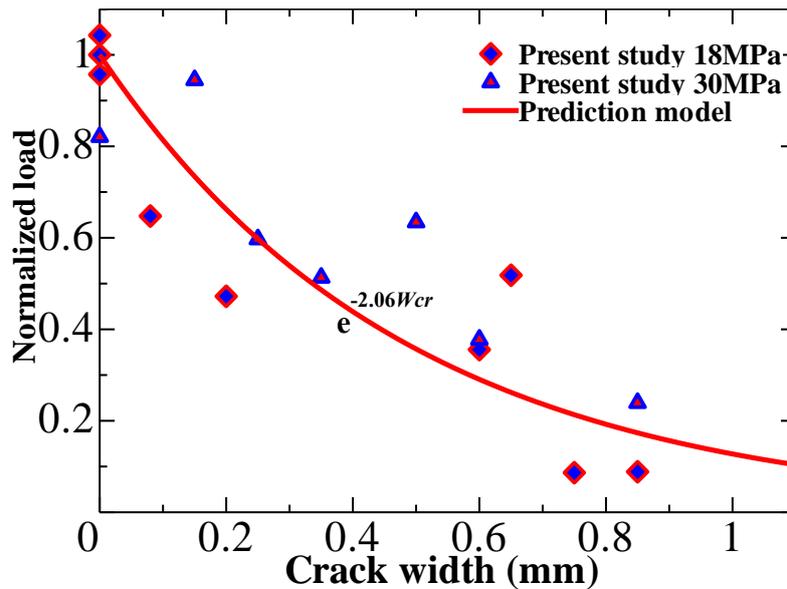
Fig. 4.16 Result and prediction model

Analysis	Equations	R <sup>2</sup>
<i>Linear</i>	$-0.103W_{cr}+1$	0.71
<i>Logarithmic</i>	$-0.24(W_{cr}) + 0.23$	0.62
<i>Exponential</i>	$e^{-2.06 W_{cr}}$	0.82

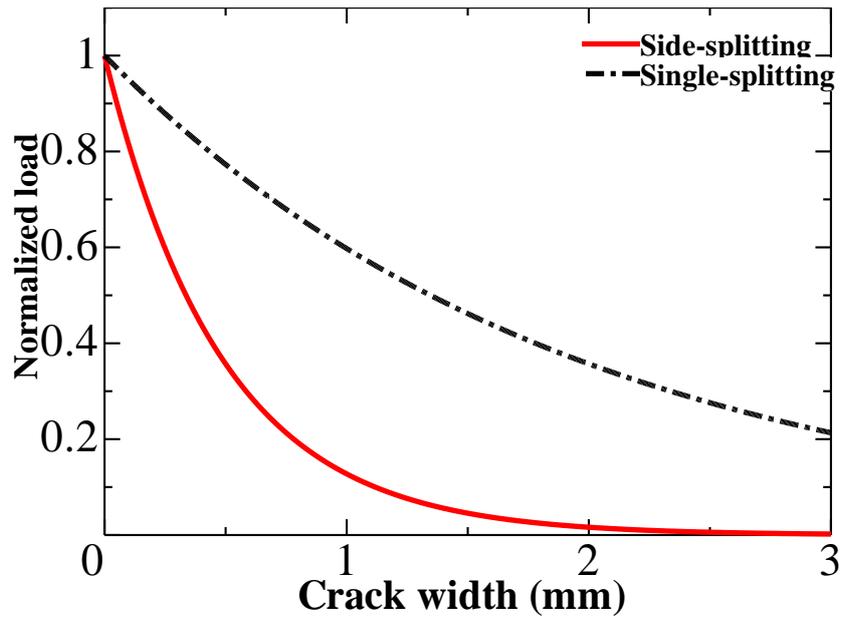
**Fig. 4.17** Proposed evaluation formula from test result
