# **A Numerical Investigation on the Collapse of** the Champlain Towers South in Florida

Abstract— In this study, the Champlain Towers South building collapse in Florida allegedly caused by a deck collapse was examined through the finite element analysis based on the existing hypotheses and investigation. The Adaptively Shifted Integration (ASI) – Gauss code was applied for the numerical analysis. In addition, the member strength failure algorithm of RC components was modified, and the flat-plate structure was introduced into the numerical model of the building. According to the analyses, the building did not collapse when the pool deck beams connecting to the columns of the 1stfloor interior, so-called key columns, were removed by the collapse of the pool deck. When the model was revised to include deterioration of concrete slab and corrosion of rebars, and then triggered by the removal of columns in the underground parking garage, the middle section of the buildings reached a total collapse. This supports the latest collapse theories, which cite punching shear failure at pool deck columns as the initiating event.

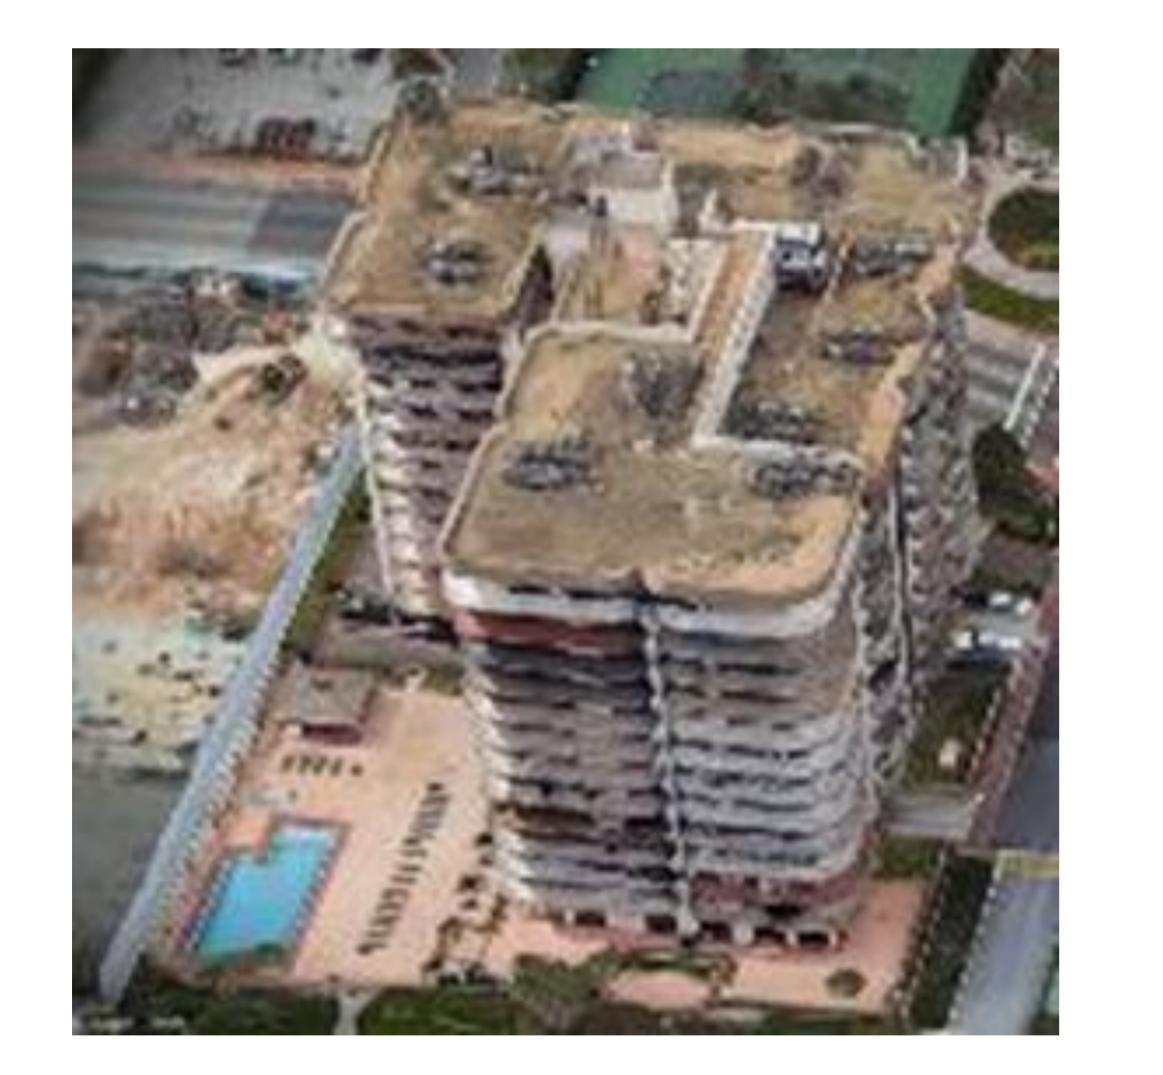
Figure 1. Champlain Towers South Condominium.

The middle and eastern sections of Champlain Towers South in Florida (Fig. 1), USA, a 13-story condominium built in 1981, collapsed without warning at approximately 1:25 a.m. on June 24, 2021. According to the surveillance video, the collapses of the middle section and the following eastern section only lasted for 12 seconds (Fig. 2). At least half of the 136 units in the building had collapsed (Fig. 3), and all of them were characterized by the fact that they collapsed instantly after it began to collapse.

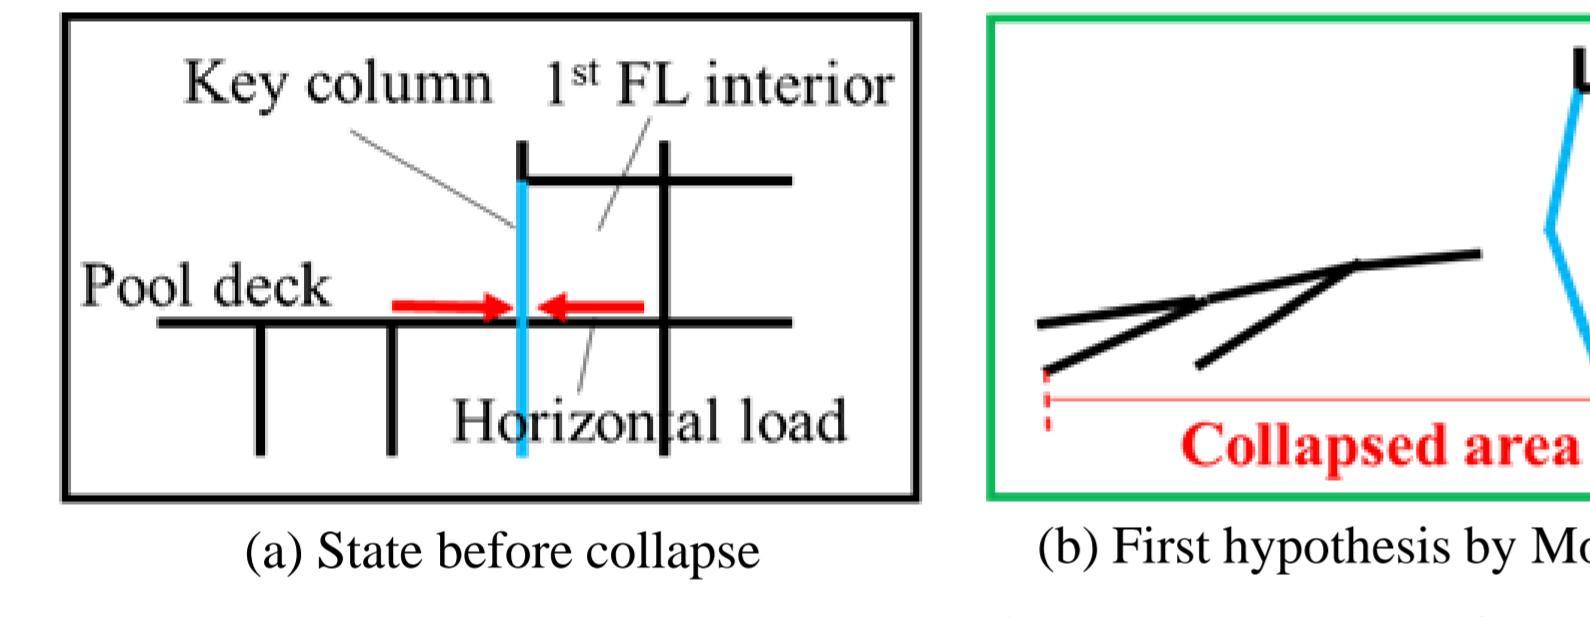
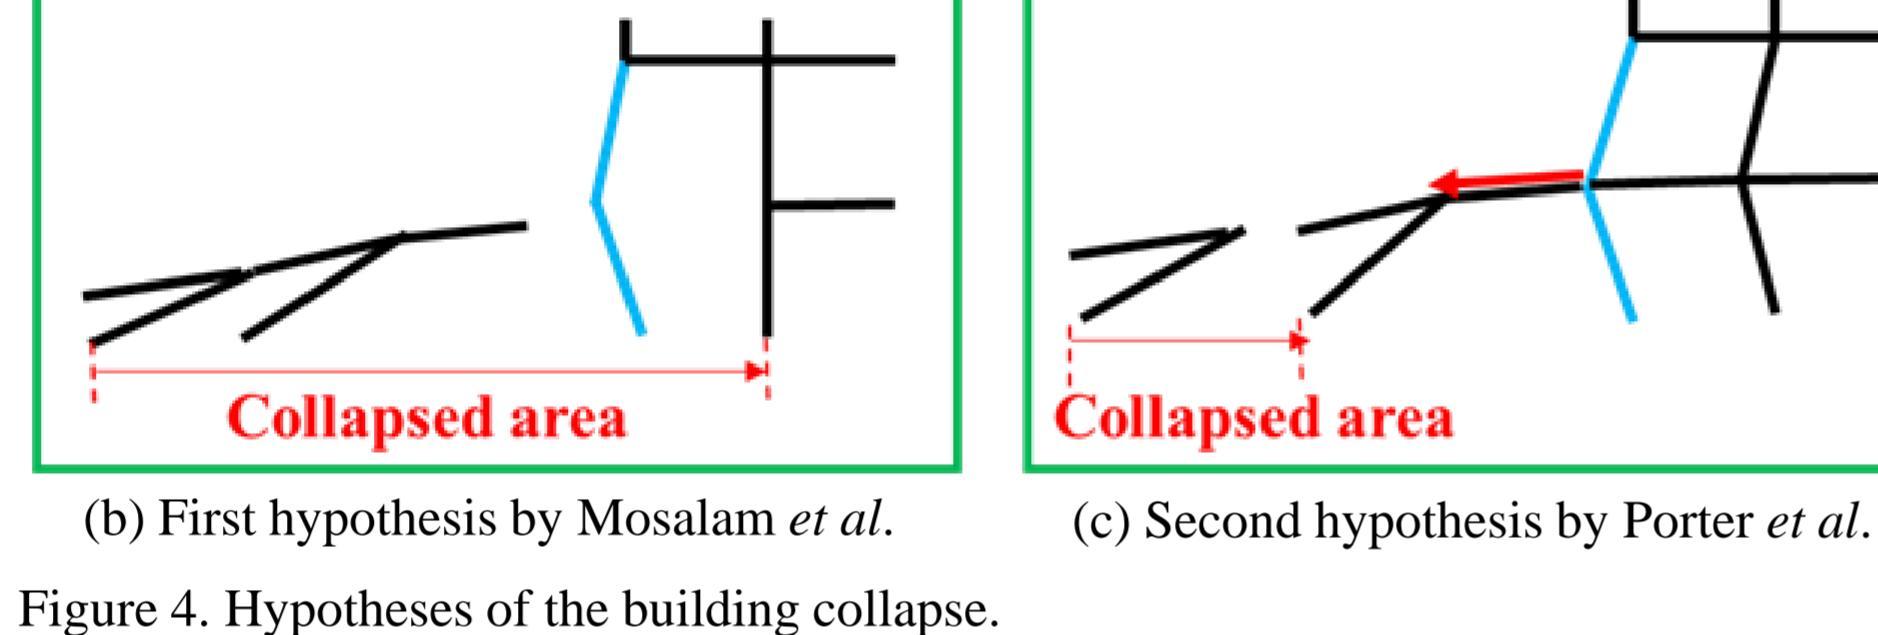
Figure 5. Numerical results based on the hypotheses with pool deck collapse as the main cause.

A 13-story RC building model was analyzed based on the hypotheses published in newspapers (Fig. 4). In the case where the extent of pool deck collapse exceeded the key column (Hypothesis 1), neither the final state nor buckling of the key column was confirmed. In the case where the extent of pool deck failure did not exceed the key column (Hypothesis 2), the key column was in the final state, but the entire building did not collapse (Fig.

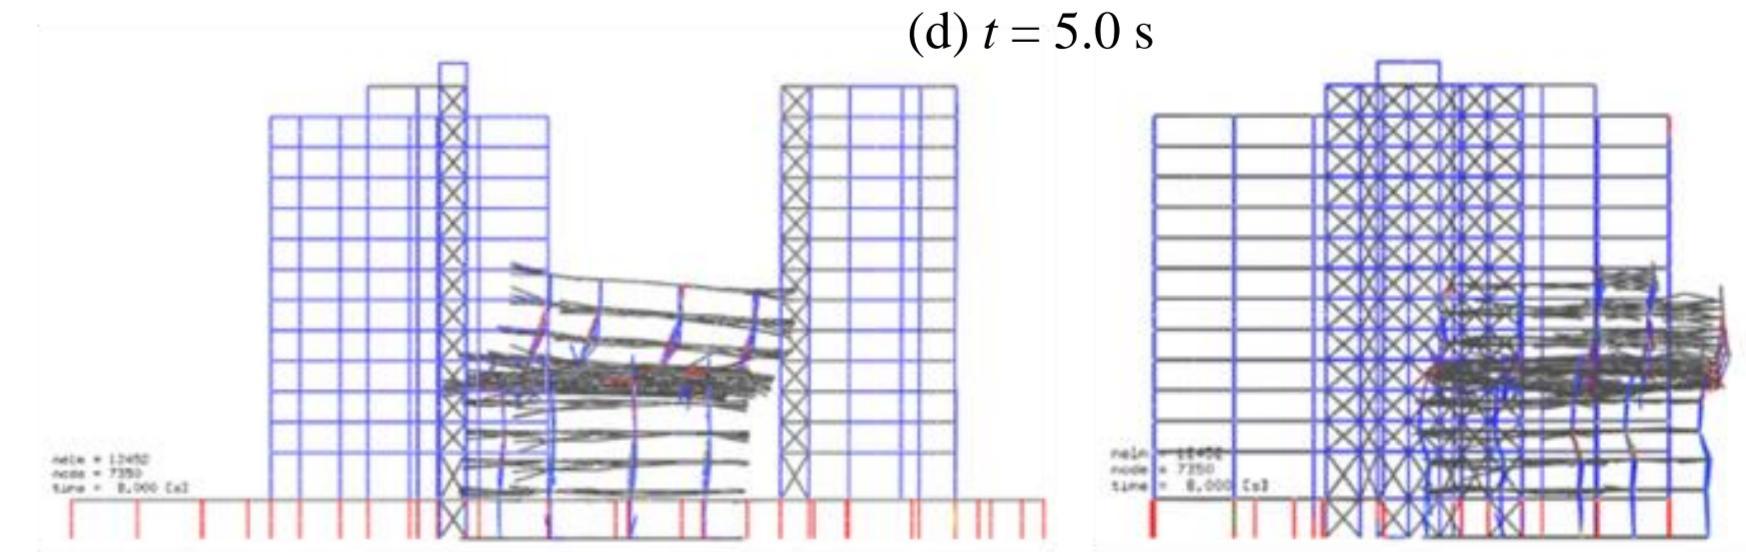
Figure 12. Numerical conditions based on the hypothesis with deterioration of concrete slabs, corrosion of rebars, and loss of key columns as the main cause.

A collapse analysis was conducted based on the hypothesis that removal of key columns was the main cause of the collapse, by constructing a model that considered the pullout of the rebar and the reduction in the bearing capacity of the reinforced concrete based on the investigation (Fig. 6 - Fig. 12). The model confirmed the collapse of the middle section, but no collapse was observed in the eastern section of the building (Fig. 13).. These results suggest that the pullout of the rebar at the connection joint between the wind-resistant wall and the flat-plate floor, the reduction in bearing capacity of the basement columns, and the removal of key columns were some of the main mechanisms of the collapse of the Florida Condominiums.
