Numerical Investigation on the Collapse of the CTV Building Caused by the 2011 New Zealand Earthquake

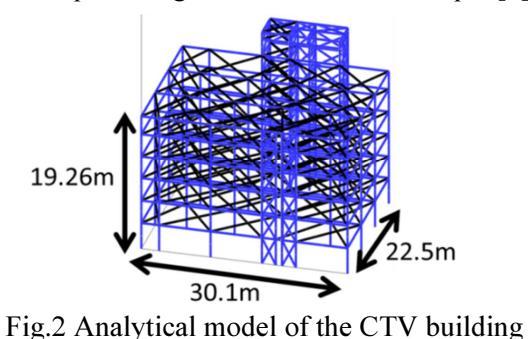
is adopted. An analytical model of the CTV building (Fig.2) is constructed based upon the structural drawing of the building. The numerical result showed a collapse behavior of a same feature with the investigation mentioned above, and it showed that the building had a problem with the structural design. We also investigated a connection between the collapse behavior of the CTV building and the structural damage resulted by the prior earthquake.
