Report on Building Damage in Central Ibaraki Prefecture by
The 2011 off the Pacific Coast of Tohoku Earthquake
Released on April 3, 2011

Dr. Toshiyuki Kanakubo,
Department of Engineering Mechanics and Energy
Graduate School of Systems and Information Engineering,
University of Tsukuba
Dr. Juan Jose Castro
Center for International Education and Exchange, Osaka University
(Translated by Shunsuke Otani, University of Tokyo)

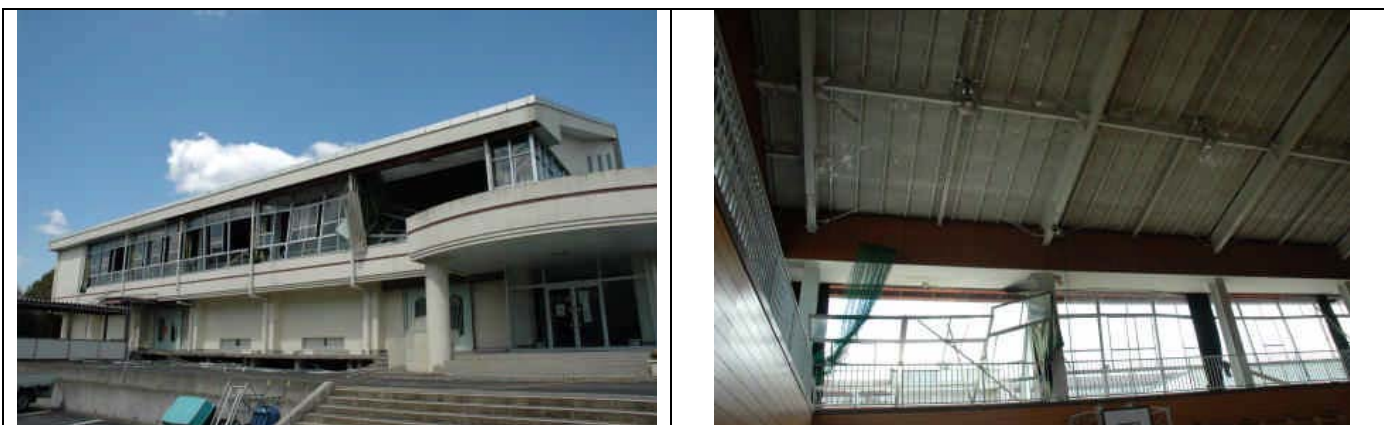
The Kanasago Elementary School is located on a hill, The gymnasium (Photo 8) was constructed in 1987; the first story is reinforced concrete and the second story is steel frame construction; there are vertical brace members in the end walls. In the gymnasium building, glass panes of the second story came off (Photo 8) and the deformation of ceiling brace members were observed (Photos 9 and 10). No damage was observed in the vertical brace members in the end wall and the first-story reinforced concrete columns (Photo 11).

Photo 8: Overall view of the gymnasium

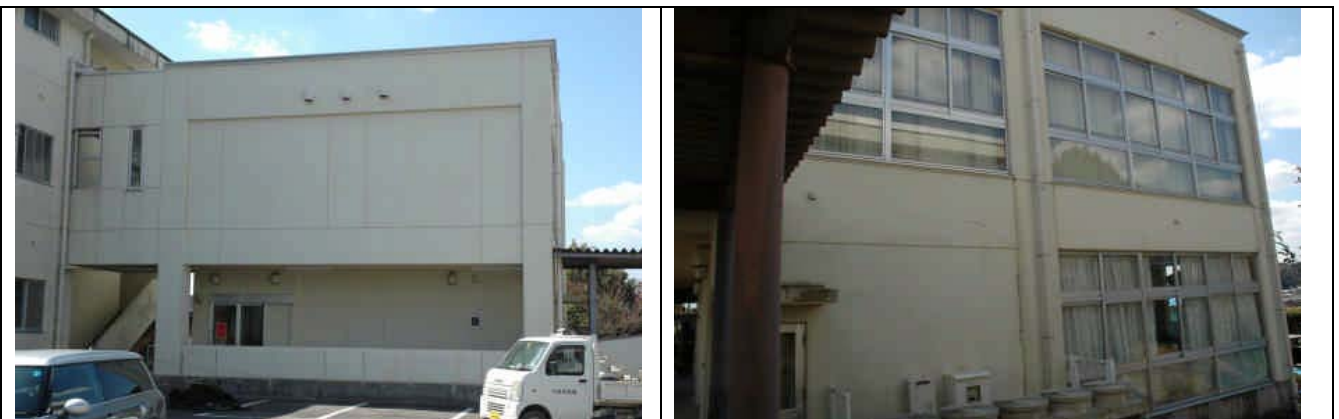
A special visual and audio education building was constructed in 2003; two-stories reinforced concrete moment-resisting frame building with 2 bays in longitudinal direction and one span in the transverse direction. Horizontal cracks in a girder, breakage of glasses (Photo 13), a diagonal crack and spalling of concrete at the top and bottom of a first story column were observed (Photo 14). Cracking does not seem to be caused by the horizontal ground shaking, there could be some effect of vertical ground shaking or uneven settlement.

Photo 12: Overall view of a visual and audio education building.

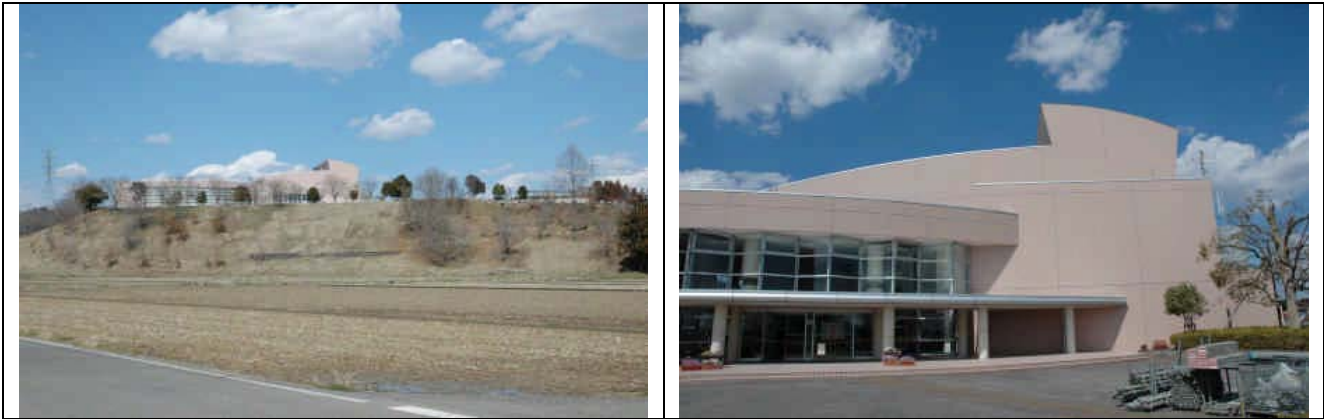
The Municipal Exchange Center building (Photo 15) is located on the same hill as the Kanasago Elementary School. The two-story reinforced concrete building was completed in 1997. The main hall is two-story open ceiling and one quarter of ceiling panels fell down (Photo 16, left). Spalling of concrete was observed in the long span girder above the stage presumably caused by out-of-plane bending (Photo 16, right). The concrete spalling was observed at mid-height of a tall column of the entrance hall; horizontal cracks were observed in other columns at about same height, these cracks may be associated with concrete placement joint.

Photo 15: Overall view of the Municipal Exchange Center Building

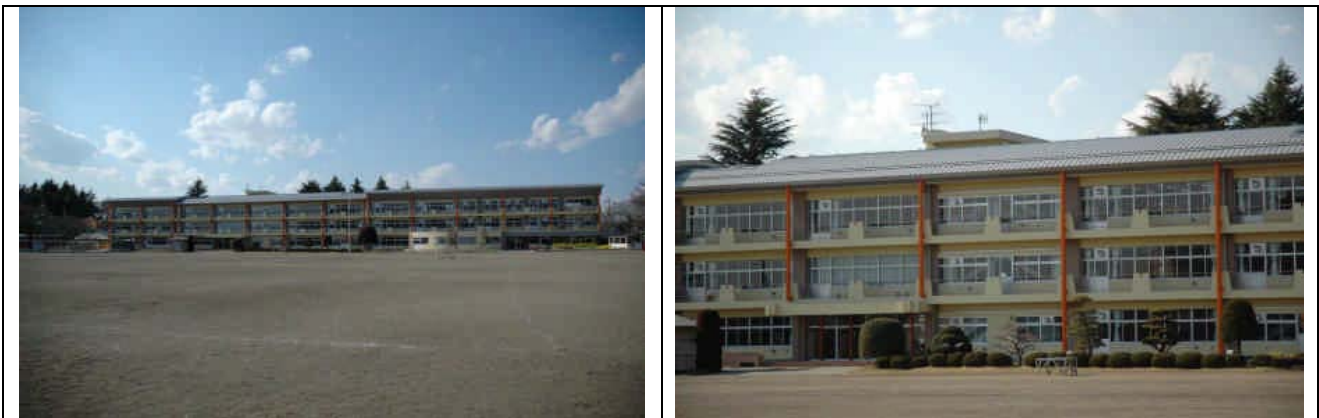
The Godai School three-story reinforced concrete building (Photo 18) was constructed before the enforcement of New Seismic Design provisions (1981). The building was retrofitted in 2006. No serious damage was observed in the structure, the penthouse (moment resisting frames in X-direction and walls in Y-direction) failed in flexure (Photo 19). At the expansion joint between the existing building and a new steel addition, ceiling panel dropped (Photo 20).

Photo 18: Overall view of Godai Elementary School

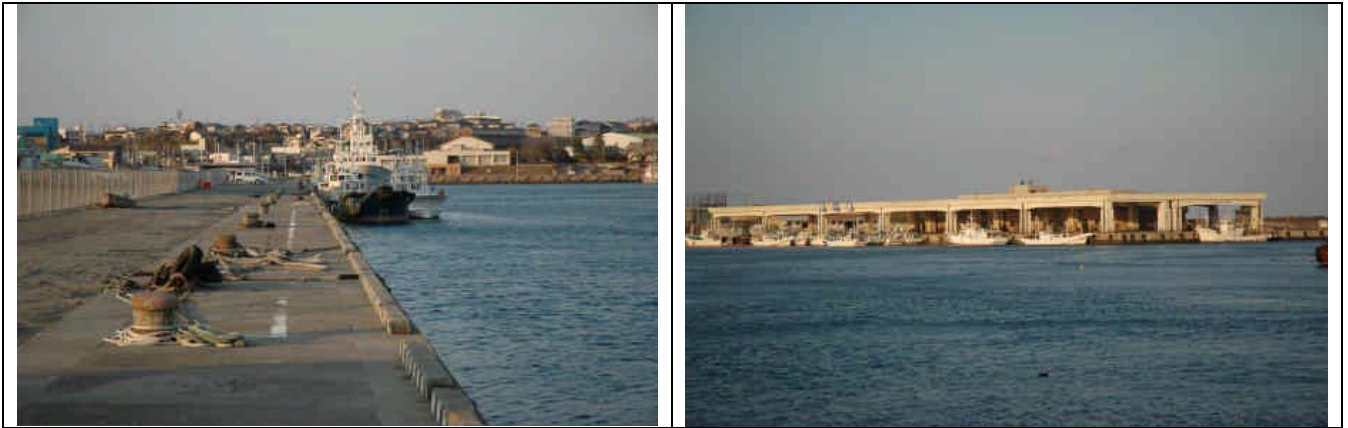
Shops of marine products were inundated above the floor, but they were cleaned at the time of visit. The harbor was also cleared and cleaned.

Photo 22: Naka-Minato Port
