## Damage Estimation of Steel Frame Buildings under Fire Using Collapse Analysis

Jun-ichi Suzuki<sup>1</sup>, Naoki Yokemura<sup>2</sup> and Daigoro Isobe<sup>3</sup>

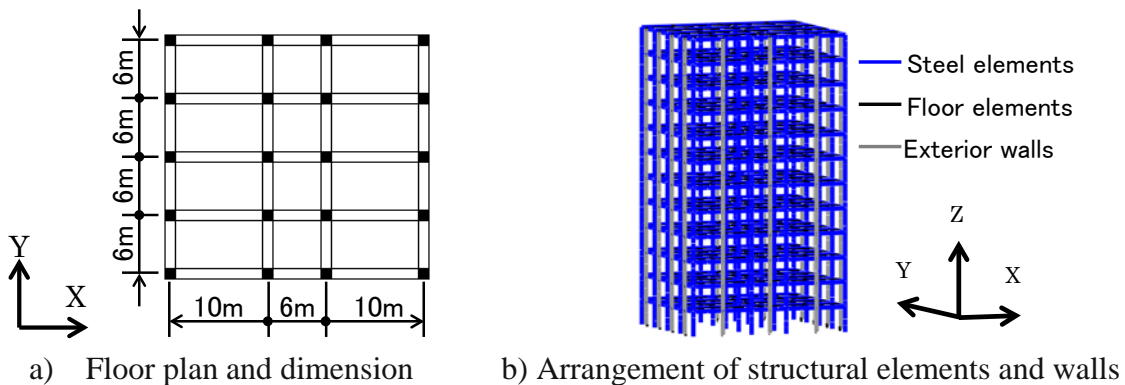
Figure 1 Structural model of steel frame building

A modified ASI-Gauss technique [1], which included a computational algorithm for degradations of structural materials at high temperatures, was used to conduct fire response analysis for interactions between steel frame structures and exterior walls of a building in this research. Figure 1 showed the floor plan of 12-storey steel frame building for the fire response analysis. The specification of the building was listed in Table 1. The dimension of the building was 48 m high, 24 m wide (4-bay) and 26m long (3-bay). Steel grade of the structures was SS400 (mild steel). The building's structure was designed for appropriate seismic capacity with a typical base-shear coefficient ( $C_b = 0.167$ ). Autoclaved aerated concrete panel (AAC) and fastening method of AAC was also modeled as exterior walls in the analysis. Criteria for detaching a wall from structures were that the rotation angle of the wall exceeded 1/20 in in-plane or out-of-plane deformation shown in Figure 2 and 3 [2].

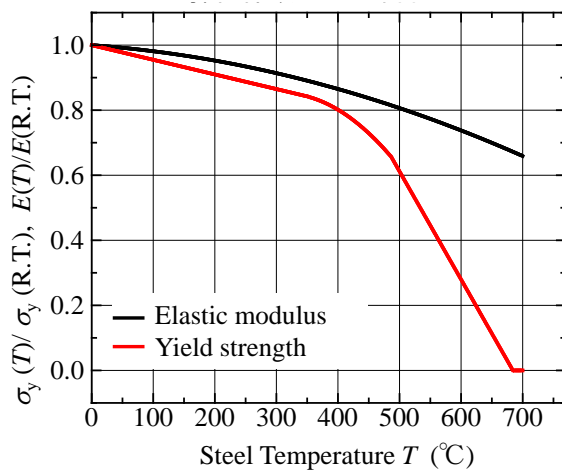
Figure 4 Residual mechanical properties at high temperatures[2]

Fire responses of the 12-storey steel frame building with exterior walls in various fire cases shown in Table 2 were analyzed. A fire in the building was simply simulated by neglecting varieties of fire spread in the building, non-uniform fire heating, thermal conduction from heated elements to adjacent elements and so on. Increase in temperature of structures in a fire compartment was considered as one of the effects of fire exposure. Thermal expansion of structural elements, degradations of elasticity and yield strength of materials in Figure 4 were

also implemented [3].

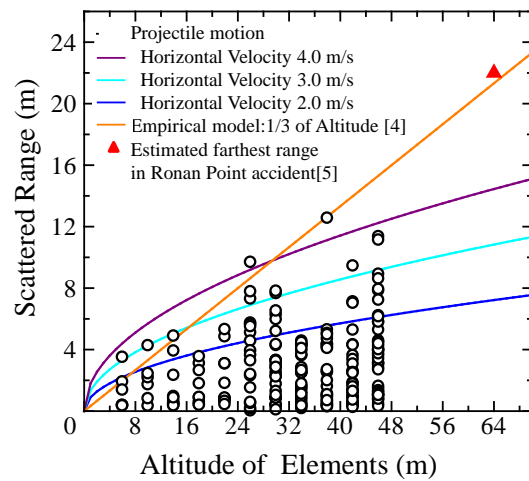
Figure 5 Relation between scattered range and altitude of building elements [4, 5]

As a result of fire response analysis, it became obvious that falling of exterior walls was caused by large deformation of local elements even if damage of the whole building was not severe. Figure 5 showed the horizontal distance of scattered building elements from the edge of the building. Empirical model [4] for estimating scattered range of exterior tiles and three curves based on projectile motion with different horizontal velocities were also drawn. Building elements located in high altitude have a high possibility of scattering farther from the building. The calculated curve of projectile motion with horizontal velocity 4.0 m/s was able to cover almost all data obtained from the analysis. The empirical model also provided approximate values for the maximum distances of the analysis and Ronan Point Apartment Tower Accident [5]. It was found that horizontal velocity of elements was induced by contact and rebound motions between building components in many cases.

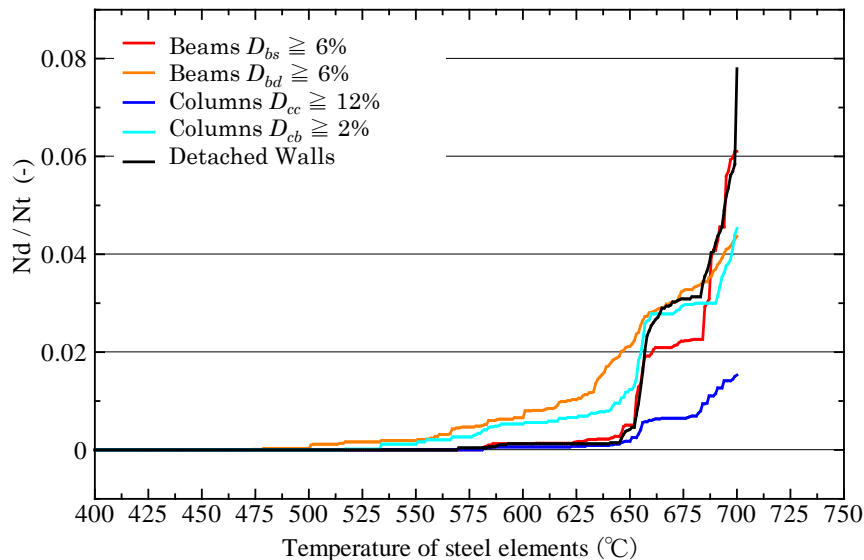
Figure 7 Temperatures of steel elements and degree of damaged elements

Figure 6 showed typical deformation type of structures in a fire. We estimated the damage of structure by 4 types of deformation: Slant angle of beams (1) and deflection at midpoints of beams (2), contraction of columns (3) and bending deformation of columns (4). Figure 7 showed the relation between steel temperature and degree of damaged elements  $Nd/Nt$ . Here,  $Nd$  was the number of deformed elements or detached walls.  $Nt$  was the total number of elements above fire floor. The number of detached walls correlated strongly with  $D_{bs}$ . On the other hand,  $D_{bd}$  did not influence on the damage of walls. In general, the severe damages of outer columns and beams affect largely to the fall of exterior walls; however, some exceptions where severe damages of inner structure affect the fall of exterior walls were observed.
